ALMA MATER STUDIORUM - UNIVERSITÀ DI BOLOGNA

TESI DI LAUREA

BRIDGE FAILURES:

CAUSES, CONSEQUENCES AND CHANGES IN CODES

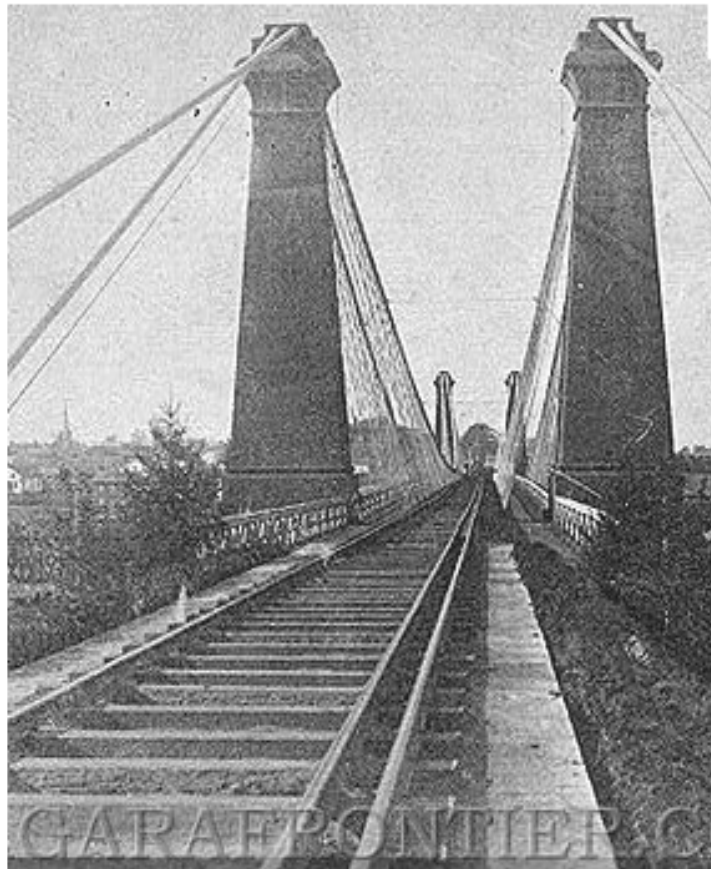
Figure 3

Ashtabula (cast iron) bridge, Ohio

Therefore the structure was deficient in many parts and the failure of one of these weak parts was the trigger.

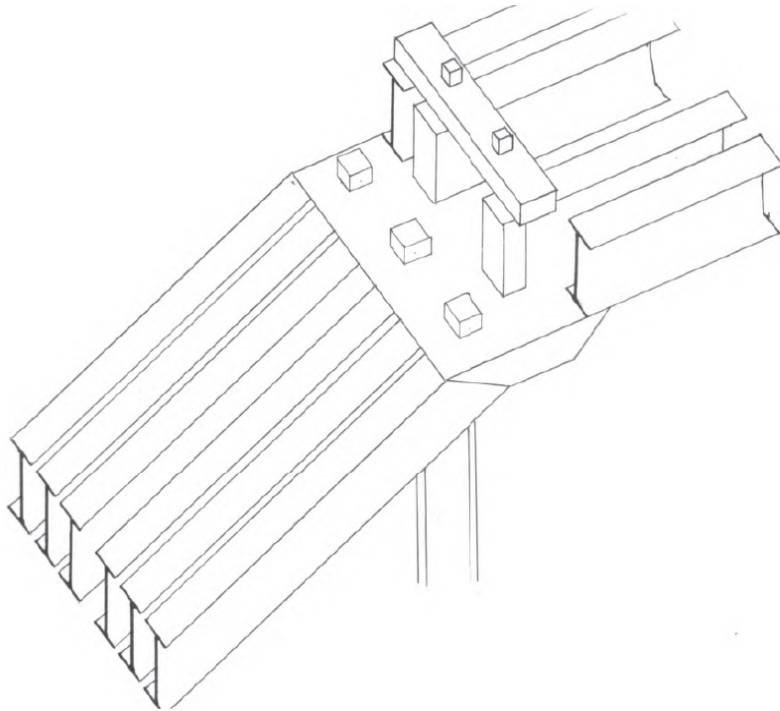
Figure 4:Joints acting like free hands

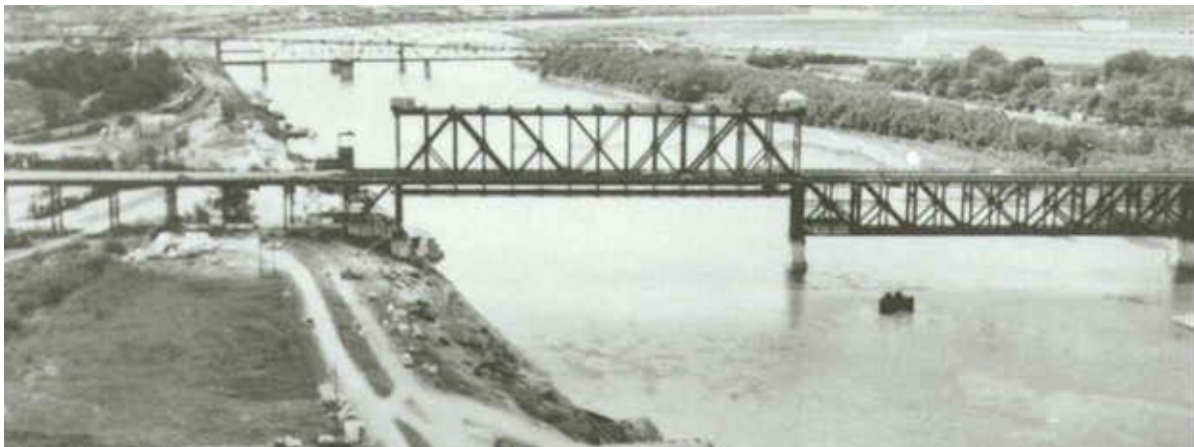
Figure 6

The Tay disaster between Dundee and Wormit (Scotland)

Bouch had been advised that calculating wind loads was unnecessary for girders shorter than 200 feet (61 m), and had not followed this up for his new design with longer girders. The section in the middle of the bridge, where the rail ran inside high girders (through trusses), rather than on top of lower ones (deck trusses), to allow a sea lane below high enough for the masts of ships, was potentially top heavy and very vulnerable to high winds. The piers consisted of four cast iron columns 15in. In diameter, and two columns 18in in diameter, in the form of cylinders, all one and a half inches in thickness, and filled with portland cement concrete. These seven pieces were put together by horizontal and diagonal braces. The wind pressure requie to overturn the structure, with a train on it was not over the 50lbs per sq. ft. The piers being light lacce the weight to resist overturning.

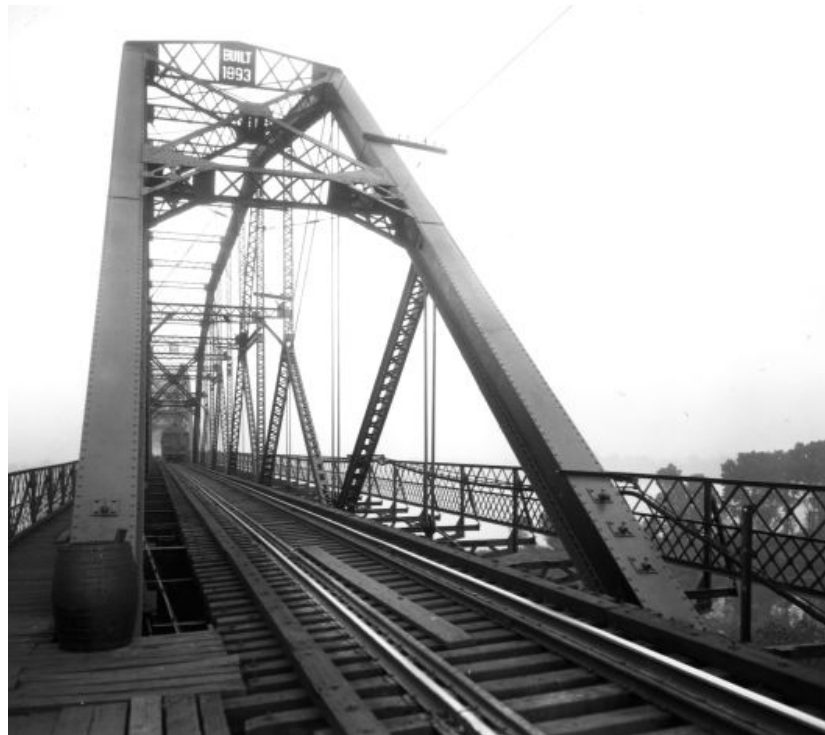
Figure 10

The Big Four Bridge had one of the biggest bridge disasters in the United States, occurring on December 15, 1893 when a construction crane was dislodged by a severe wind, causing the false-work support of a truss to be damaged and the truss—with forty-one workers on it—fell into the Ohio River. Twenty of the workers survived, but twenty-one died. Hours later, a span next to the damaged span also fell into the river, but was abandoned at the time, causing no injuries. The failure was caused by the wind that overturn the traveler, putting all the weight in the crane corner. The contractor stated that the wind picked up the truss bodily and dropped it into the river. However it seems improbable considering that the truss weighted only 2M lb and the wind was 30m/h. So it was developed that not all the lateral bracing ware in place, and probably it accounts for the failure.

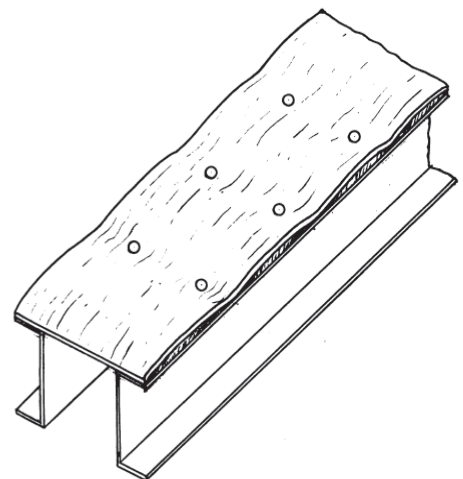
Figure 12

In other parts the rived were spaced too far in the end post that the cover plates are bulged up between the rivets.

Bedford Bridge, Ohio

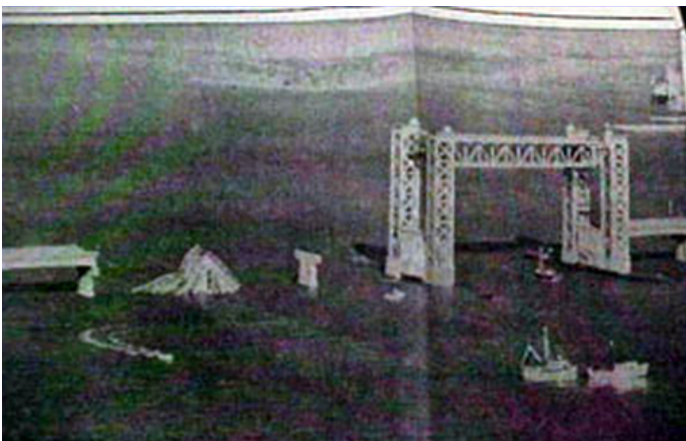
Figure 28

The ship noticed that it was heading into the bridge so the ship dropped its anchor, but the anchor failed to hold. When the ship hit the bridge, it knocked several spans apart. Ten to fifteen automobiles fell into the water when the spans fell apart.

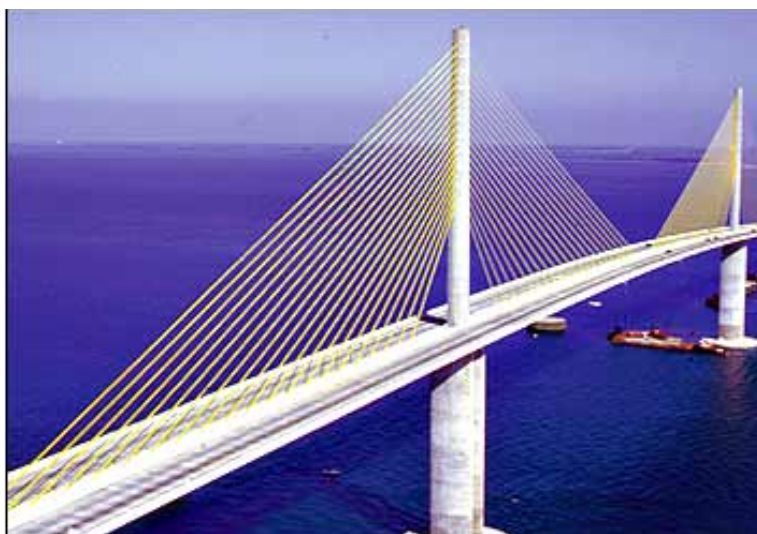
Figure 35

Ironically, the south main pier (the one that required reinforcement before completion) withstood the ship strike without significant damage. It was the second pier to the south of it that was destroyed, a secondary pier that was not designed to withstand a large ship strike.

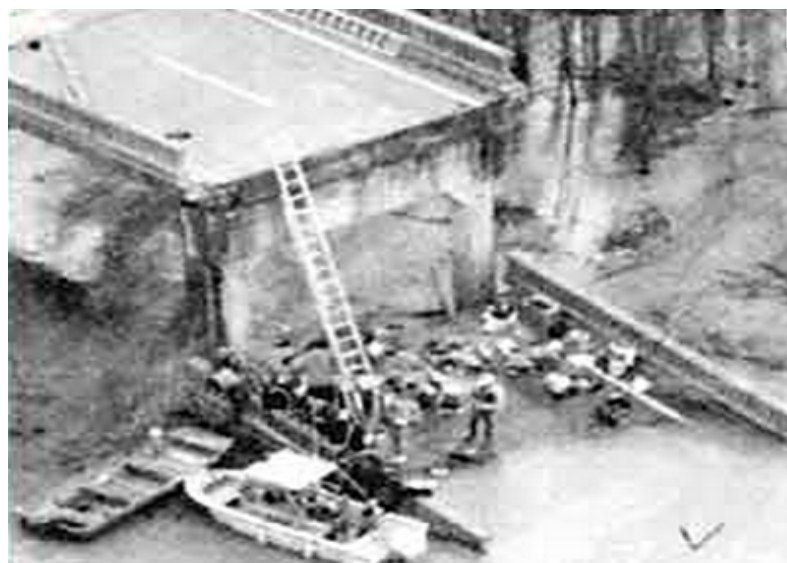
Figure 46

A federal investigation found that the river channel had moved 83 feet since the bridge was built in 1936, and that the bridge likely failed as a result of the deterioration of timber piles that were originally buried and not designed to be in water.

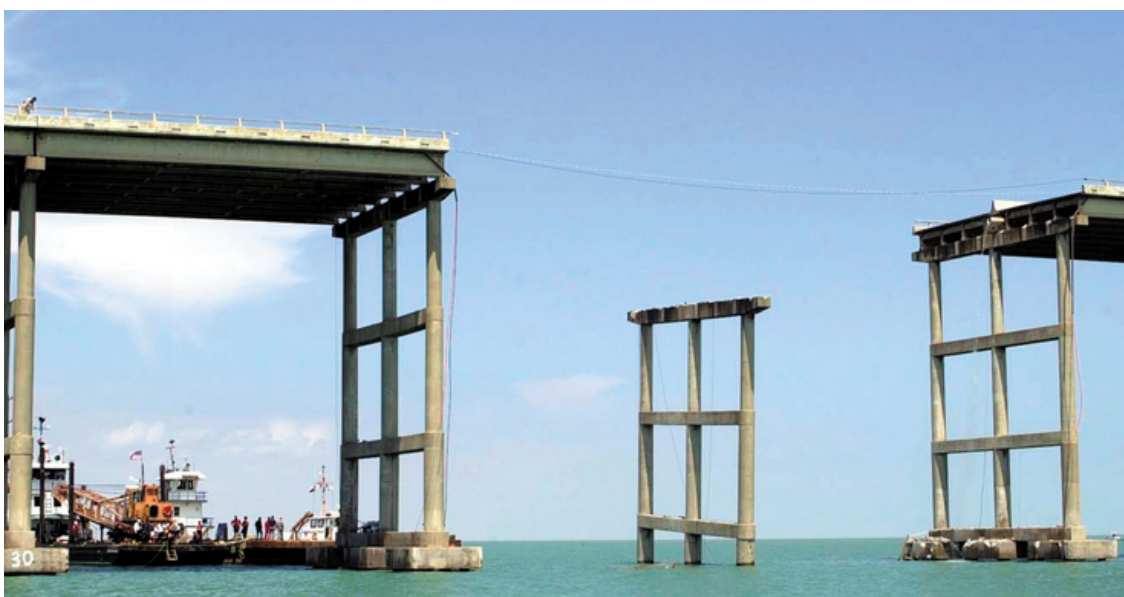
Figure 47

Four loaded barges crashed into one of the support columns traveling at 2/10ths of 1 mile per hour. Three 80-foot sections of the bridge fell into the water, leaving a large gap in the roadway. The collapsed sections were just next to the highest point of the causeway, making it difficult for approaching drivers to notice. Eight people were killed as their cars fell 85 feet into the water. Five vehicles were recovered from the water along with three survivors.

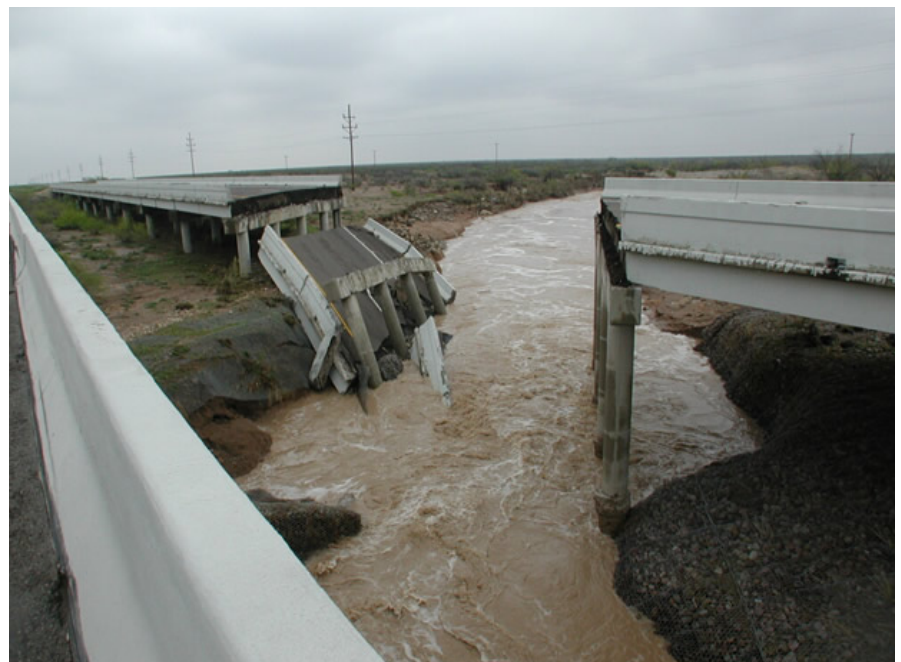
Figure 58

A storm system passed through the southwest U.S. and western Texas from April 3-6, 2004, resulting in multiple waves and heavy rainfall over west Texas and southeast New Mexico. The heavy rainfall led to significant flash flooding in small rivers there are not supposed to have. Flood waters rushed out of the Davis Mountains through Salt Draw towards the Pecos River resulting in the collapse of an Interstate-20 bridge ten miles west of Pecos

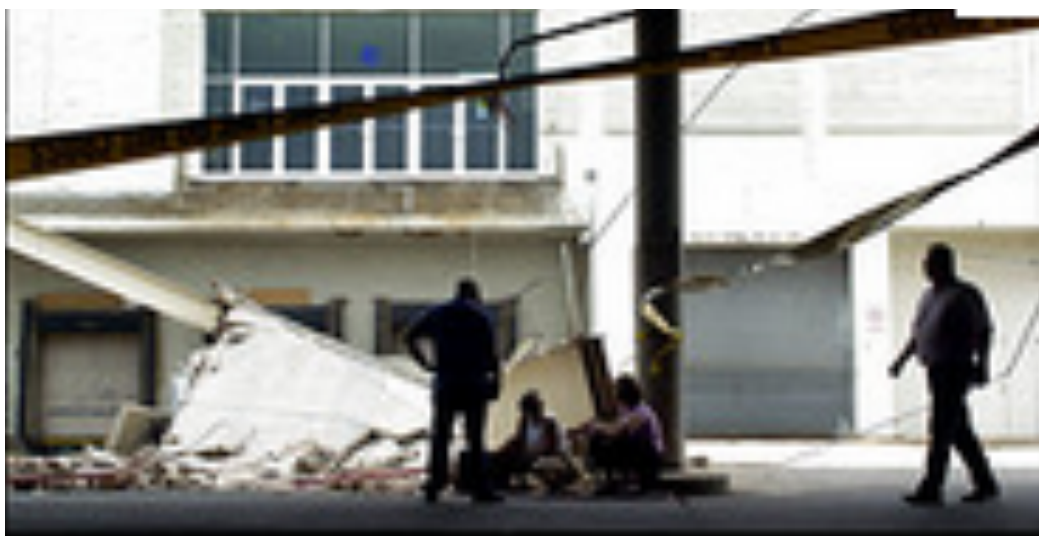
Figure 67

The bridge, which connects the second story of the parking garage to the stores, was attached by large metal bolts and brackets, which had corroded by rust.

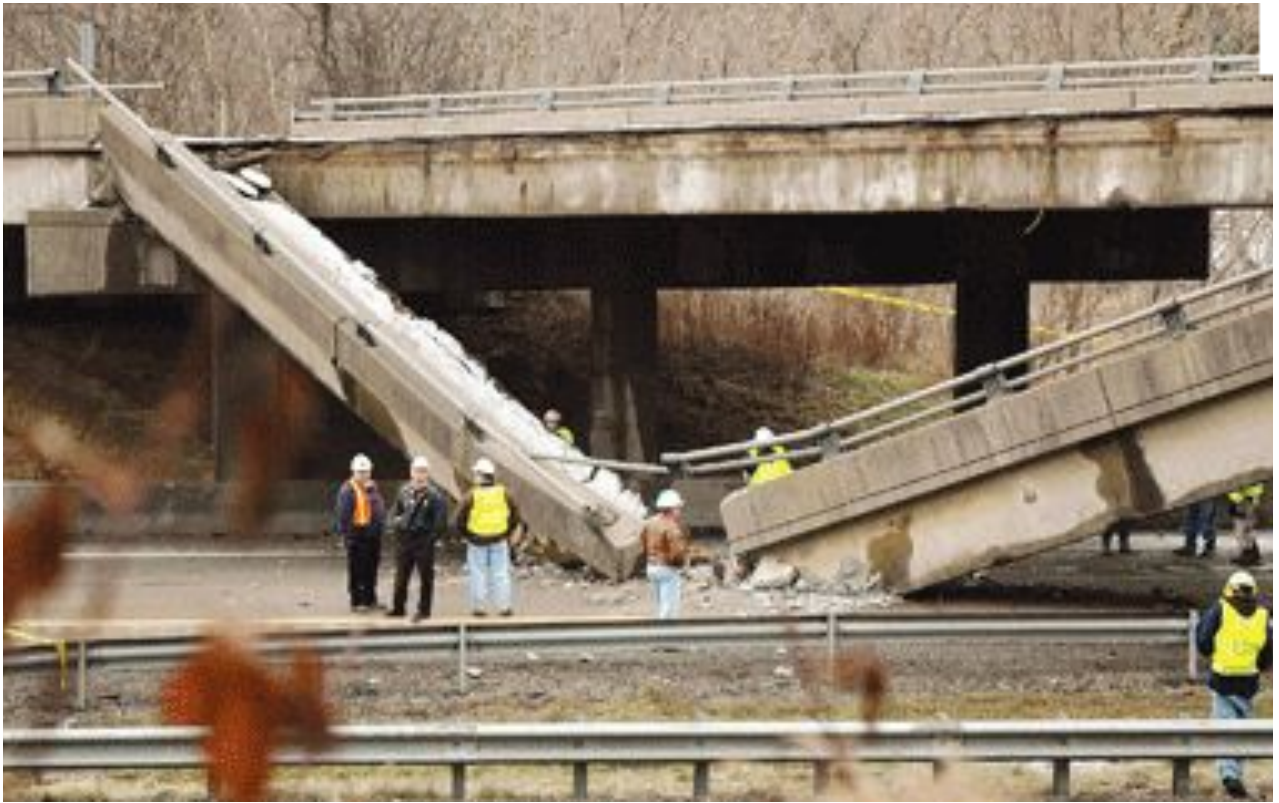
Figure 68

The 45-year-old bridge also had sustained damage from oversized trucks, so precise reasons for its collapse still aren't clear and most likely involved a combination of factors, including design, weather, wear and tear.
