**TESI DI LAUREA**

in  
Advanced Design of Structures

**Seismic Vulnerability Assessment and Retrofitting of the Great Hall of  
The University of Sydney**

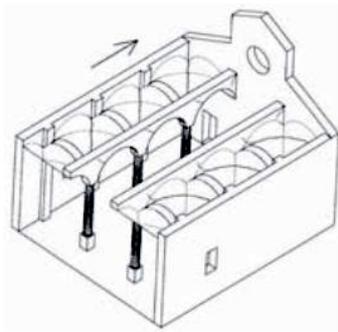
## Abacus 2.5. Hall response

Longitudinal response of the colonnade in the churches with multiple naves that causes cracks in the arches and longitudinal architraves, crushing and/or cracks at the base of the columns and shear cracks in the vaults of the lateral naves. The presence of heavy vaults in the central nave and heavy roof may represent vulnerability indicators.

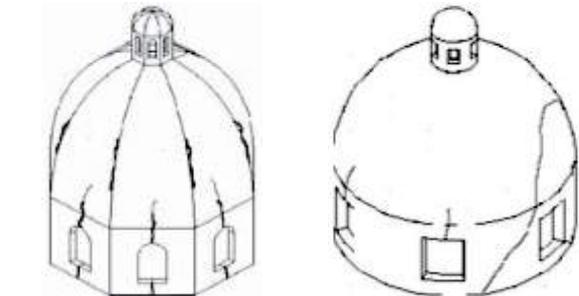
Cracks in the lantern's dome. Piers' rotation or displacements. The high slenderness of the lantern and the presence of large openings and small piers may represent vulnerability indicators.

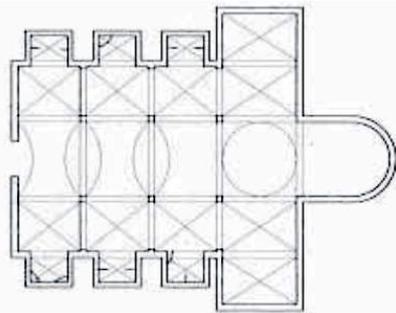
Cracks in the chapel's vaults. Vault's disconnections from lateral walls. The concentrated loads transferred by the roof and the presence of lunettes or irregularities in the vaults' profile may represent vulnerability indicators.

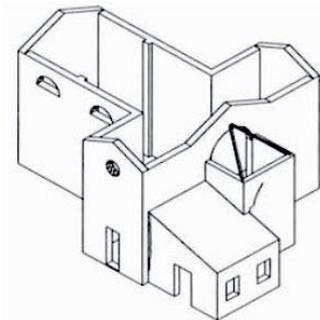
Cracks in presence of in plane and altimetric irregularities, due to the development of the hammering effect. The high difference in the stiffness of the two juxtaposed bodies and the possible concentrated loads transferred by the connecting element may represent vulnerability indicators.

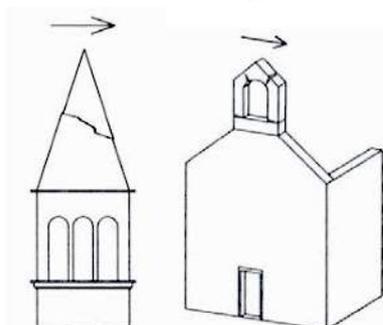
Permanent displacements or rotations of the overhang. The high slenderness of the elements or the asymmetric position of a heavy overhang respect to the underlying element may represent vulnerability indicators.

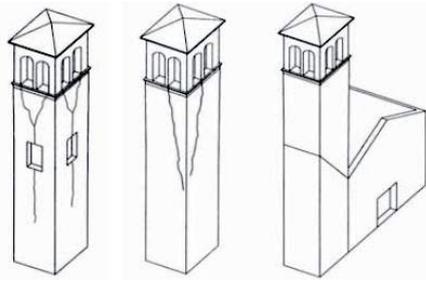
Cracks in the bell tower close to the church body, shear cracks and corner's expulsions. The presence of large openings on multiple levels, irregular or asymmetric supports at the tower's base (like arches) may represent vulnerability indicators.

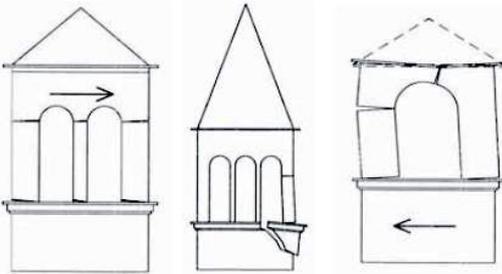
Cracks in the arches of the bell tower's cell. Piers' rotation or displacements. The presence of a pushing and heavy roof may represent vulnerability indicators.

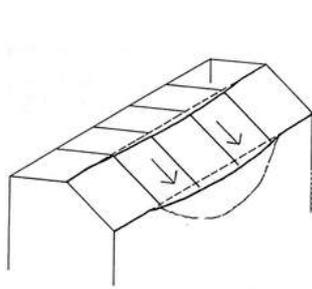
**Pushing roof**

Due to the horizontal thrust caused by the roof's struts that are inadequately restrained at the support.

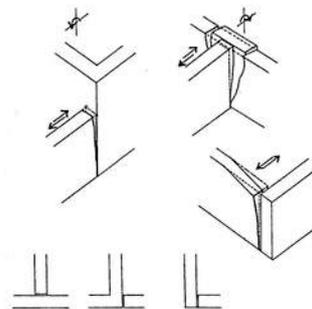
**Wall - wall connection**

The ineffective tothing causes hammering, detachment and relative sliding between walls.

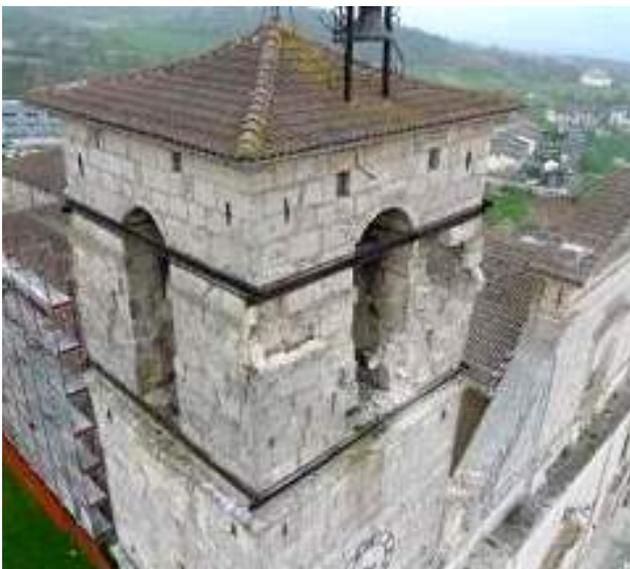
Insertion of steel ties, located at the floors' level and at the bearing walls in the two main directions of the building, anchored to the masonry by means of steel anchor plates. The traction force exerted on the wall should not be excessive in order to avoid the punching failure.

Functions of this intervention:

1. During the earthquake, the steel tie goes under traction, preventing the wall from the out-of-plane overturning;
2. Resisting the roof thrust;
3. Improvement of the connections wall-wall, wall-roof and wall-floor;
4. Reduction in the risk of slipping out the floor beams from the supports on the walls;
5. Encouraging the monolithic box behaviour.

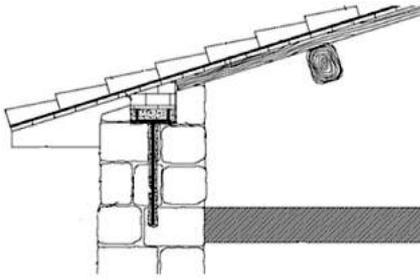
Horizontal bond beams should be built at every floor level, at the top of all structural walls, in order to ensure an effective connection between floor and walls. Steel bond beams (as in the image) are preferred to the reinforced concrete ones, because the high stiffness of the reinforced concrete bond beams may cause the pounding effect on the wall.

1. Preventing the wall from the out-of-plane overturning;
2. Resisting the roof thrust (if built at the roof's level);
3. Improvement of the stiffness at the ends of the floor/roof;
4. Distribution of the vertical loads under static conditions;
5. Connection of the orthogonal walls;
6. Encouraging the monolithic box behaviour.

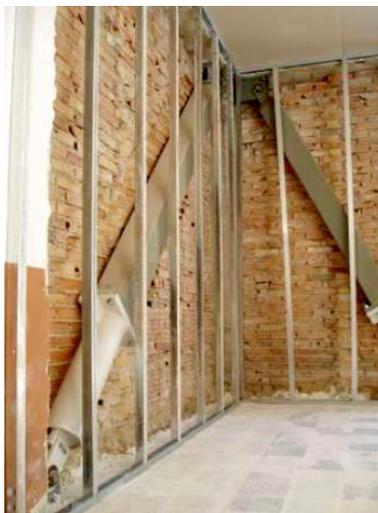
### Energy dissipating systems

By increasing the damping effect in a structure, the response to dynamic loads is reduced. The aim of energy dissipating devices is to strongly increase the structural damping without modifying the stiffness. Viscous dampers (image) constitute one of the most common devices used for retrofitting interventions (Villaverde 2009).

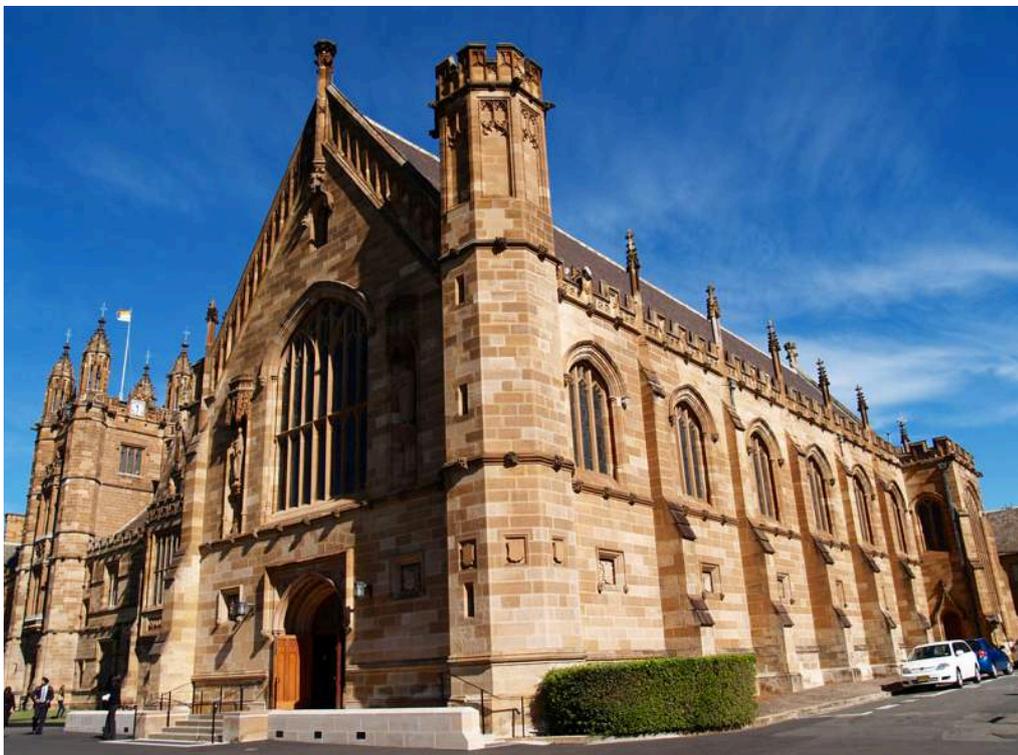
**Figure 4.1.** The Great Hall

The Great Hall (Figure 4.1), located at the northern end of the Main Quadrangle of The University of Sydney (Figure 4.2), is a sandstone masonry structure designed in 1854 and completed in 1859 by Edmund Blacket, a British Colonial architect (Lawton and Steele 1981).

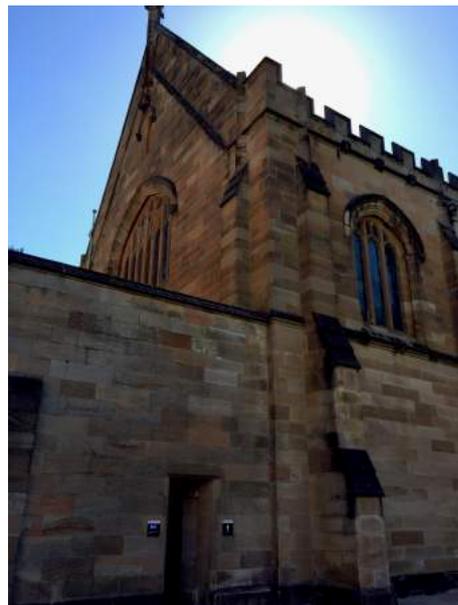
**Figures 4.3, 4.4.** Front and back façades

- A symmetric front and back façades (Figures 4.3 and 4.4), dominated by a large window with mullions. The back façade is restrained by a horizontal roof.

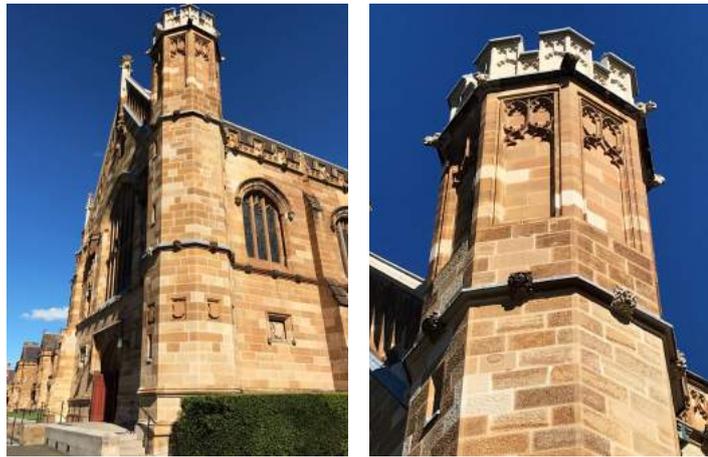
**Figures 4.5, 4.6.** Corner octagonal stair turret

- A corner octagonal stair turret (Figures 4.5 and 4.6) that flanked the chief façade.

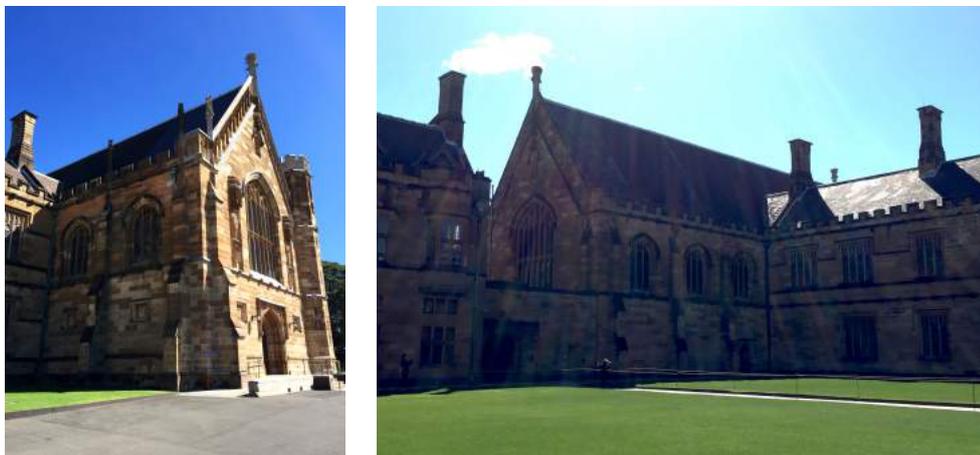
**Figure 4.10, 4.11.** Left side wall

- The left side wall (Figures 4.10 and 4.11), restrained by the walls of the adjacent perpendicular building and buttresses (as the right side wall).

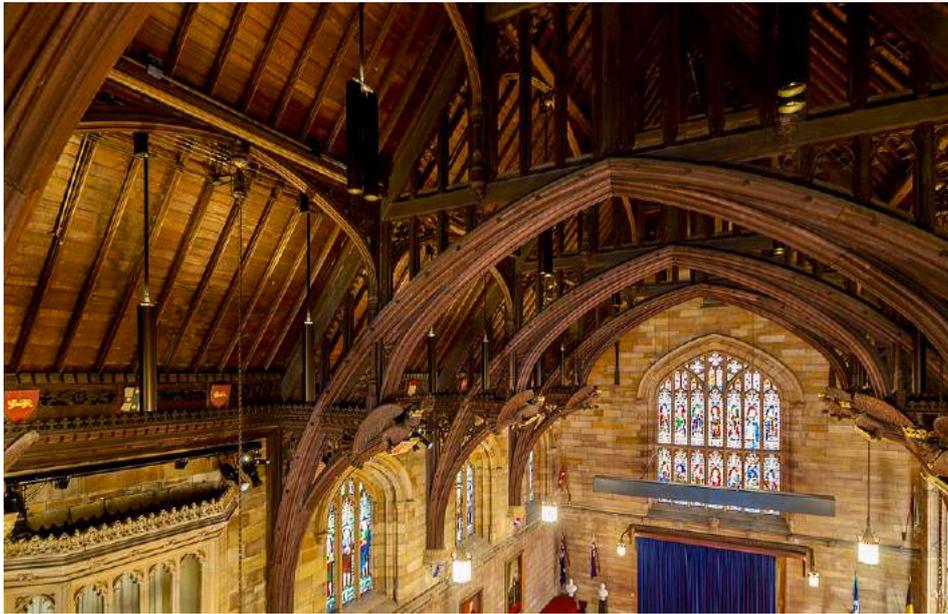
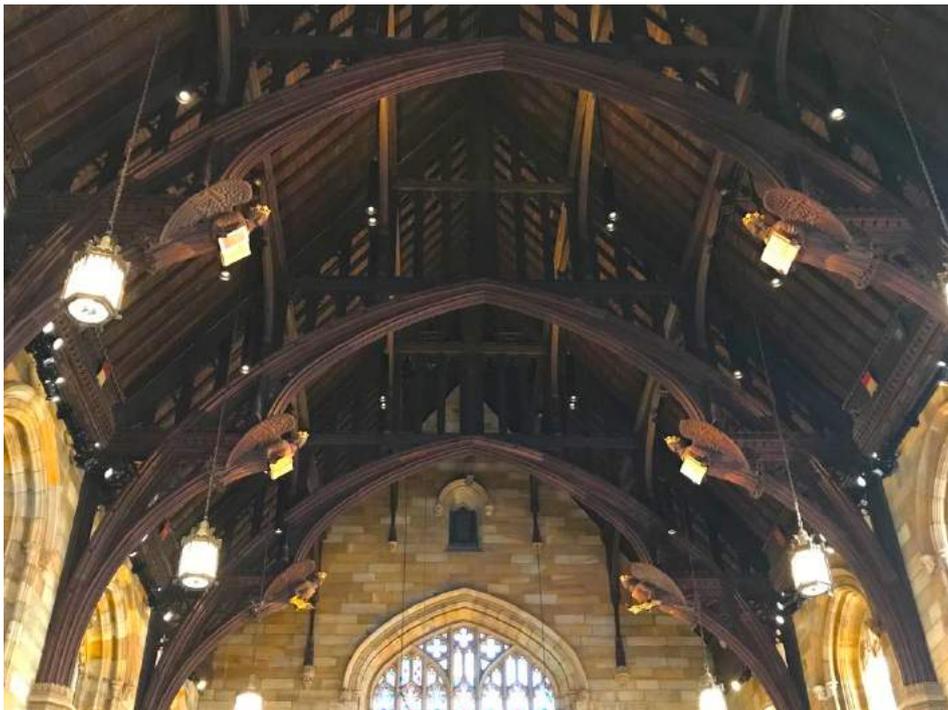
**Figures 4.12, 4.13. timber trusses**

- The timber battens and the welsh slate roof is sustained by six ironbark timber trusses covered by ornamented cedar wood (Figures 4.12 and 4.13).

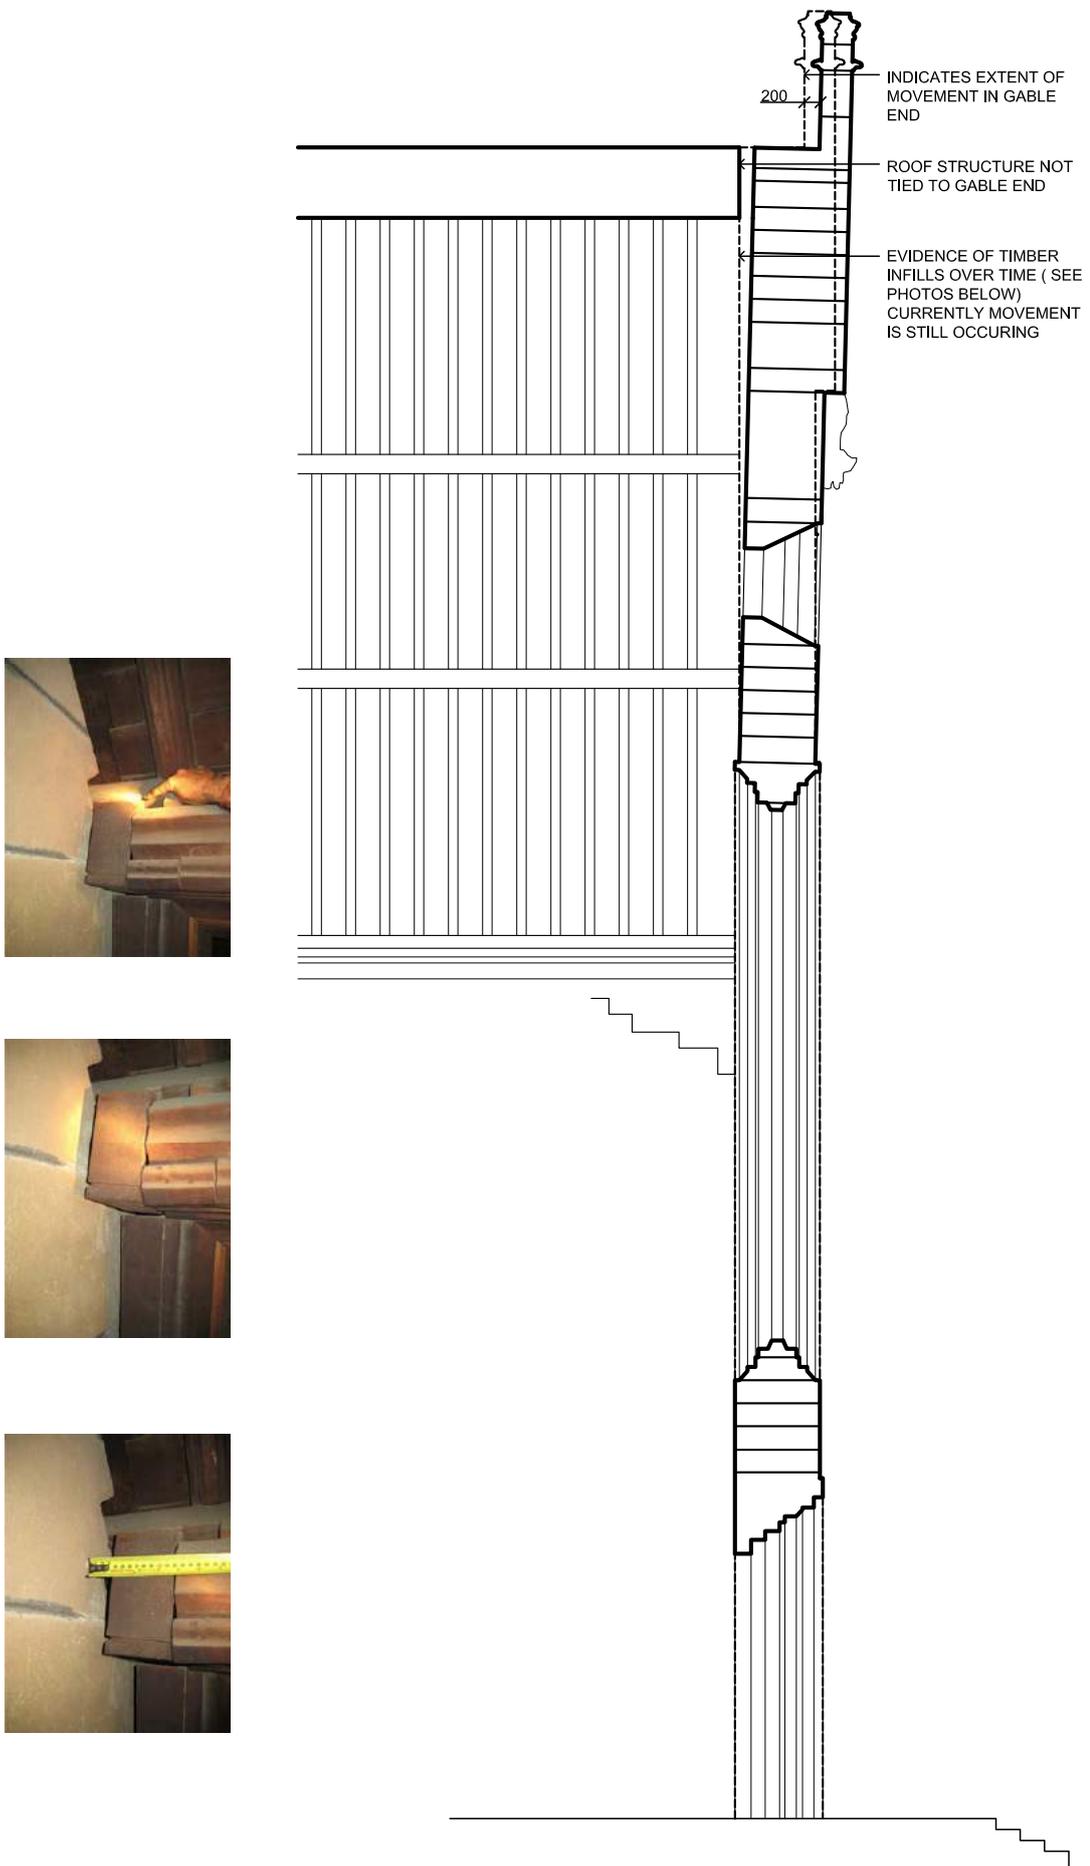
**Figure 4.18.** Movement of the front gable (Shreeji Consultant 2009)

The most important problem for the structural safety and stability of the Great Hall, highlighted by the structural inspection of 2009, is the outward displacement of the front and back gables. The following image (Figure 4.18) represents the movement of the front gable.

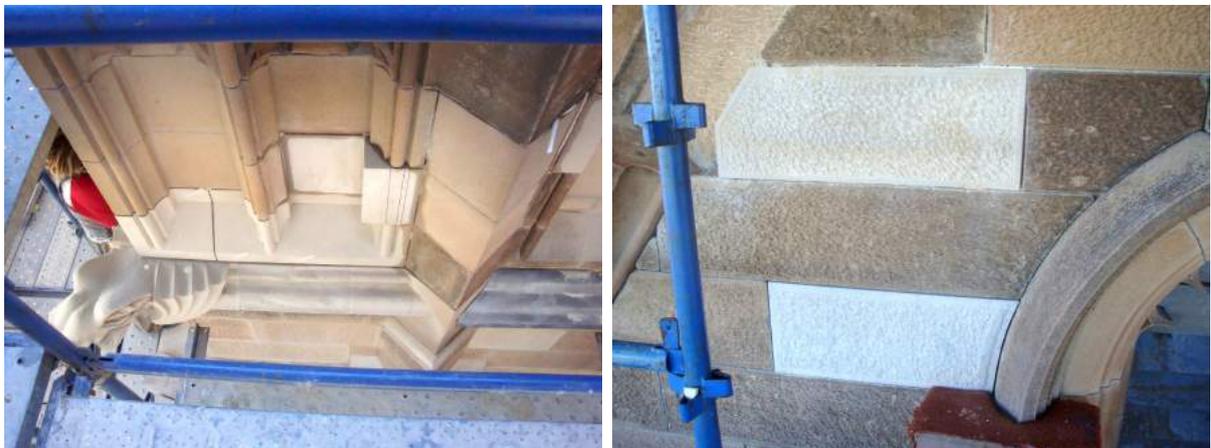
- Replacement of the damaged stones with fine to medium grained McCaffrey Pymont Yellowblock Sandstone, which closely matches the original sandstone of the Great Hall (Figures 4.19 and 4.20).

**Figures 4.19, 4.20.** Replacement of the damaged stones

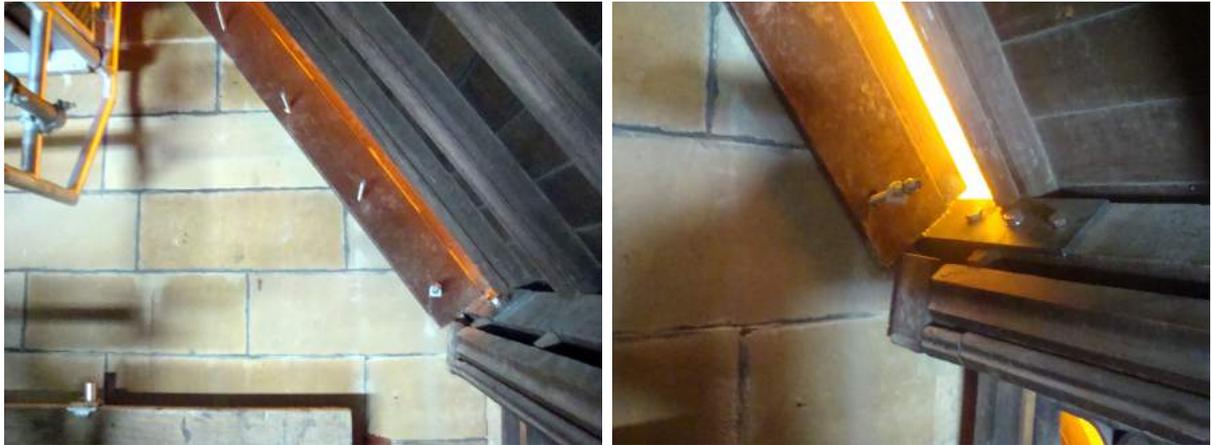
- Stabilisation of the gables. Steel plates 200x16 mm welded at the end and M20 bolts were used to connect the front and back gables to the roof structure at the purlins (Figures 4.21 and 4.22). Moreover, connection plates 200x16 mm and M20 bolts were installed at the intersection between the outer trusses and the upper purlins. Contrary to what has been suggested, the connection between the two gables through ties in the roof structure was not carried out.

**Figures 4.21, 4.22.** Steel plates 200x12 mm welded at the end and M20 bolts, used to connect the front and back gables to the roof structure at the purlins

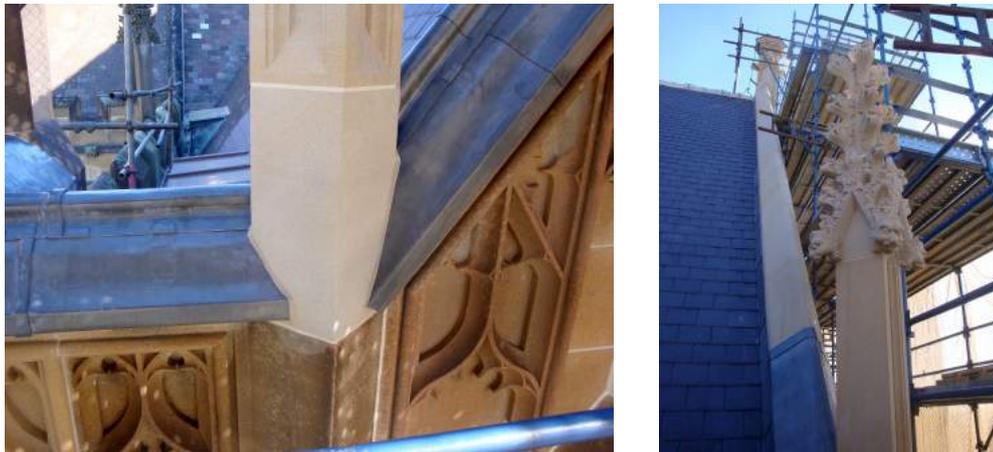
- Replacement of the damaged and unstable pinnacles (Figures 4.23 and 4.24).

**Figures 4.23, 4.24.** Replacement of the damaged and unstable pinnacles

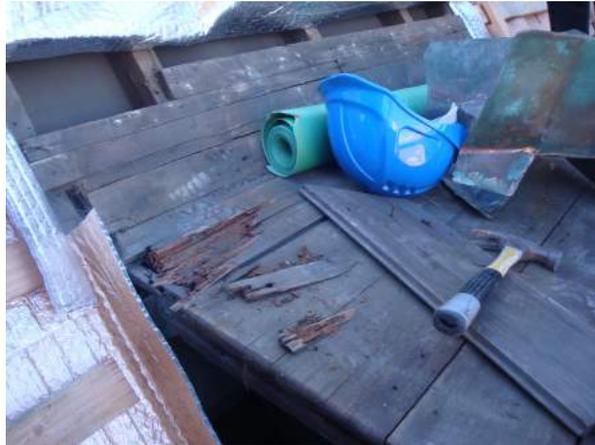
**Figures 4.25.** Removal of the damaged battens

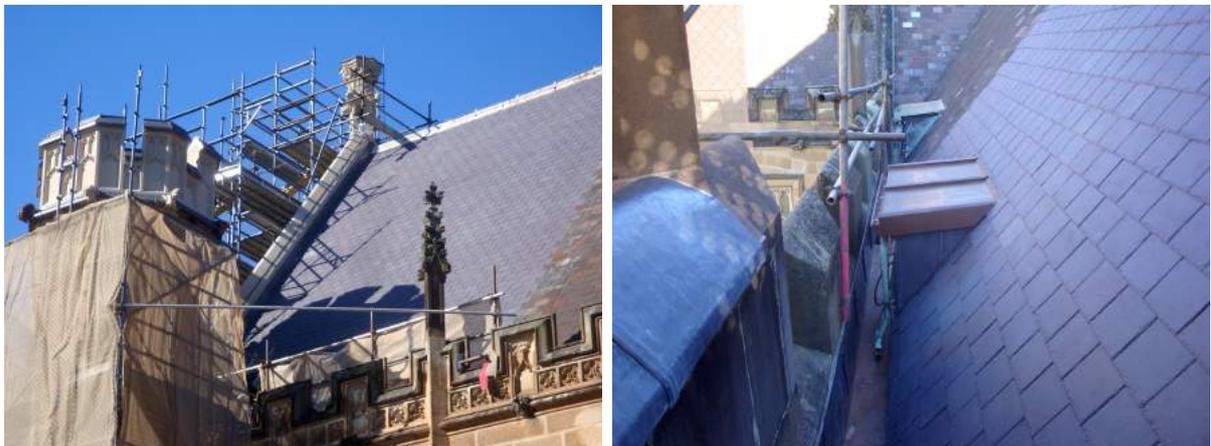
- Battens in two layers (75x25 mm F8 Oregon wood).
- Vapour permeable underlay

**Figures 4.26, 4.27.** Installation of a new roofing system

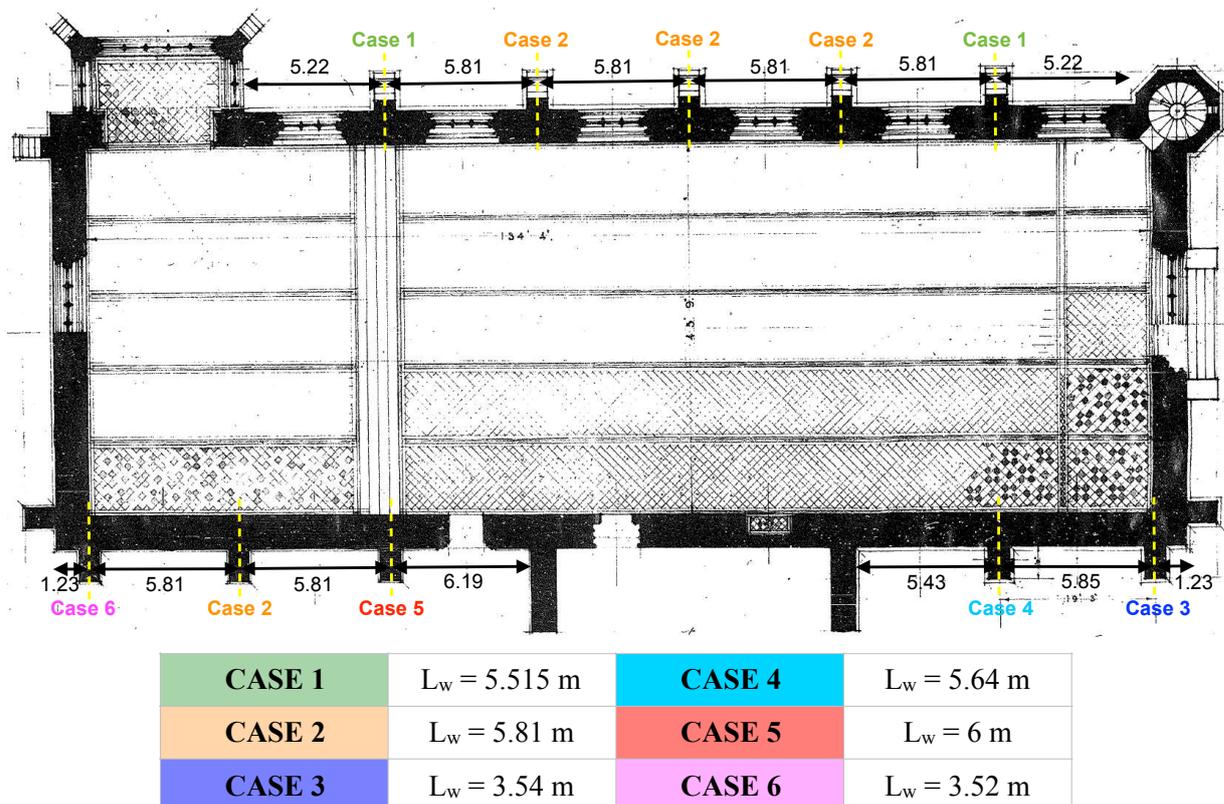
Below it is reported the evaluation of the capacity of the lateral walls' buttresses, in order to verify if they are adequate to prevent the overturning of the lateral walls. Since the applied loads on the buttress depend on the length of influence ( $L_w$ ) and due to the fact that the buttresses spacing is not constant, there will be more than one case to be analysed (Figure 4.29):

Figure 4.29. Spacing between the buttresses and length of influence

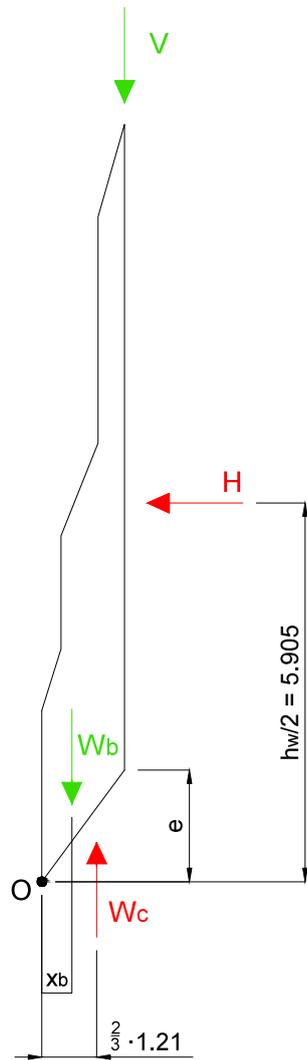
The moment equilibrium about O has been applied to the fractured buttress (Figure 4.31):

$$\sum M_o = 0: W_b \cdot x_b + V \cdot 1.21 - W_c \left( \frac{2}{3} \cdot 1.21 \right) - H \cdot 5.905 = 0$$

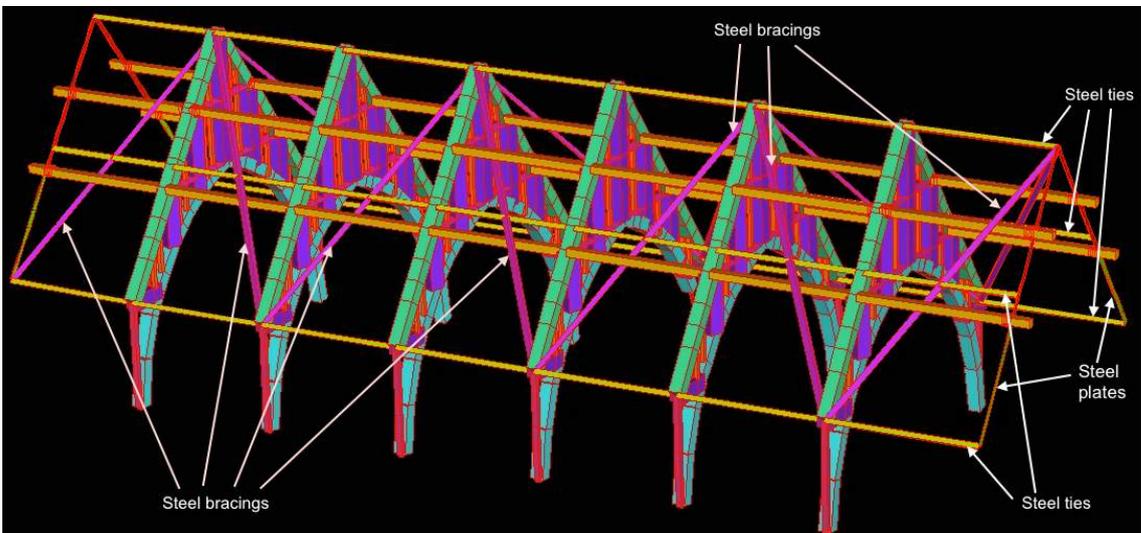
Figures 4.34, 4.35 Retrofitting interventions

1. Connecting the two gables through longitudinal ties in the roof structure, in order to ensure the global monolithic box behaviour of the structure and provide an effective constraint against the out-of-plane mechanism of the façades. Moreover, inserting longitudinal ties improves the in-plane behaviour of the façades.
2. Introducing bracings in the roof, in order to make it stiffer.

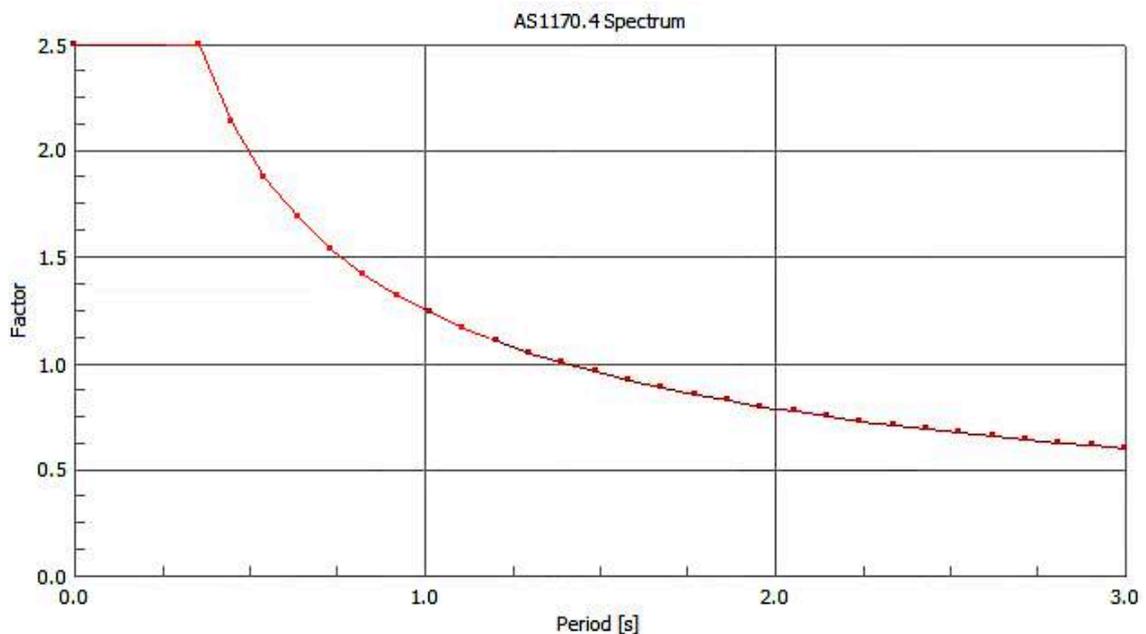
The earthquake load is given by a normalised response spectrum curve taken from Clause 7.2 of the Australian Standard (AS 1170.4 1993), assuming a site factor (S) equal to 1 (Figure 4.37).

**Figures 4.37.** Normalised response spectrum (S=1)

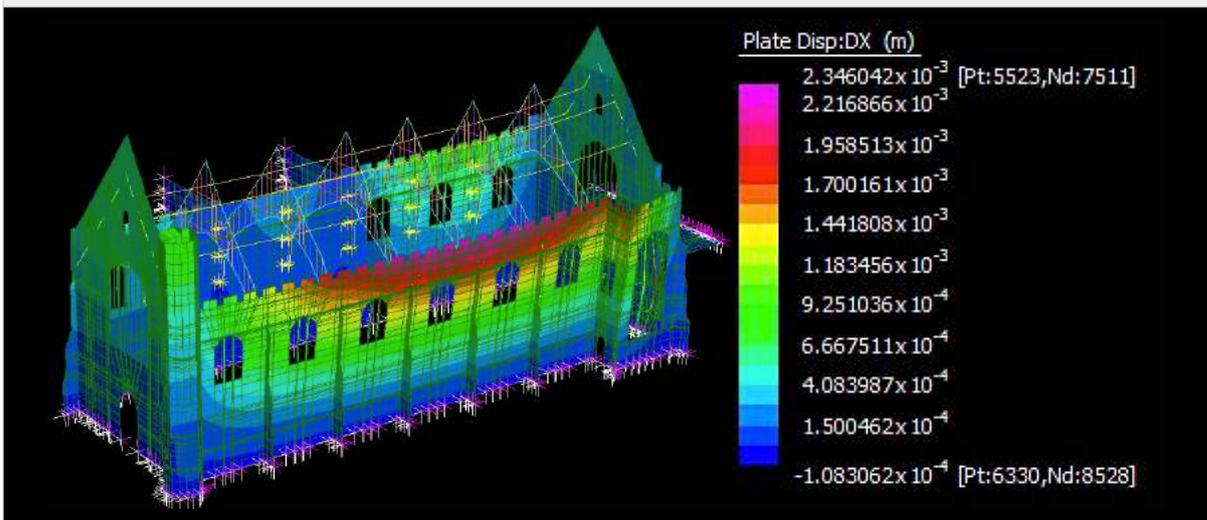
**Displacement of the upper part of the right side wall (Node 7511)**

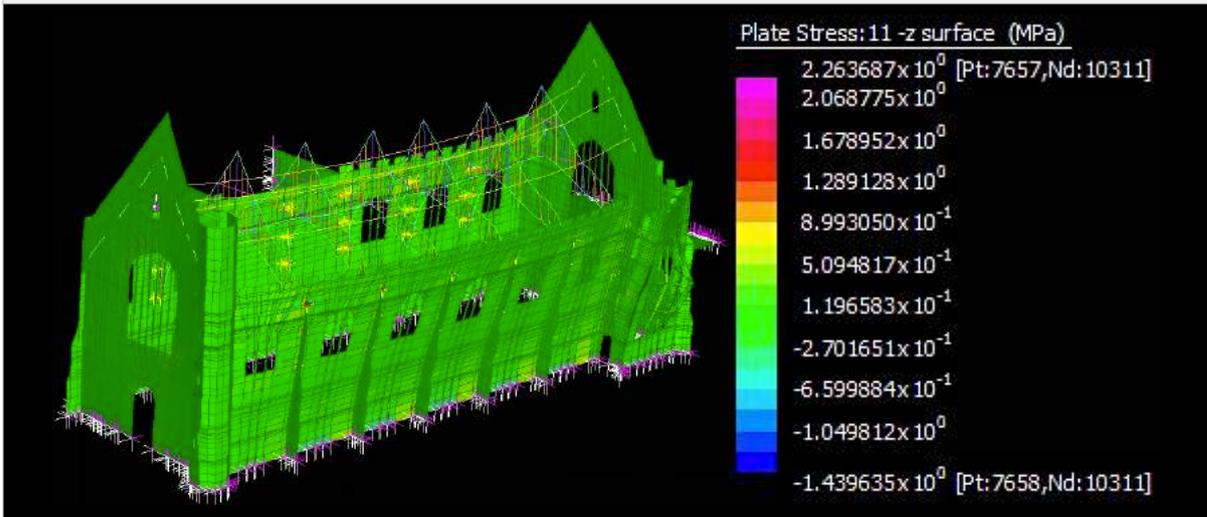
**Concentrated stress at the link truss-right side wall  
(Plate 7657, Node 10311)**

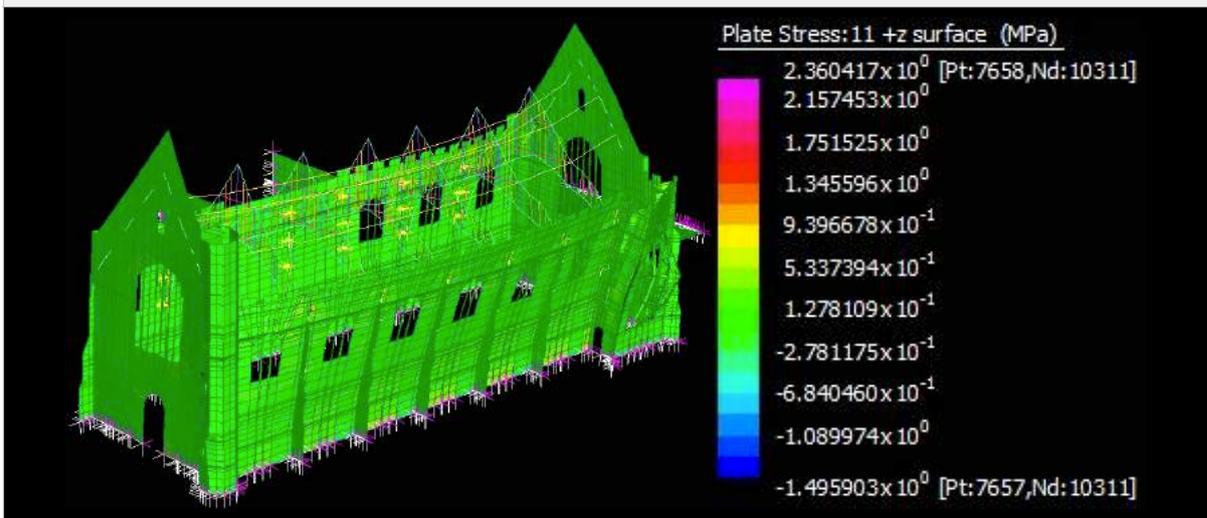
**Concentrated stress at the link truss-right side wall  
(Plate 7658, Node 10311)**

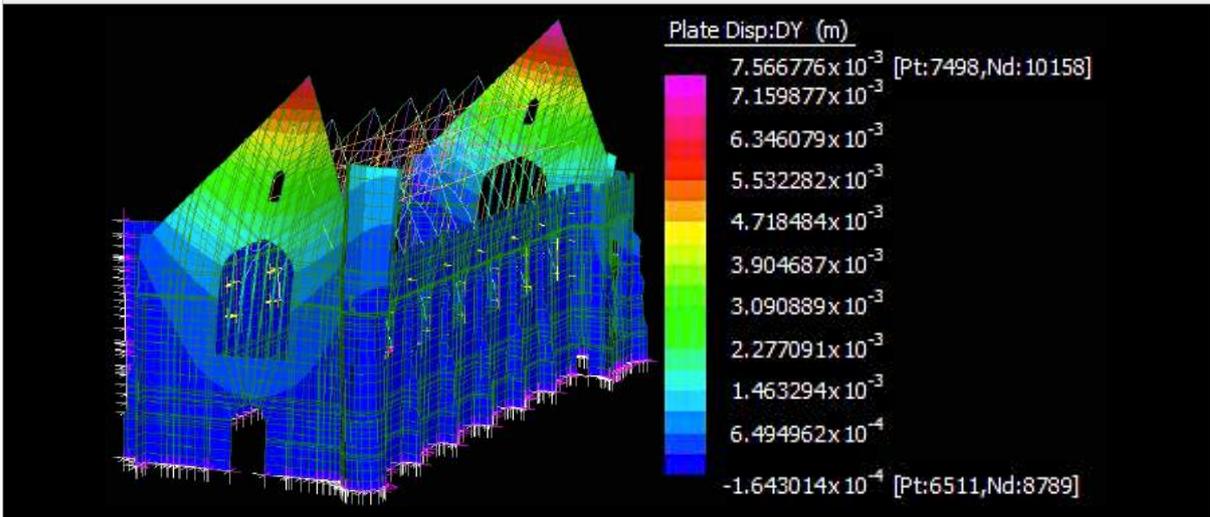
Displacement of the front gable (Node 10119)	DY = 6.715 mm
Displacement of the back gable (Node 10158)	DY = 7.567 mm

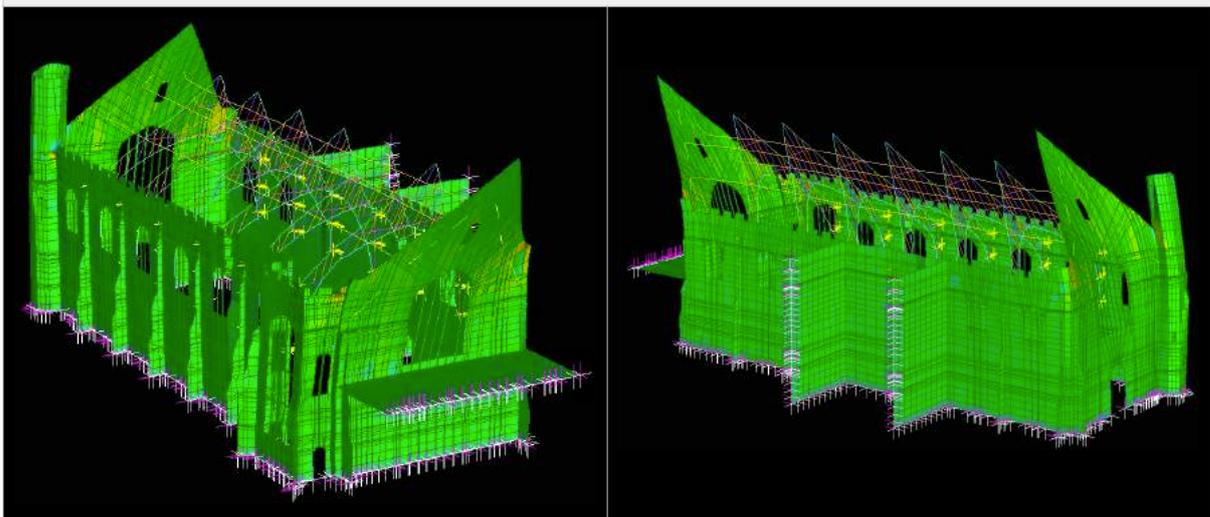
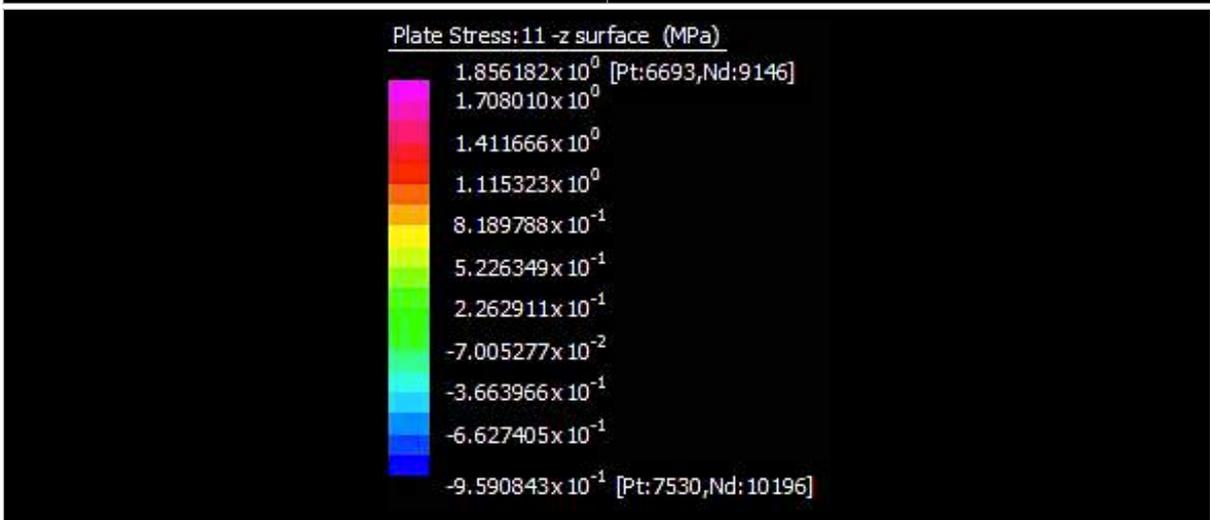
<b>Intersection tower-right side wall (Plate 10532, Node 5966)</b>	$\sigma_t = 2.737$ MPa
<b>Intersection tower-front façade (Plate 10622, Node 1516)</b>	$\sigma_t = 1.701$ MPa
<b>Intersection wall projecting bay-right side wall (Plate 3195, Node 4570)</b>	$\sigma_t = 2.268$ MPa

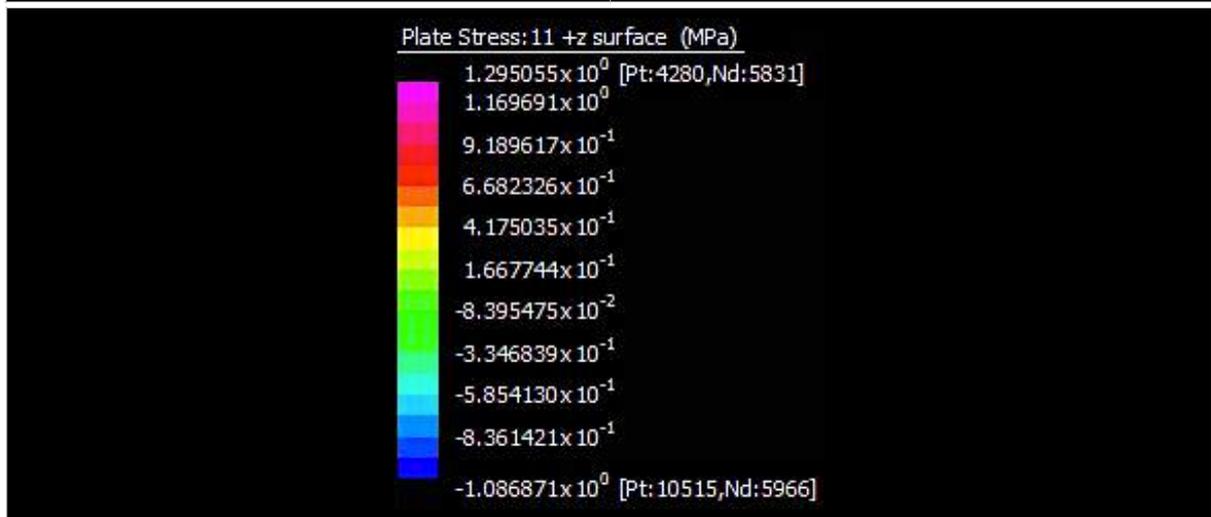
<b>Intersection back façade-left side wall (Plate 11911, Node 2039)</b>	$\sigma_t = 1.576$ MPa
<b>Intersection tower-front façade (Plate 913, Node 1516)</b>	$\sigma_t = 1.213$ MPa
<b>Intersection wall projecting bay-right side wall (Plate 4280, Node 5831)</b>	$\sigma_t = 1.788$ MPa

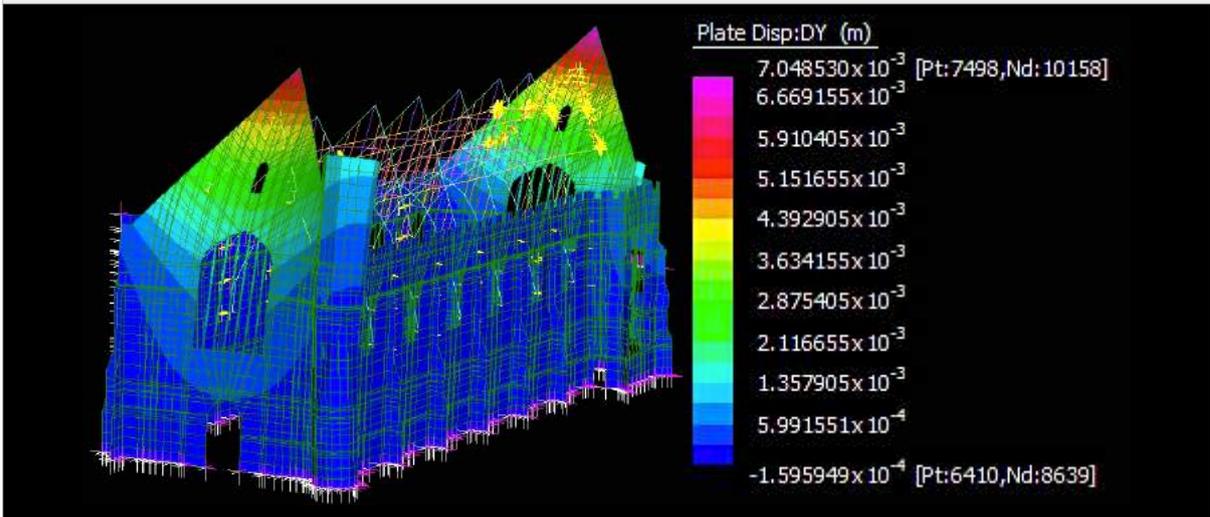
<b>Displacement of the front gable (Node 10119)</b>	DY = 6.230 mm
<b>Displacement of the back gable (Node 10158)</b>	DY = 7.049 mm

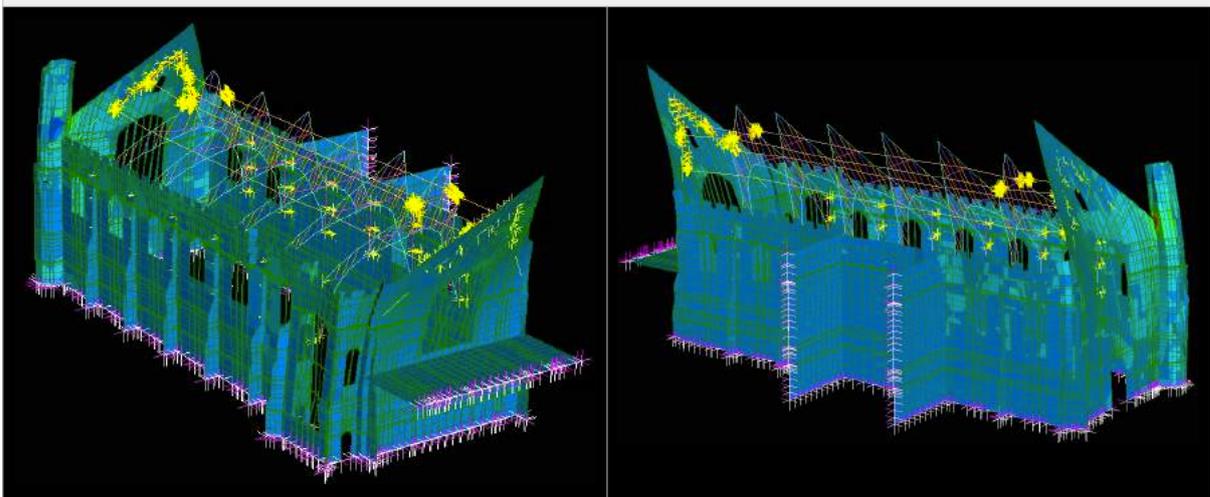
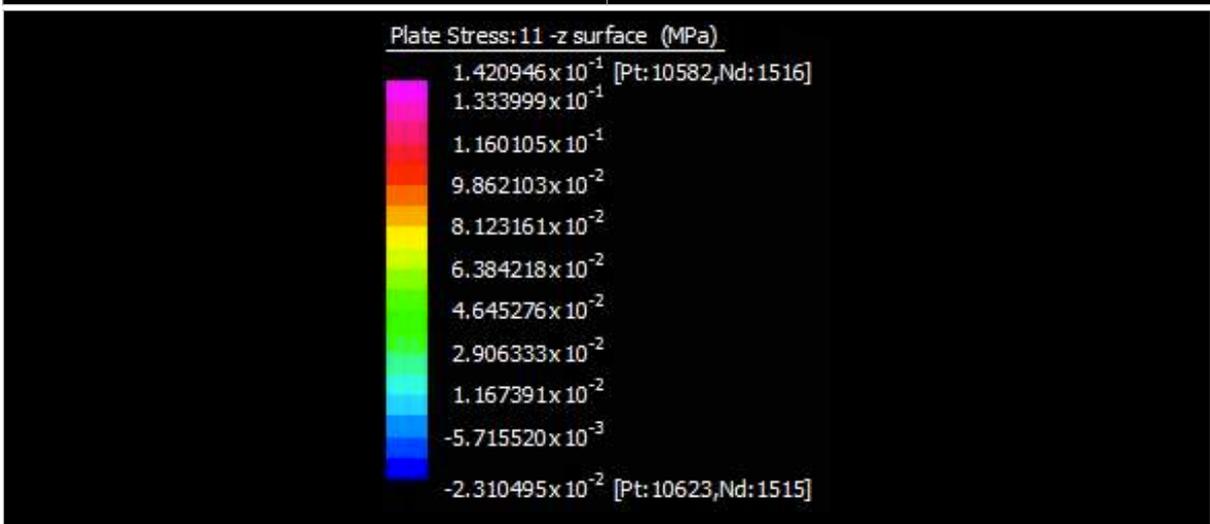
<b>Intersection tower-right side wall (Plate 10532, Node 5966)</b>	$\sigma_t = 2.660 \text{ MPa}$
--	--------------------------------

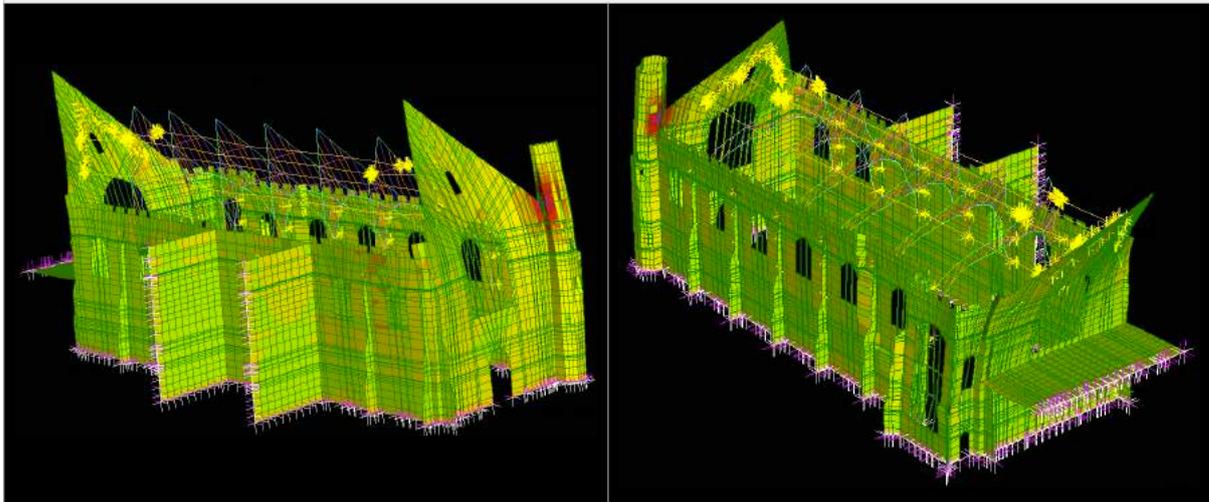
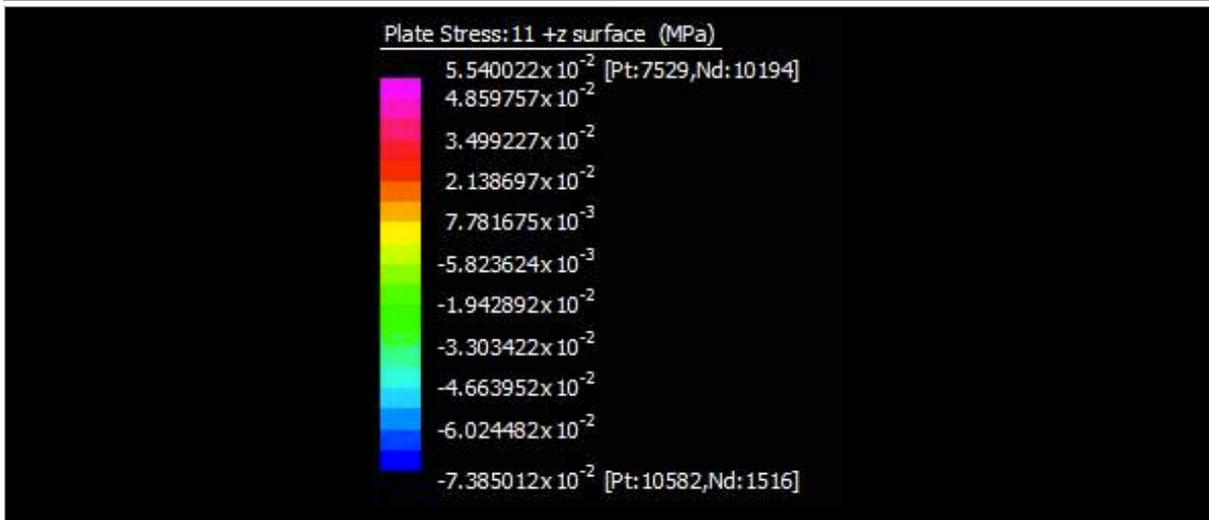
<b>Intersection back façade-left side wall (Plate 11911, Node 2039)</b>	$\sigma_t = 1.518 \text{ MPa}$
<b>Intersection tower-front façade (Plate 913, Node 1516)</b>	$\sigma_t = 1.130 \text{ MPa}$
<b>Intersection wall projecting bay-right side wall (Plate 4280, Node 5831)</b>	$\sigma_t = 1.731 \text{ MPa}$

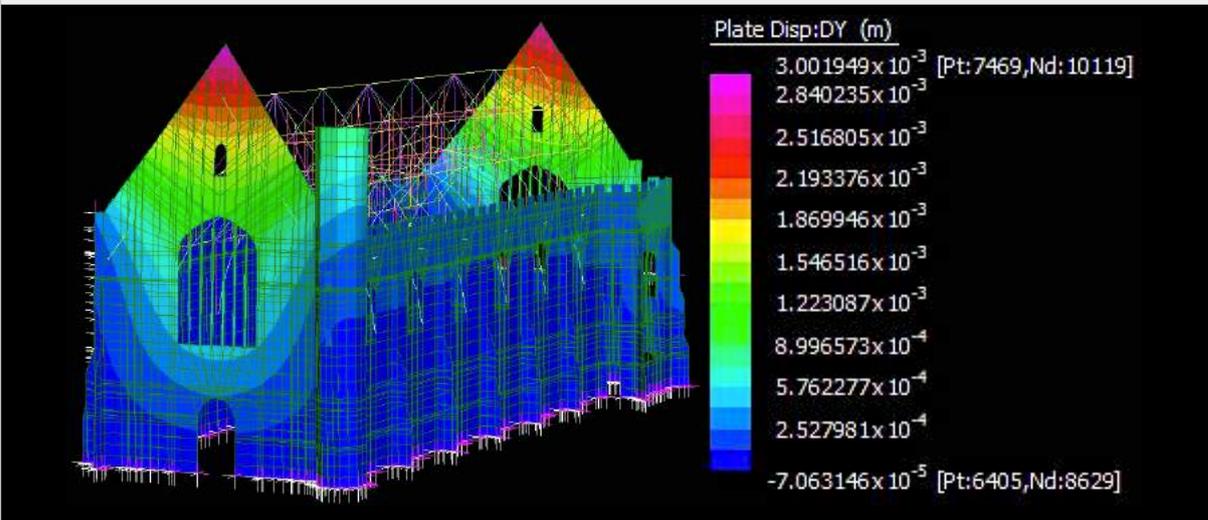
<b>Displacement of the front gable (Node 10119)</b>	DY = 3.002 mm
<b>Displacement of the back gable (Node 10158)</b>	DY = 2.843 mm
