**TESI DI LAUREA**

in  
Advanced Design of Structures

**Seismic Vulnerability Assessment and Retrofitting of the Great Hall of  
The University of Sydney**

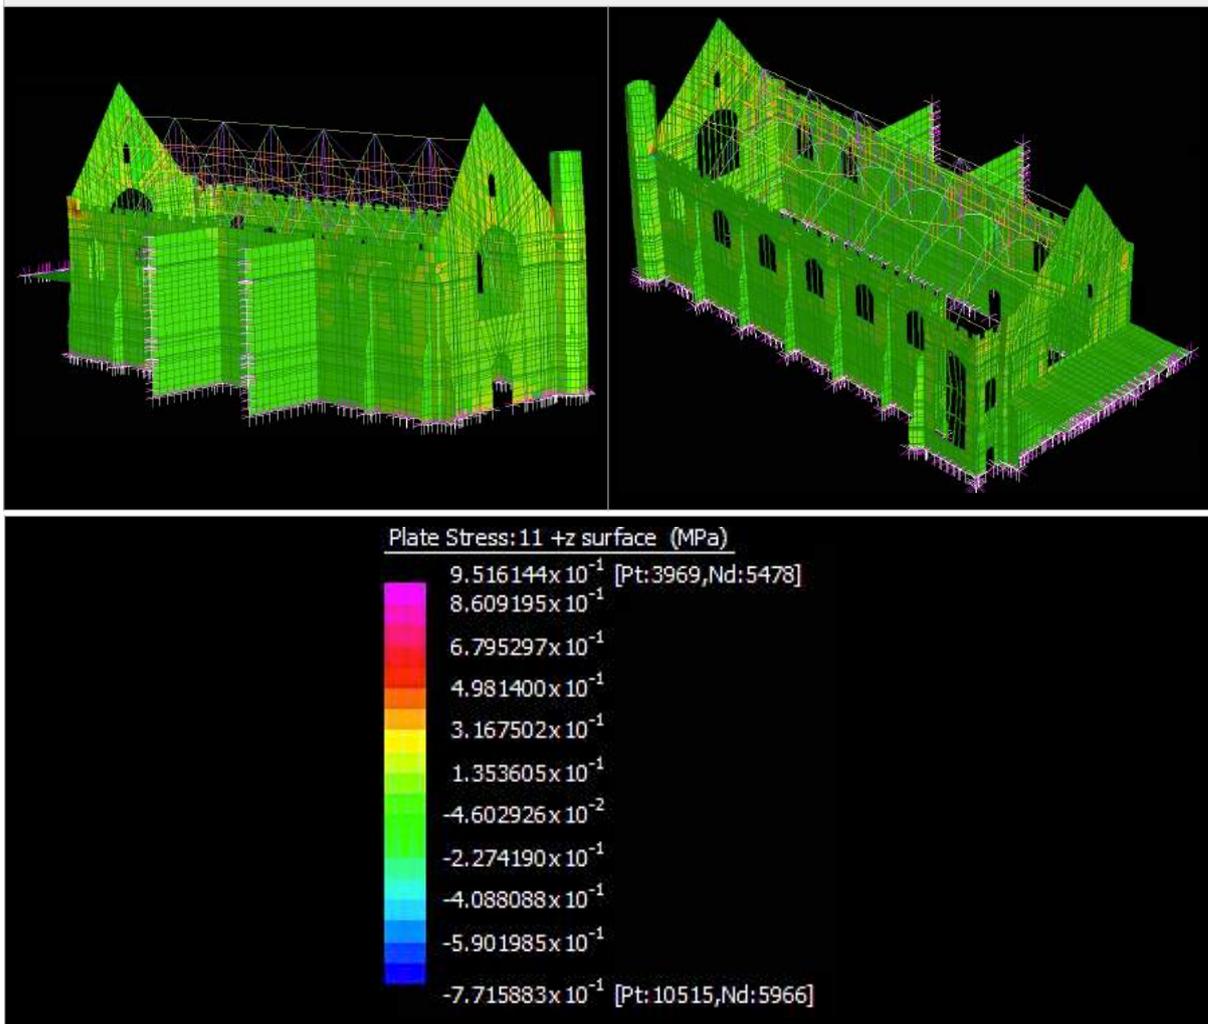
<b>Intersection back façade-left side wall (Plate 11911, Node 2039)</b>	$\sigma_t = 0.814$ MPa
<b>Intersection tower-front façade (Plate 913, Node 1516)</b>	$\sigma_t = 0.524$ MPa
<b>Intersection wall projecting bay-right side wall (Plate 4280, Node 5831)</b>	$\sigma_t = 0.863$ MPa

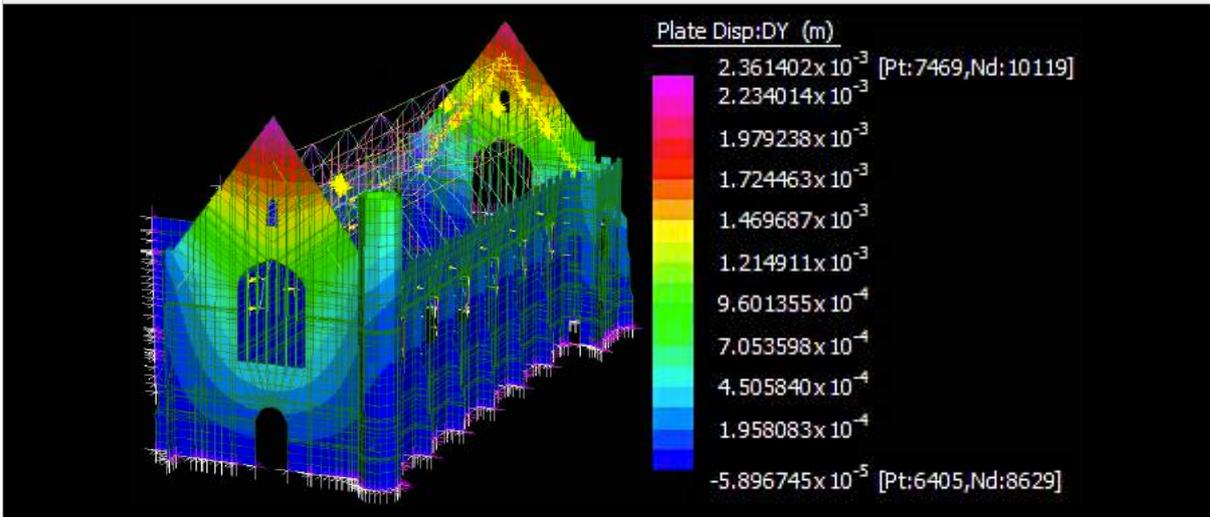
<b>Displacement of the front gable (Node 10119)</b>	DY = 2.361 mm
<b>Displacement of the back gable (Node 10158)</b>	DY = 2.152 mm

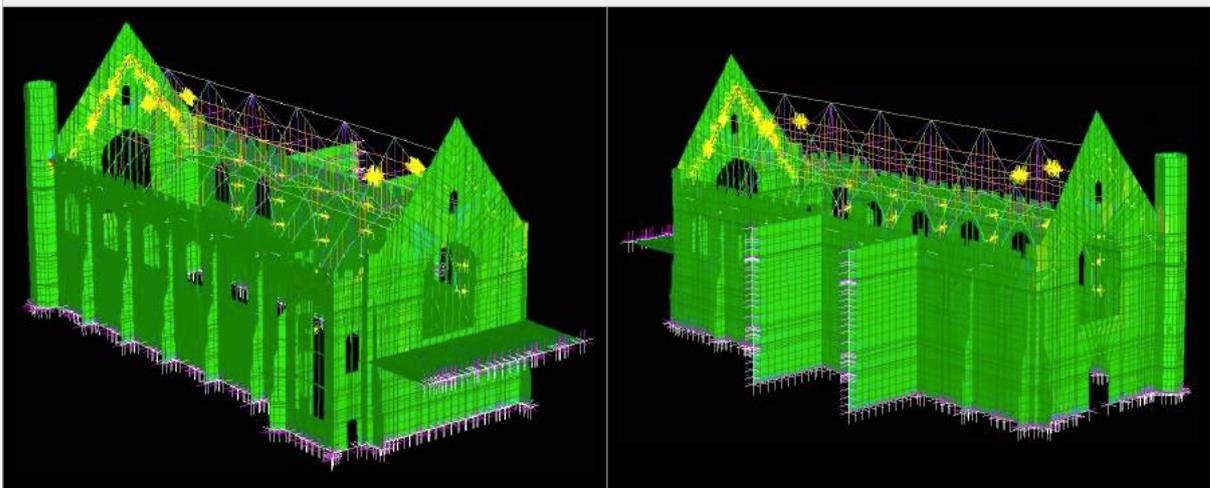
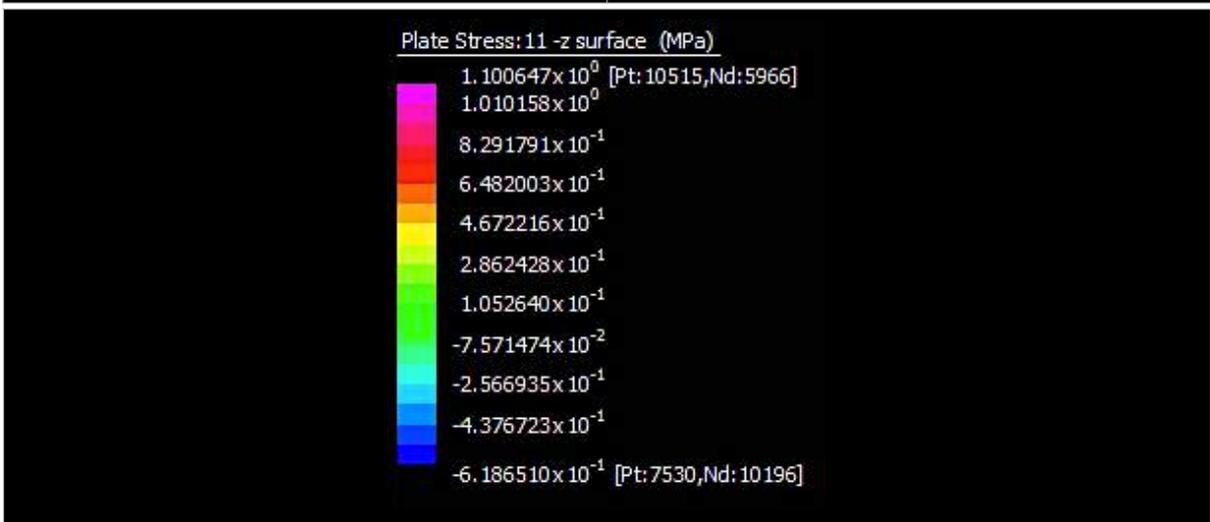
<b>Intersection tower-right side wall (Plate 10532, Node 5966)</b>	$\sigma_t = 1.743$ MPa
--	------------------------

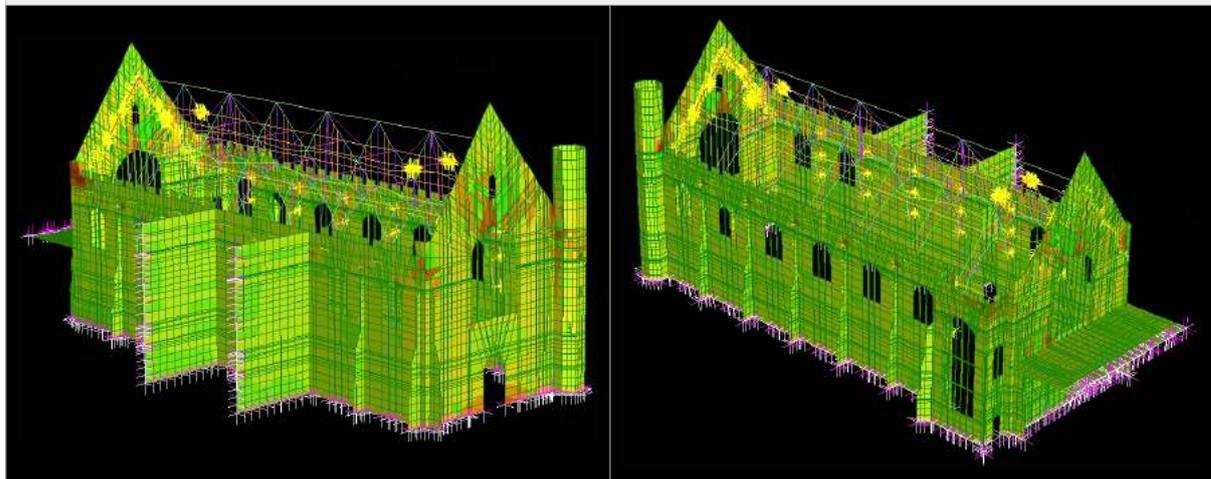
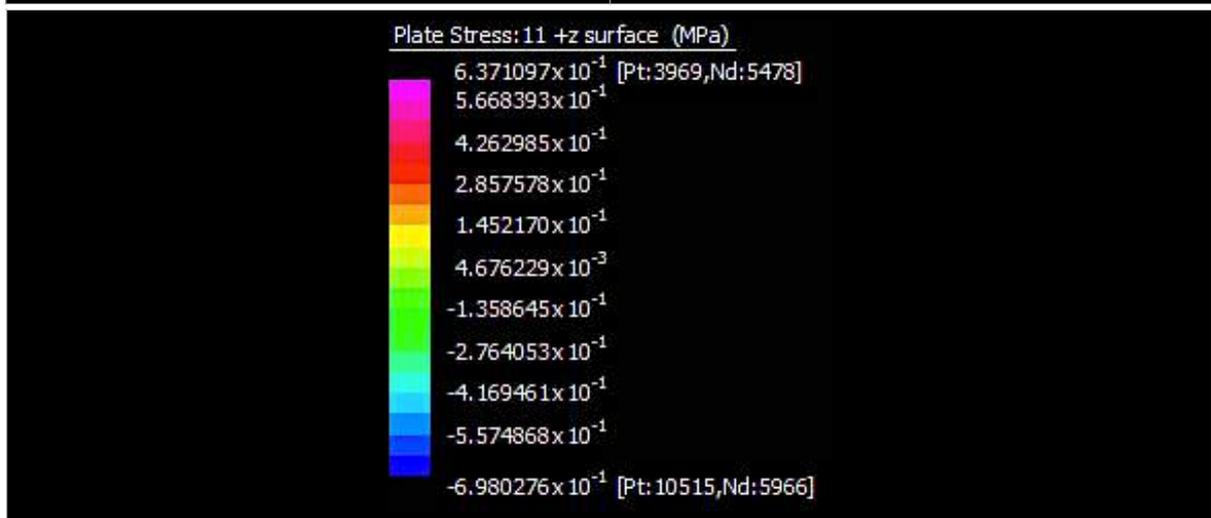
<b>Intersection back façade-left side wall (Plate 11911, Node 2039)</b>	$\sigma_t = 0.722 \text{ MPa}$
<b>Intersection tower-front façade (Plate 913, Node 1516)</b>	$\sigma_t = 0.417 \text{ MPa}$
<b>Intersection wall projecting bay-right side wall (Plate 4280, Node 5831)</b>	$\sigma_t = 0.736 \text{ MPa}$
