CIVIL ENGINEERING MASTER THESIS

LEARNING FROM EXPERIENCE:

**ANALYSIS OF THE CIVIL LITIGATION REGARDING
BUILDING STRUCTURES ON THE COURT OF BOLOGNA
IN THE YEARS 2011/2012**

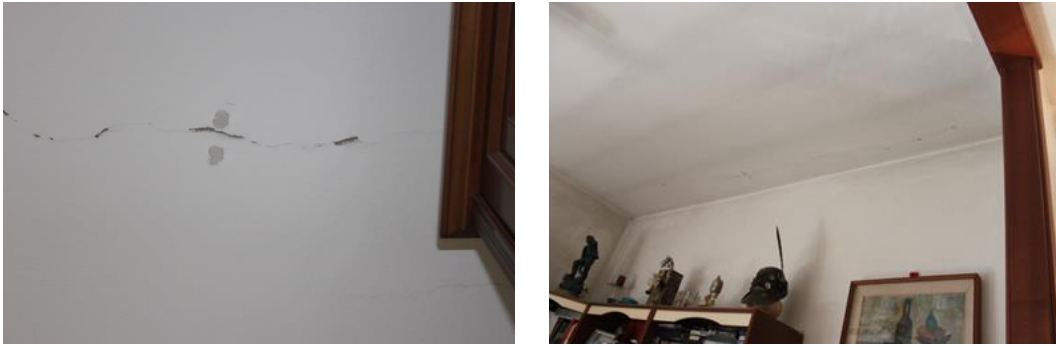
On the wall are been detected crack pattern not ascribable to structural failure. The defect involves only the plasterwork, without any problem for the safety or the usability of the property.

Figure 4.2 Cracks on the plasterwork

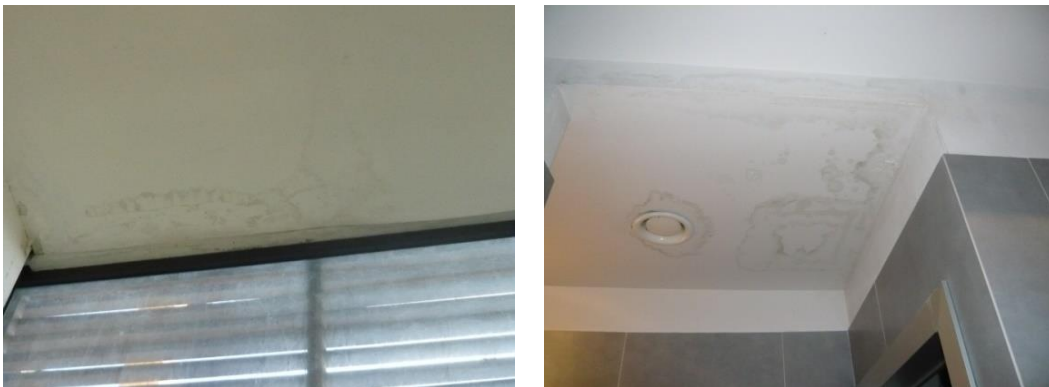
Small water stains are detected. During the rainfall event occurs in the day of the inspection, no evidence of the defects are displayed. The phenomenon is occasional and not implies any reduction for the usability and the functionality of the place.

Figure 4.3 Dampness patches on the intrados of the slab

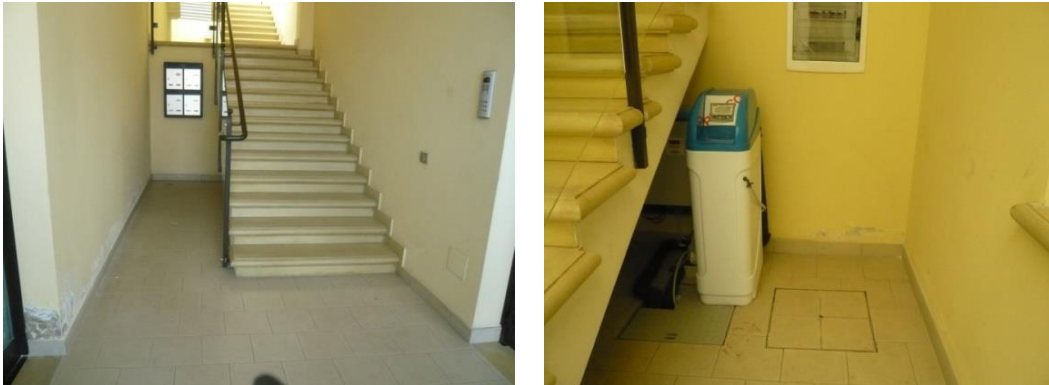
There are dampness patches on the wall, however the defect does not impair the usability and the healthiness of the place.

Figure 4.4 Evidence of dampness on the walls

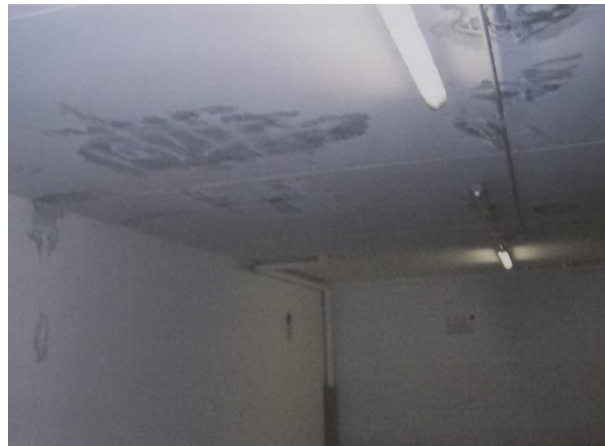
On the ceiling of a garage are been detected water infiltration due to errors in the installation of the waterproofing. The dampness patch are visible indifferent portion but considering their extension and the category of use of the room they do no reduce the usability.

Figure 4.5 Water infiltration evidence on a ceiling

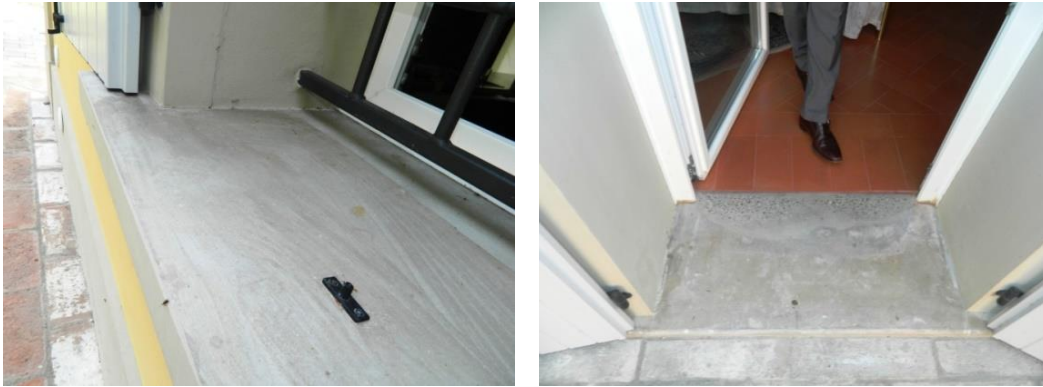
The majority of the window sills and the thresholds show cement stains producing an aesthetical damage of the elements.

Figure 4.6 Cement stains on the windows sills and thresholds

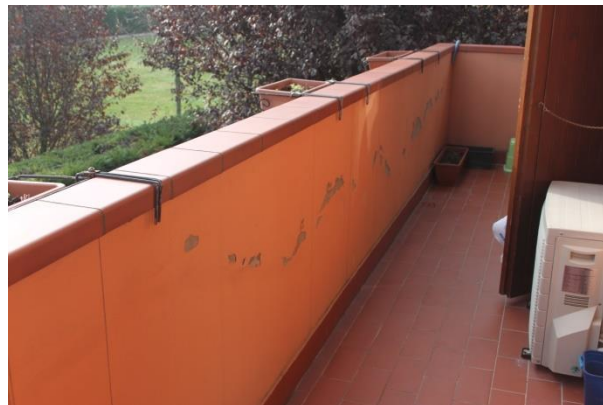
The painting shows swellings and scattered detachment. These defects are located on a balcony and are not able to impair its usability producing only aesthetical damages.

Figure 4.7 Detachment and swelling of the painting

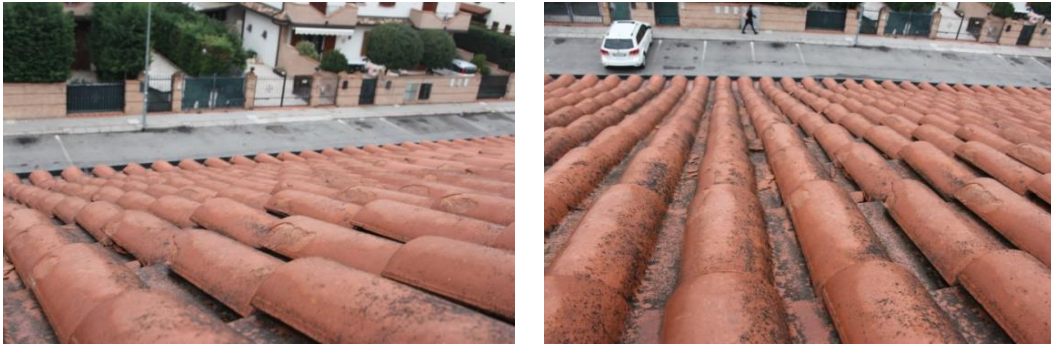
The roofing shows cleavages, the shingles are decayed and cracked. Despite the deterioration there is no danger for the safety of the people furthermore within the structure are not detected damages.

Figure 4.8 Deterioration of the shingles

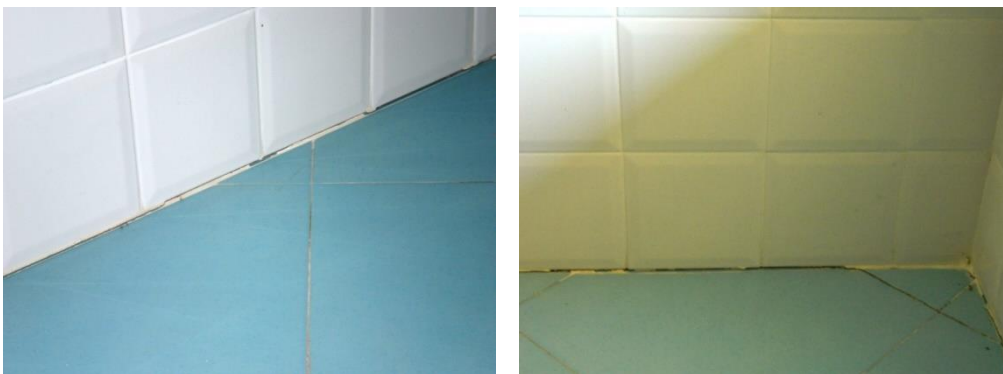
There is a detachment between the flooring and the sealing of the wall. The cause of the defect is a defective execution. The usability of the flooring is not compromised.

Figure 4.9 Detachment between the flooring and sealing of the wall

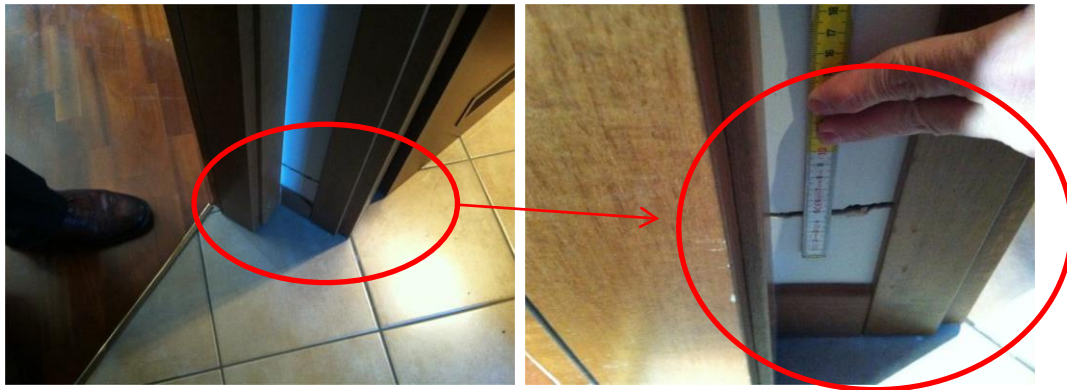
A scattered crack pattern is visible on the wall. The cracks are quite wide (6/7 mm) and are due to an excessive deformation of the slab. The dimensions of the cracks are bigger with respect to the one reported in previous documentation. This means that the phenomenon represents an increasing instability that impairs the static and the functionality of the work.

Figure 4.10 Large crack on the wall

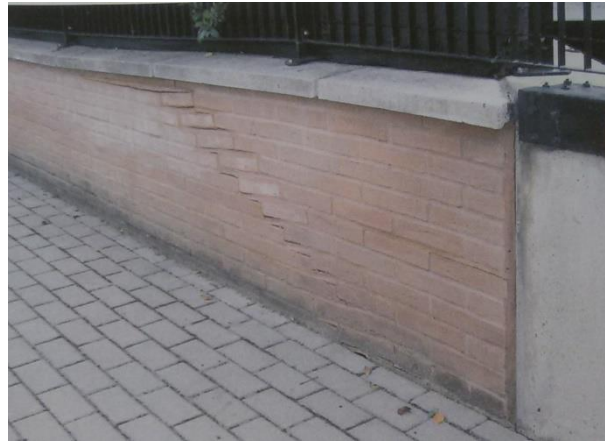
The masonry enclosure shows small cracks due to an excessive deformation. The code limits the deformation of the structure. The measurement proves that the serviceability limit state is not verified.

Figure 4.11 Cracks on a masonry enclosure

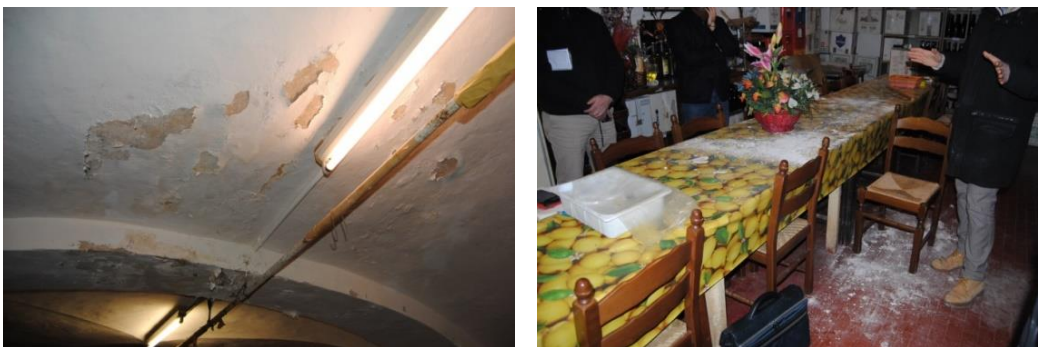
The water infiltration cause the deterioration and the detachment of a large portion of the plasterwork surface making impossible the usage of the property.

Figure 4.12 Deterioration of the surface due to infiltration of water

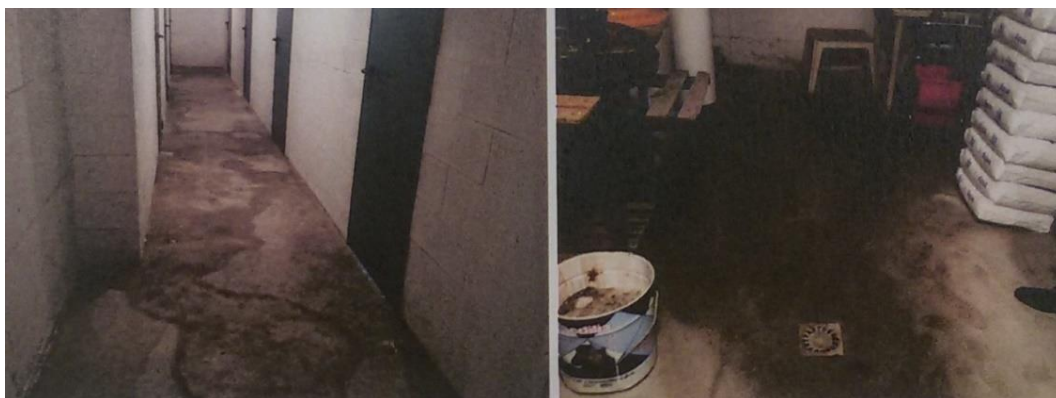
On the wall is possible to see stains due to water infiltrations. Moreover extreme rainfalls event cause the flood of the rooms preventing the regular usage. In this case the water infiltration could not be considered only as an aesthetical damage but impart the serviceability of the good.

Figure 4.14 Stain on the flooring due to water stagnation

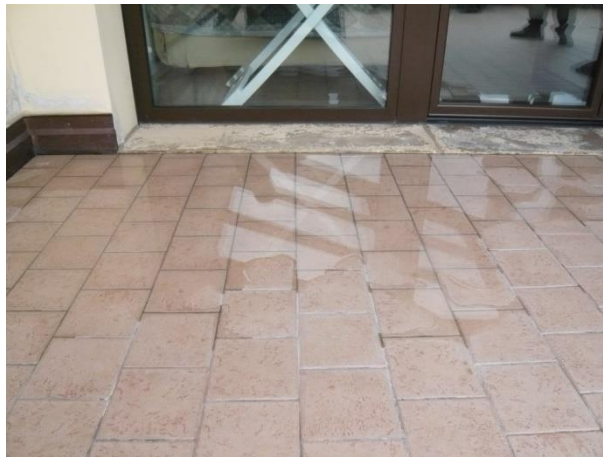
The slope of the balcony is not been realized in the proper way. During the rainfalls event the balcony are completely flood and could not be used for several day. This defect reduce the their usability.

Figure 4.15 Water stagnation on a balcony

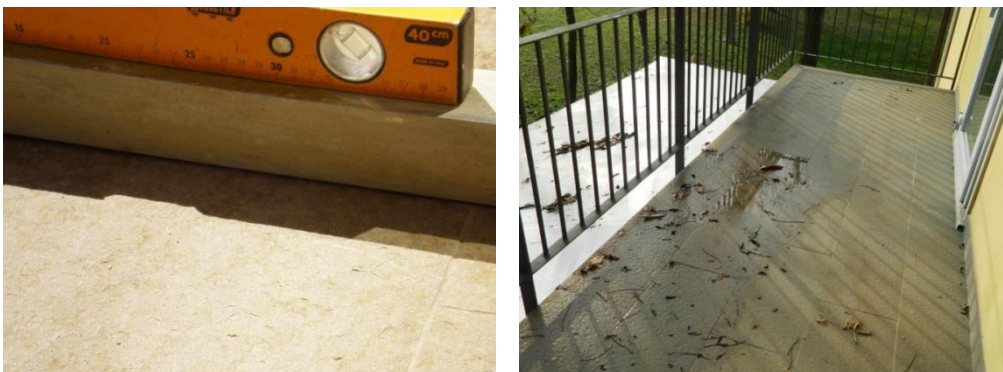
The measurements made by using the bubble level show the lack of flatness of the flooring of the balcony causing water stagnation that prevent the regola usage beyond the formation of unpleasant stains.

Figure 4.16 Water stagnation due to inadequate slope

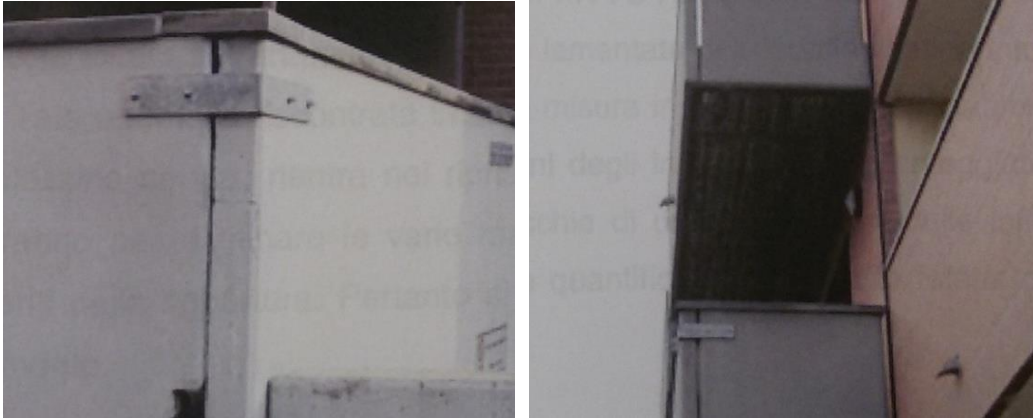
The railing of the building, made by pre-fabricated elements in pre-stressed reinforced concrete, are decayed, disjoint and inclined. The cause is an insufficient anchorage. Between the panels and the case structure of reinforced concrete cast in situ. This situation is dangerous for the integrity of the people. The panel, inclined only for the action of their self-weight, are not able to resist to the lateral forces defined by the code. The defect impairs the static of the elements.

Figure 4.18 Instability of the railing of the building

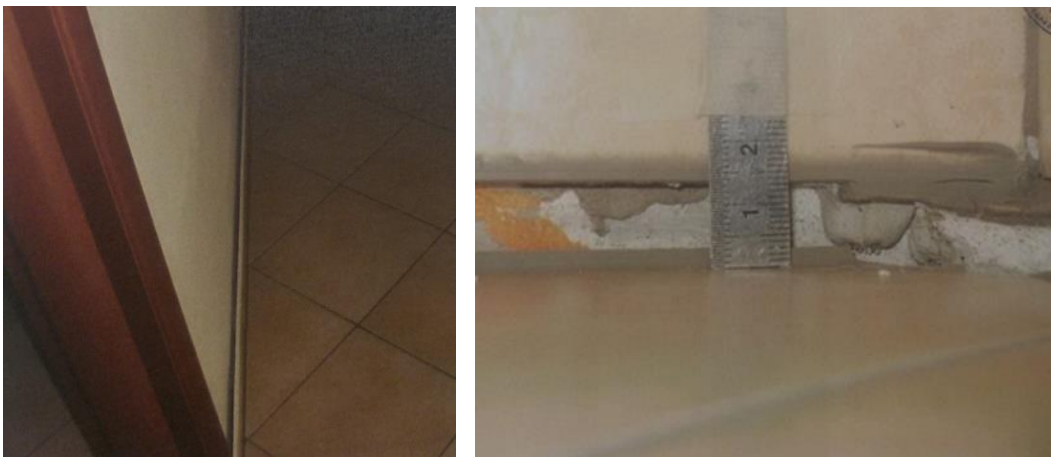
The baseboard is detached from the flooring. The cause of the defect is an excessive deformation of the slab. Beyond the undeniable aesthetical damage this defect reduce the functionality of the good since the requirement prescribed by the serviceability limit state in the code are not fulfilled.

Figure 4.19 Detachment of the base board

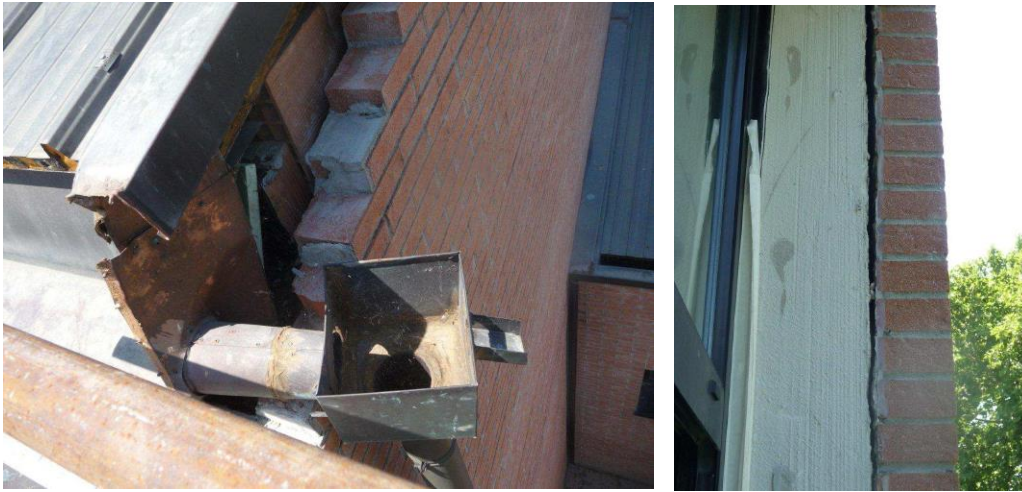
Figure 4.20 Collapse of the top part of the front and detachment of the wall covering

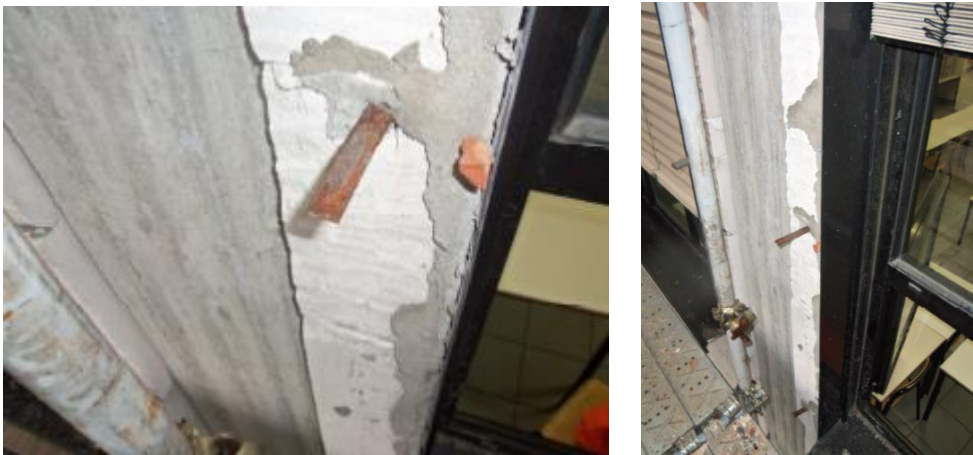
Figure 4.21 Connection element near the windows and in the jambs between the windows

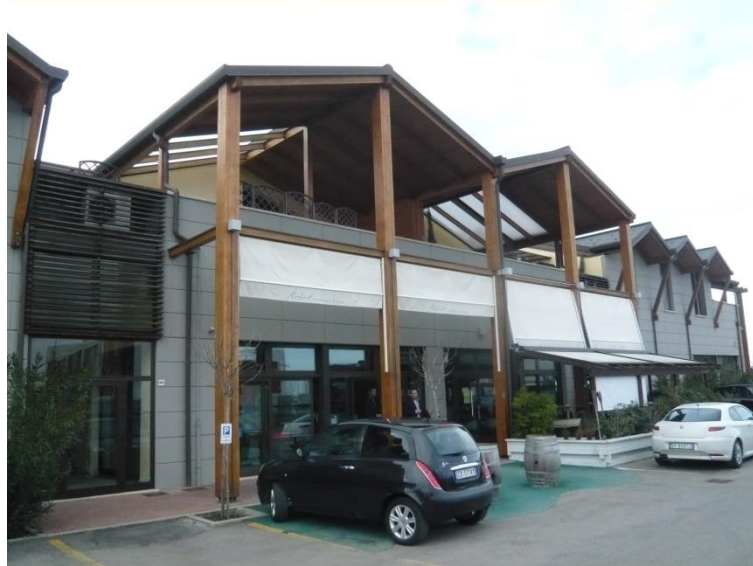
claimed that after few years from the construction these elements show an high level of deterioration.

Figure 4.26: Degradation of a wood roofing

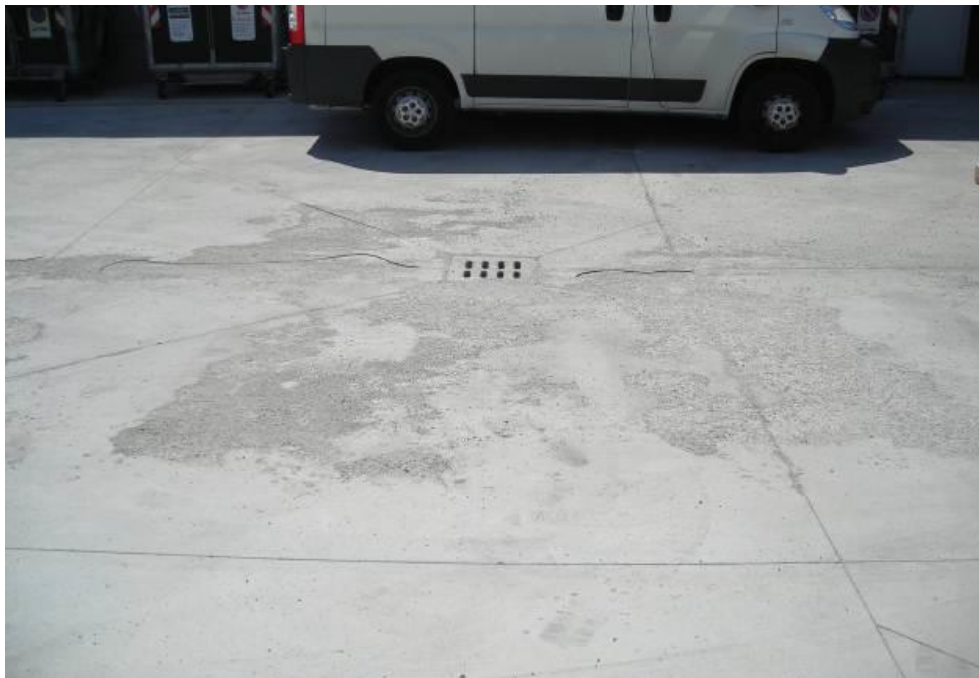
The crumbling is a loss of cohesion between the cement and the aggregates contained in the concrete. In the figures 6.70 is possible to see as this phenomenon involve all the flooring, in particular it is evident in correspondence of the gallipots of the service area.

Figure 4.27 Crumbling of and industrial flooring

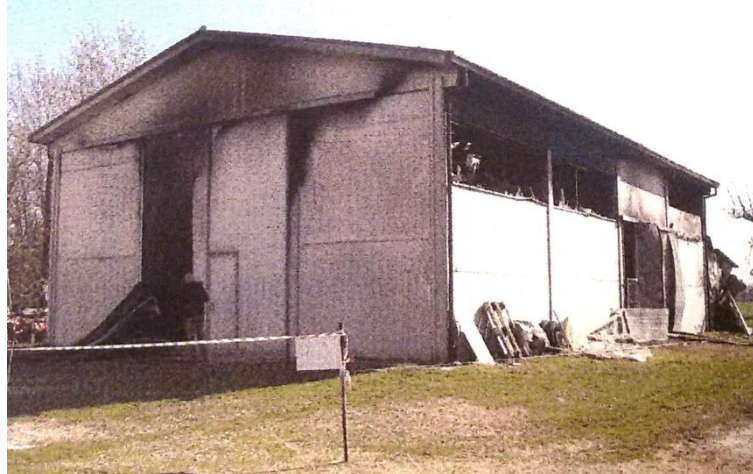
The structure is made of: 13 cast in situ columns on pre-fabricated plinths, 5 reticular truss, wall covering of pre-fabricated panels and a concrete flooring.

Figure 4.28 Partial collapse of a building due to a fire

The majority of reinforced concrete elements show a porous surface. The phenomenon is due to an irreversible dehydration, with consequent destruction of the crystalline structure of the cement that leads to the decline of the mechanical property of the concrete. This is an evidence of the fact that during the fire the temperature was around $600/650^{\circ}\text{C}$, if not even higher.

The fire burns up in the structure reached temperature much greater of the one normally considered in the design. For this reason, considering the characteristics of the steel and the concrete, the collapse could be considered as expected behavior.

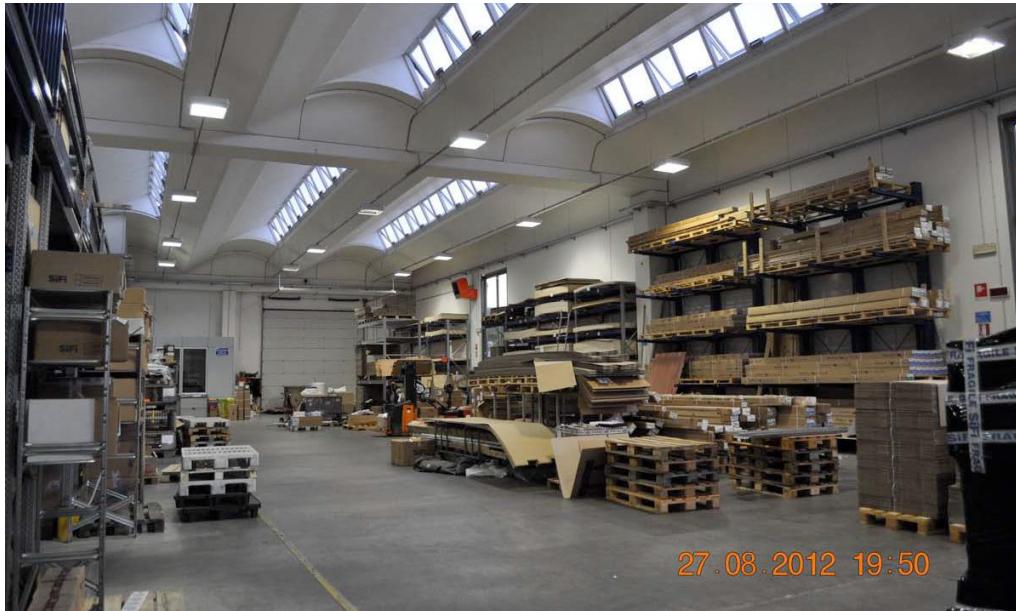
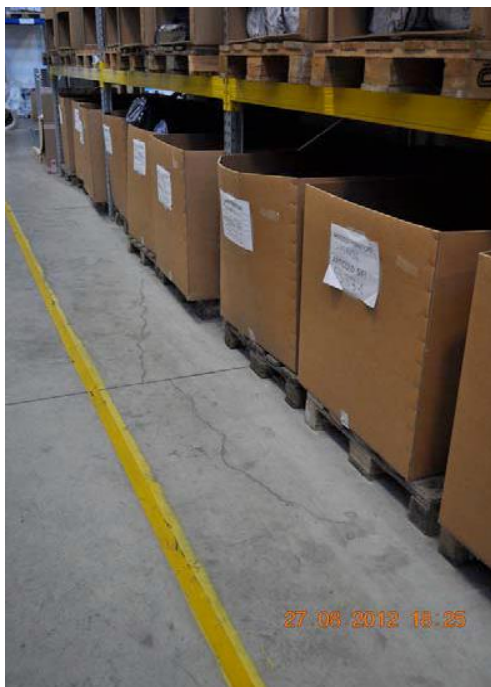
Figure 4.30 N° R.G. 10141 Crack on the flooring of an industrial hanger

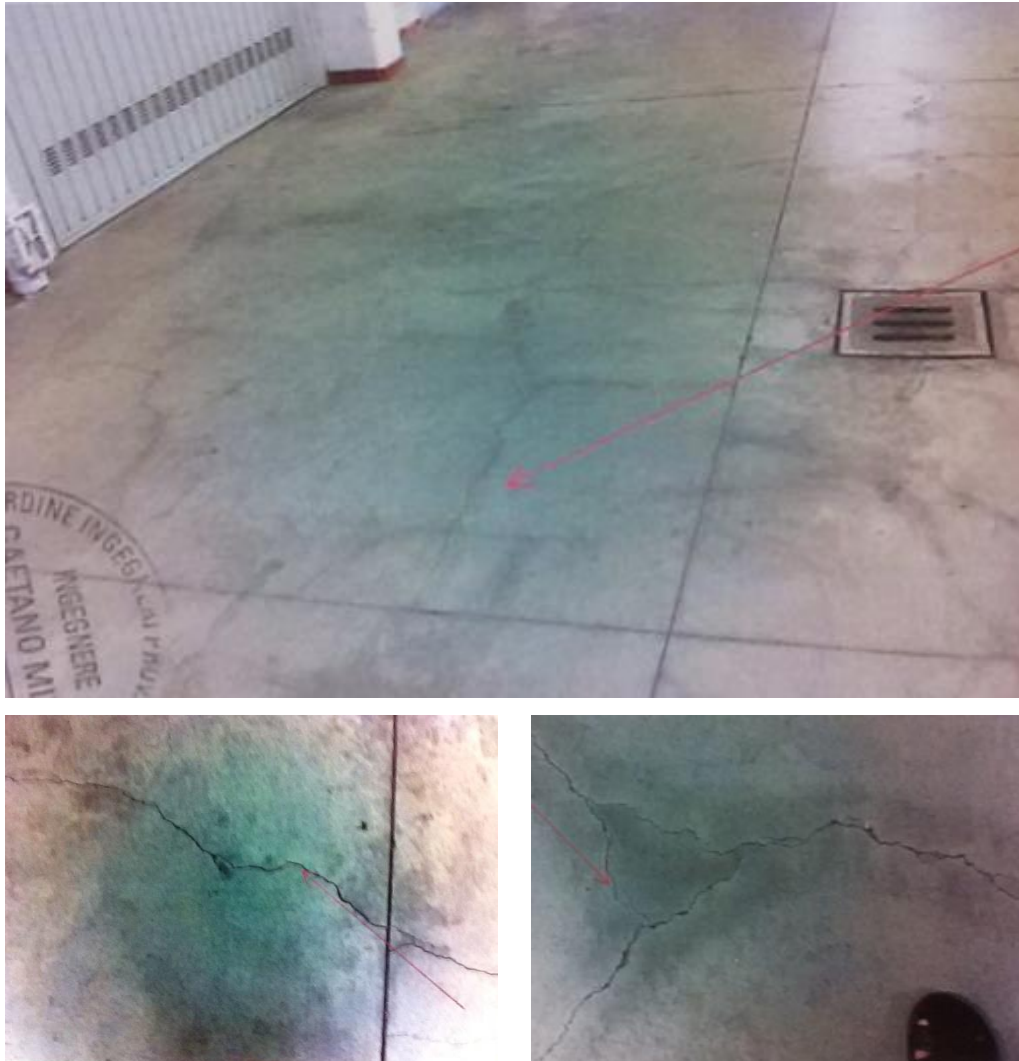
Figure 4.32 N° R.G. 2188/2012 Crack on the concrete flooring of a garage

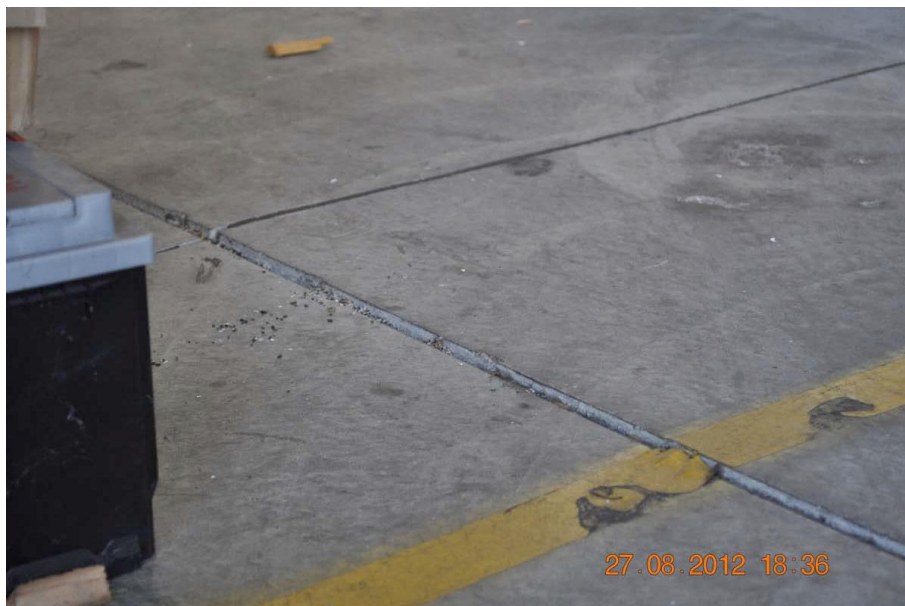
Figure 4.33 N° R.G. 10141/2012 Curling of a concrete slab

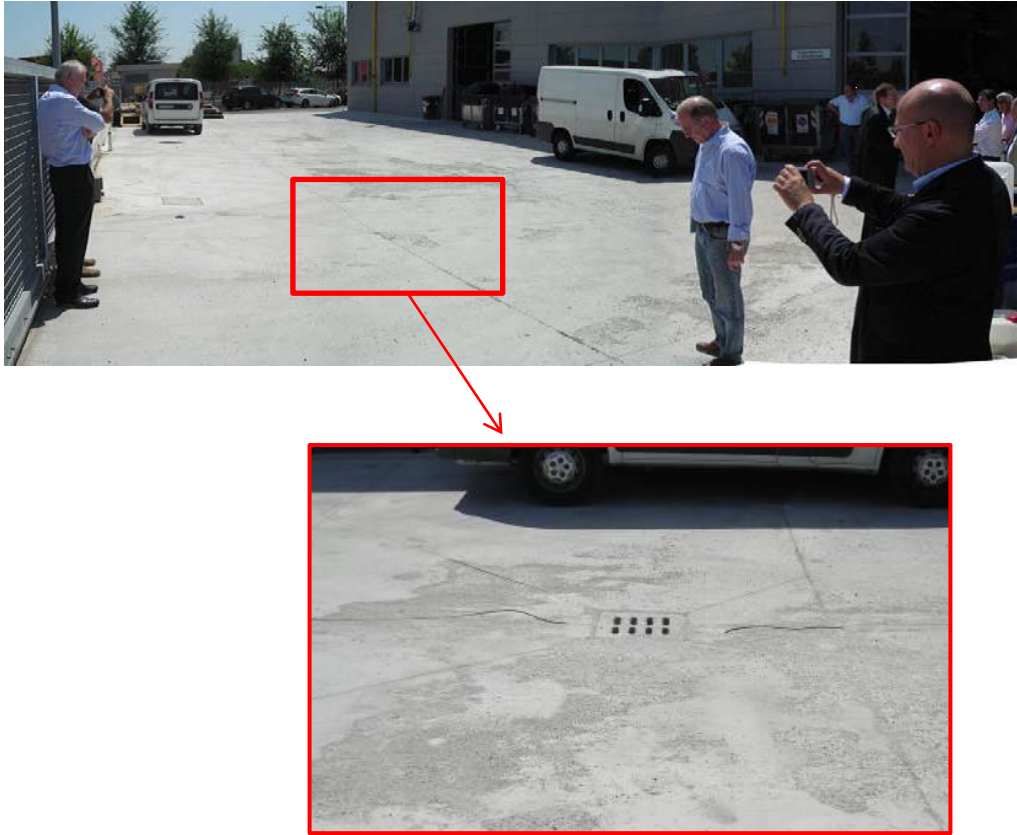
Figure 4.34 Crumbling of an external industrial flooring

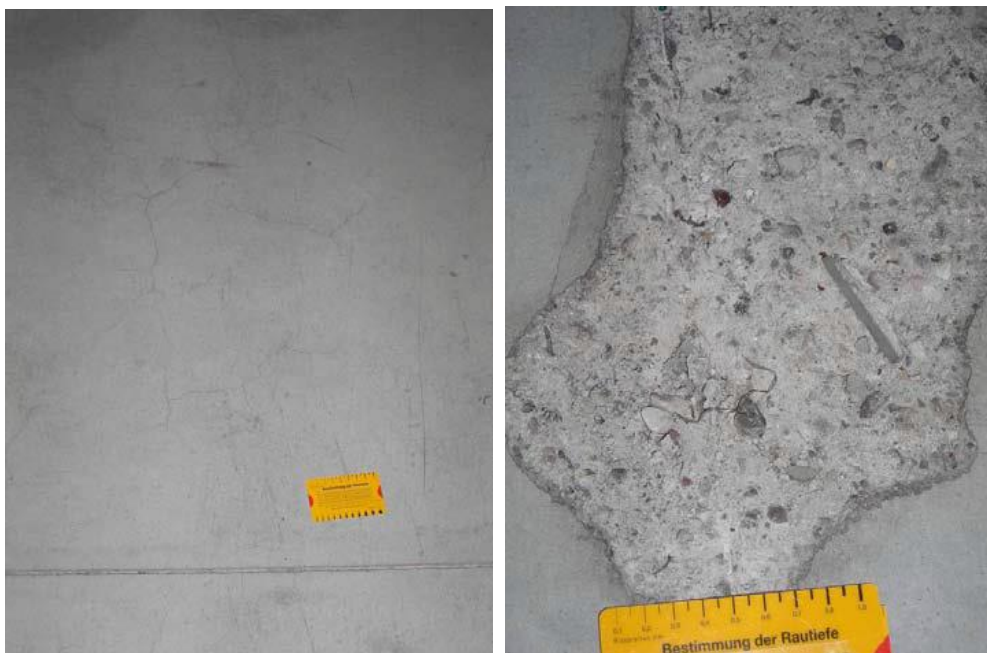
Figure 4.35 N° R.G. 6314 Delamination of an internal concrete flooring

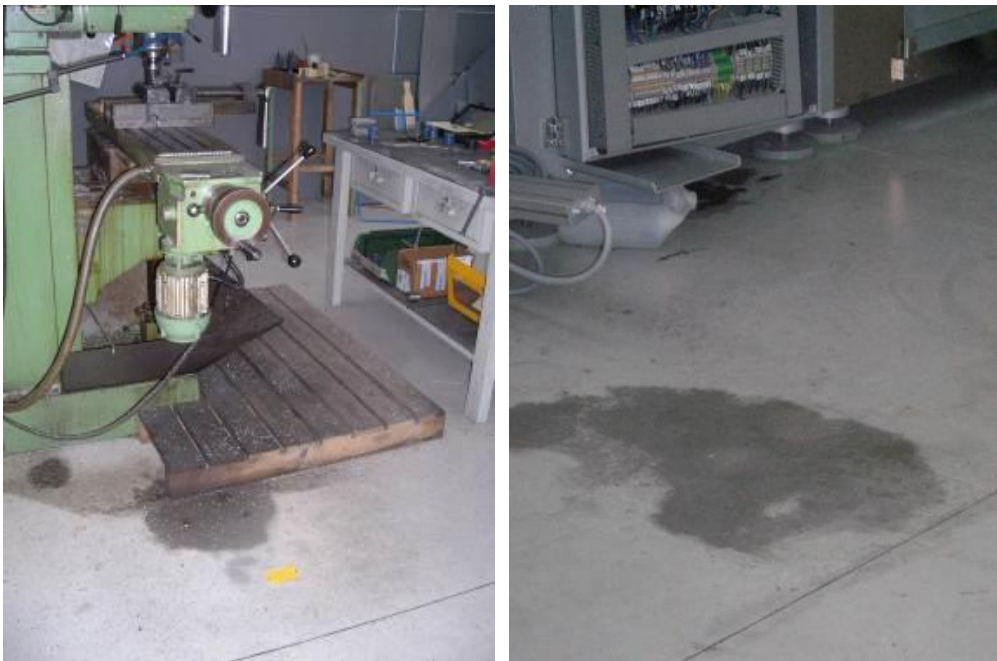
Figure 4.37 N° R.G. 6314 Chromatic non homogeneous due to the presence of oil

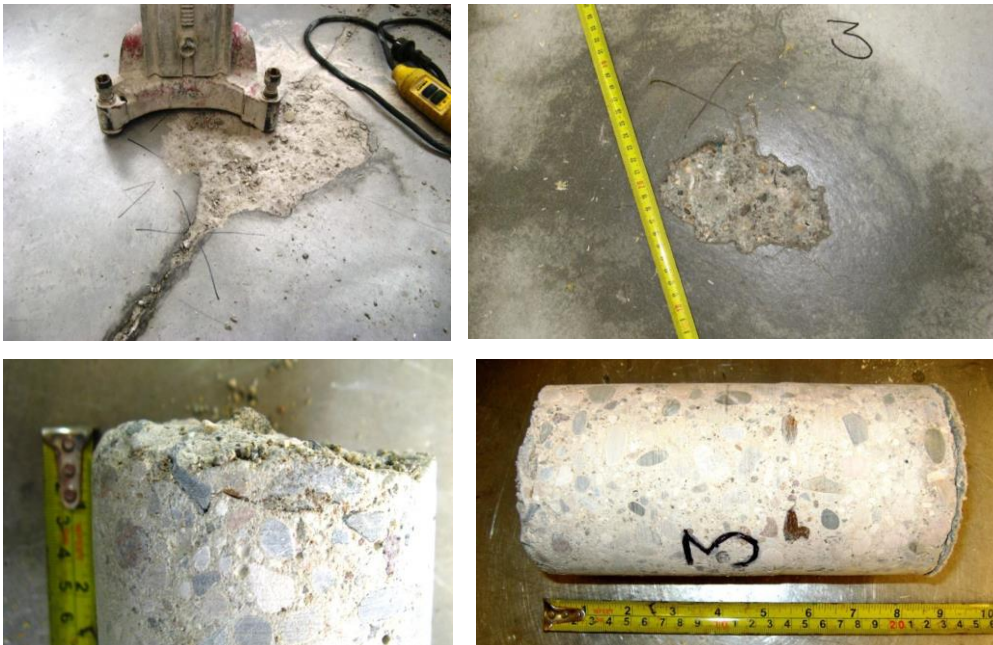
Figure 4.38 N° R.G. 6314 sampling of the inner concrete flooring

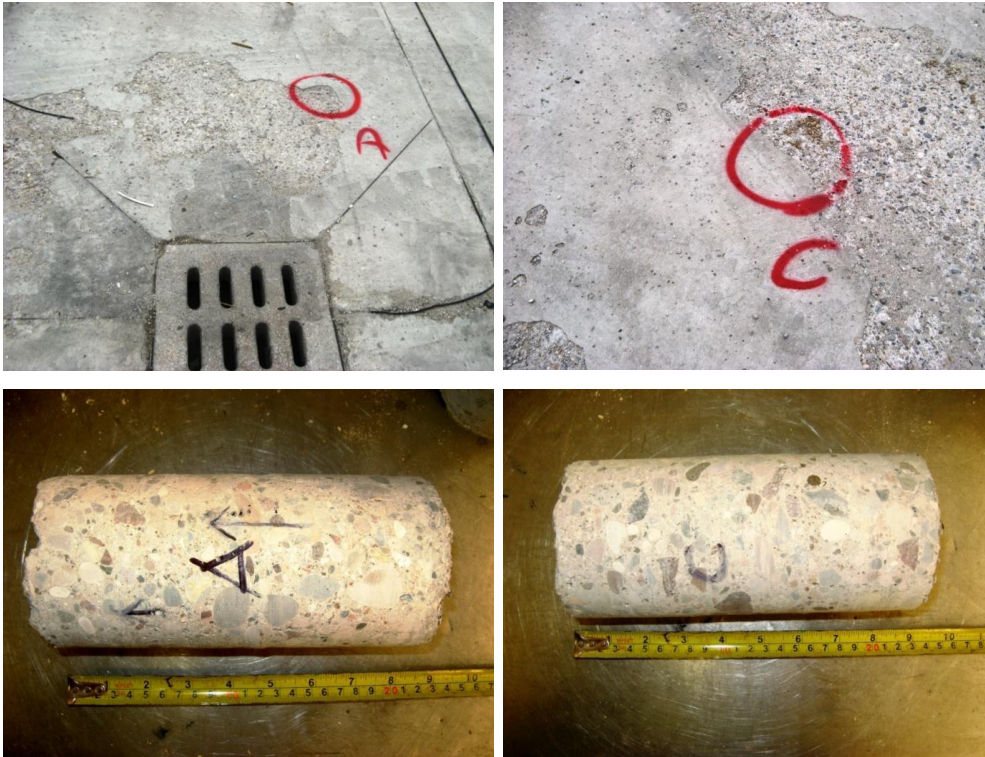
Figure 4.39 N° R.G. 6314 sampling of the outer concrete flooring

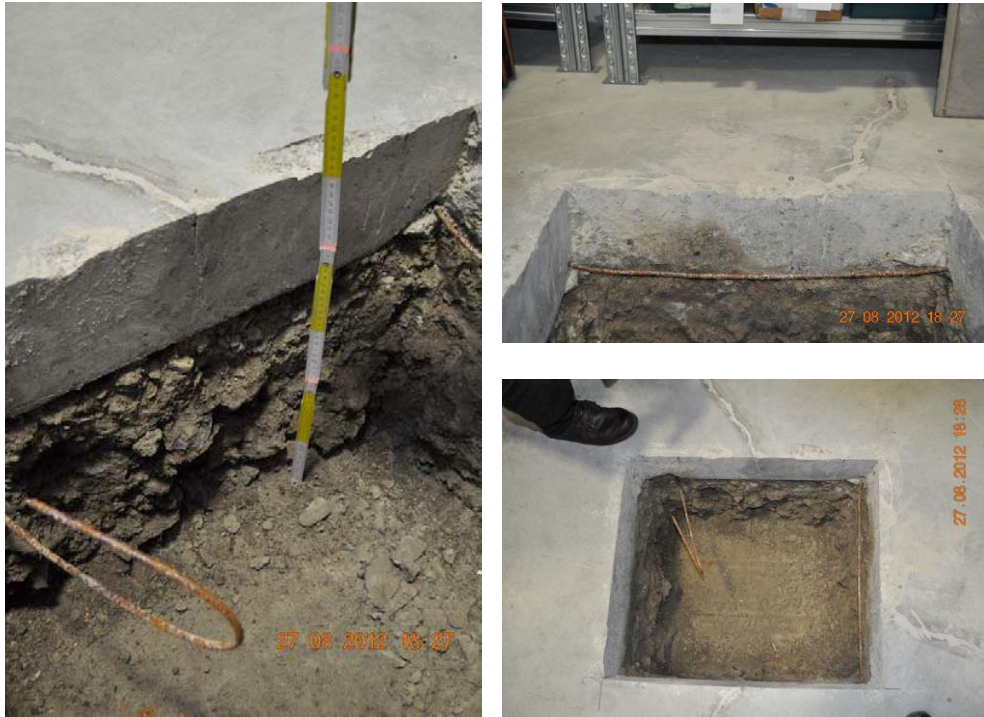
Figure 4.42 N° R.G. 10141 Example of in-situ survey

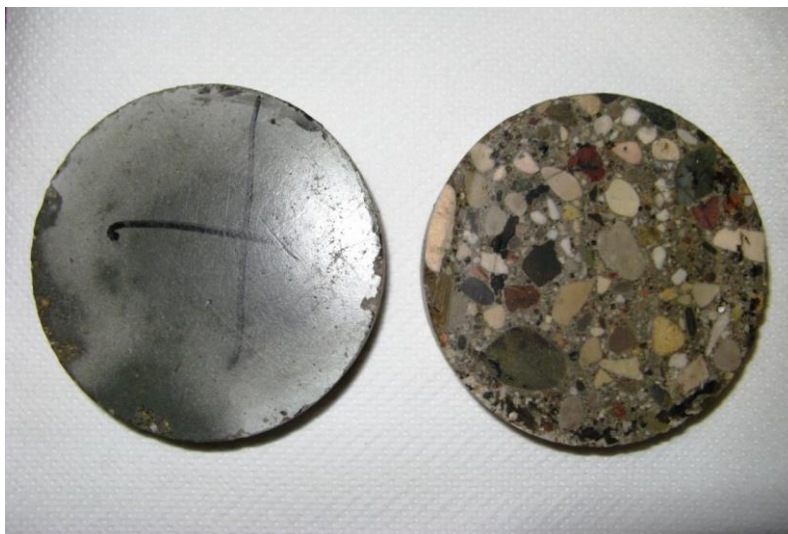
At the end of the cycle is evaluated the state of the samples. In particular if they show alteration, fractures or detachments.

Figure 4.47 N° R.G. 6314 sample subjected to chemical analysis

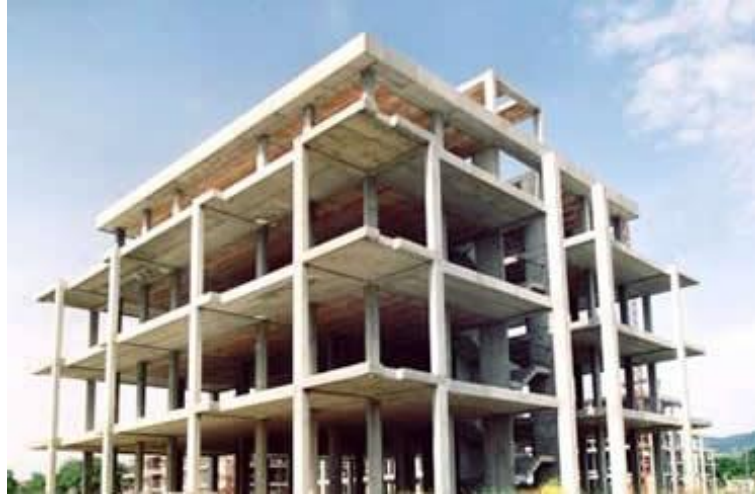
- Traditional Reinforced concrete structure;
- Pre-stressed reinforced concrete structure;
- Concrete with a low percentage of reinforcement or without it.

Figure 6.49 Example Reinforced concrete structure

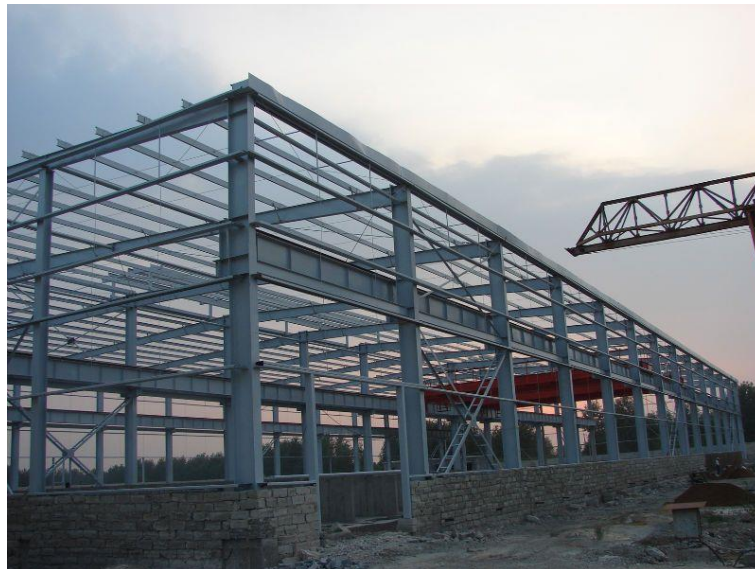
In this category are included all the works where the bearing structure (beam and columns) is made of structural steel.

Figure 6.50 Example steel structure

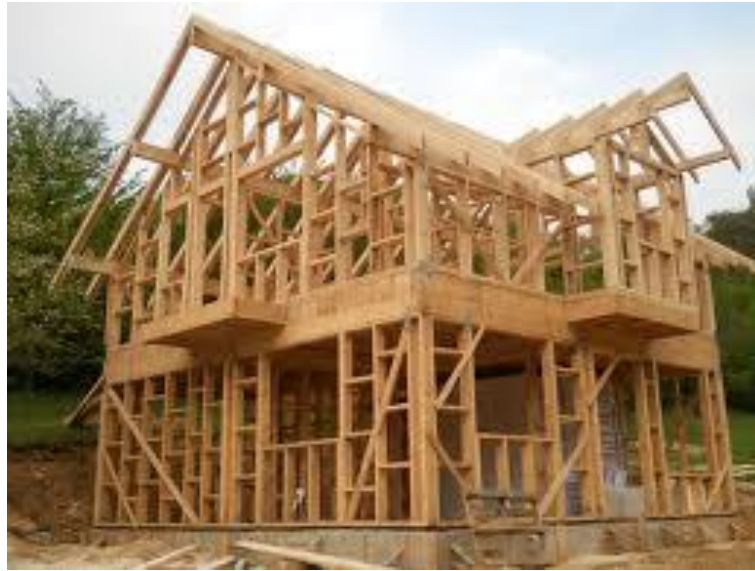
In this category are included all the works in which the bearing structure (beam and columns) is made of structural timber as the hardwood or with wooden structural element like plywood, wooden panels.

Figure 6.51 Example of timber structure

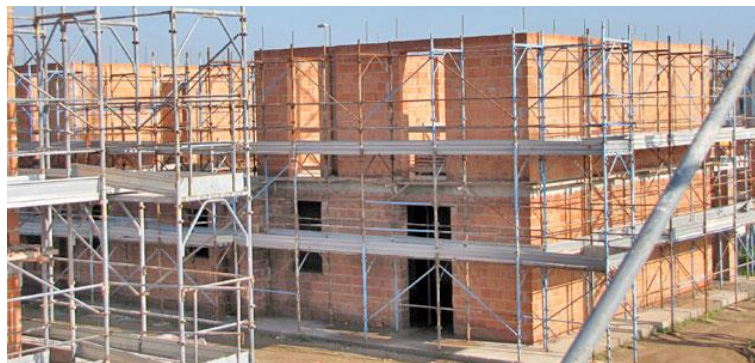
In this category are included all the works in which the vertical elements are made of masonry connected by slabs, that could be of different type.

Figure 6.52 Example of masonry structure

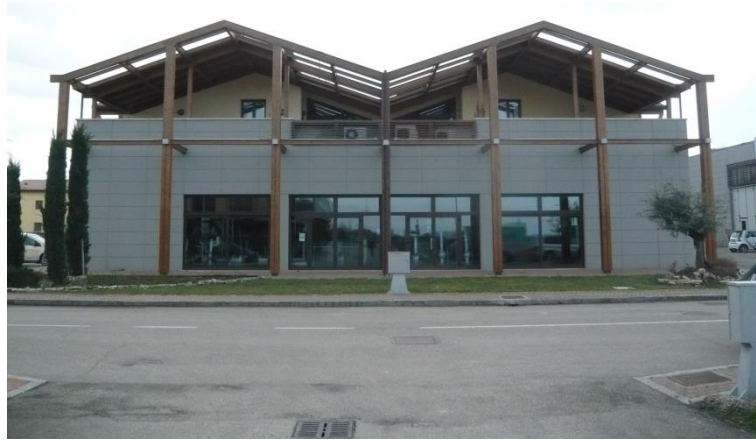
In this category are included all the works in which the bearing structure is made of different material.

Figure 6.53 Example of mixed structure

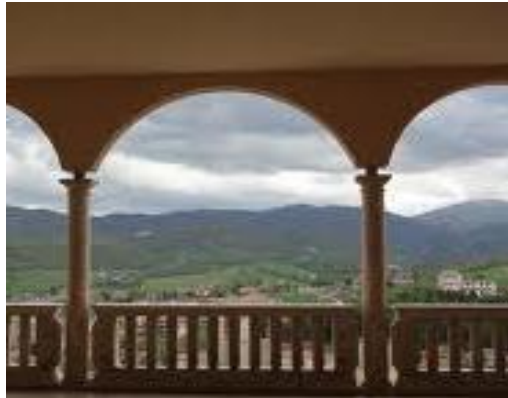
Figure 6.59 Examples of horizontal elevation structure: Arches.

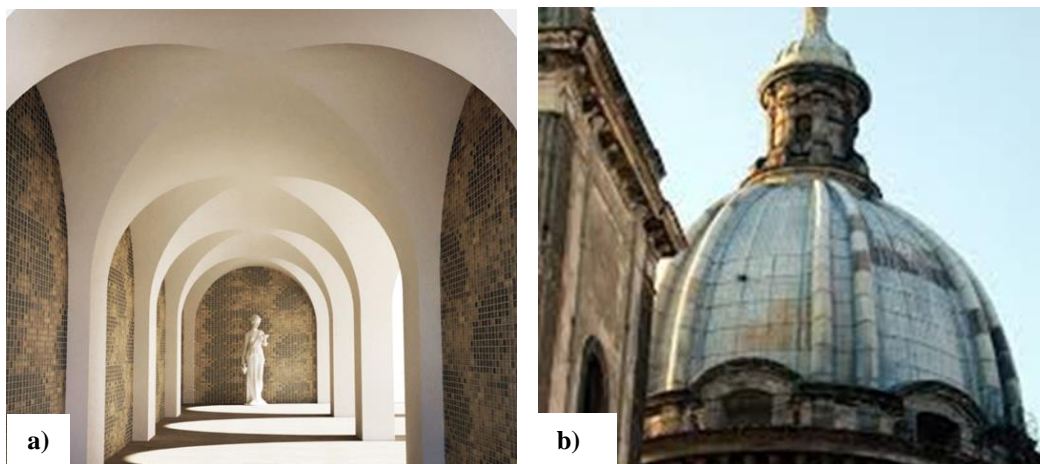
Figure 6.60 Examples of spatial elevation structures: a) Vaults; b) Cupola.

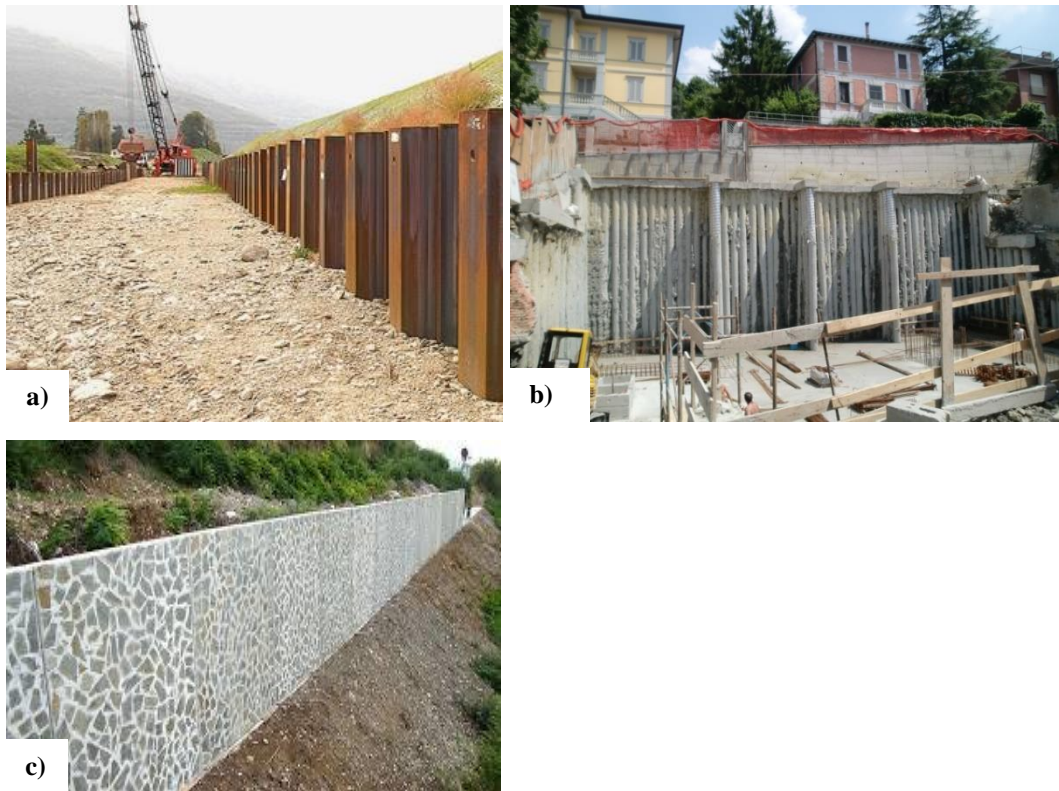
Figure 6.61 Examples of retaining structures: a) Sheet piles; b) Diaphragm wall; c) Retaining wall

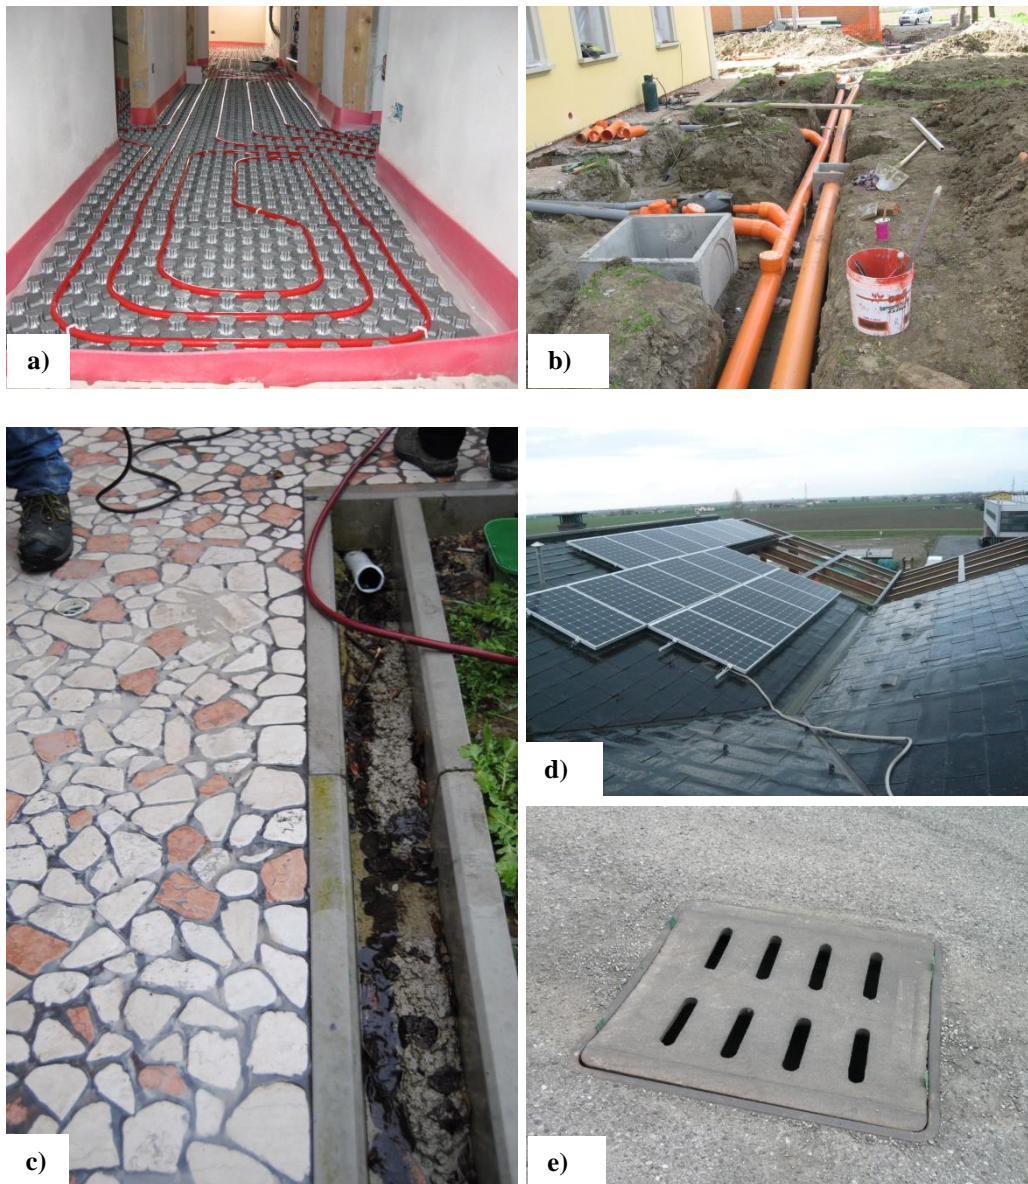
Figure 6.69 Examples of plants: a) Ground heating system; Wayer distribution system; c) Rain water removal system; d) Solar panels; e) gallipot

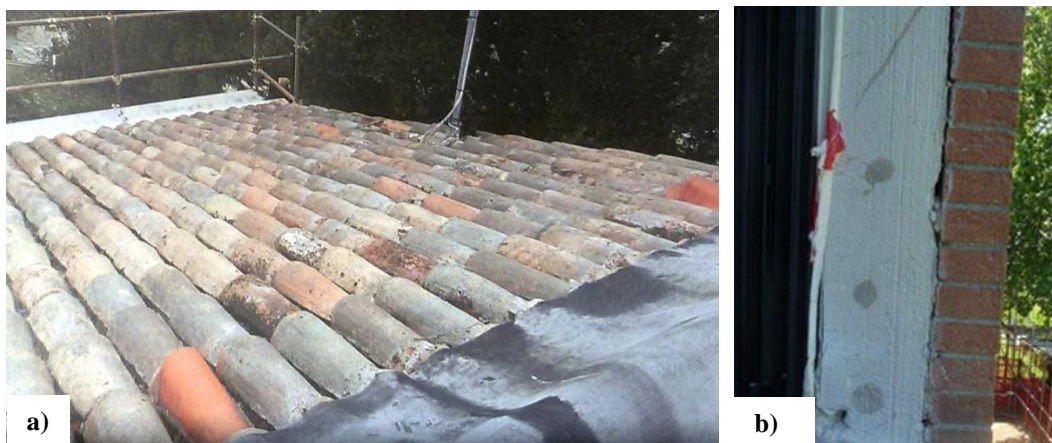
Figure 6.76 Examples of damage/deterioration: a) Shingles deterioration; b) Covering detachment
