CIVIL ENGINEERING MASTER THESIS

LEARNING FROM EXPERIENCE:

**ANALYSIS OF THE CIVIL LITIGATION REGARDING
BUILDING STRUCTURES ON THE COURT OF BOLOGNA
IN THE YEARS 2011/2012**

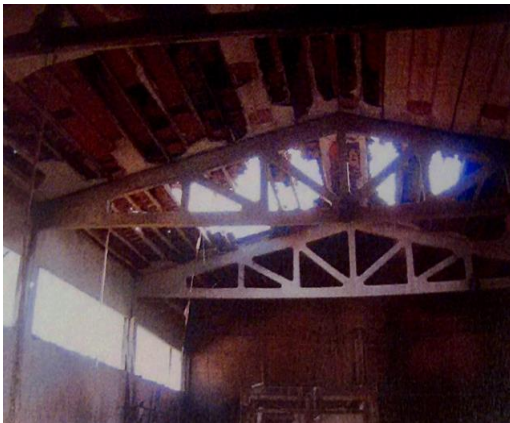
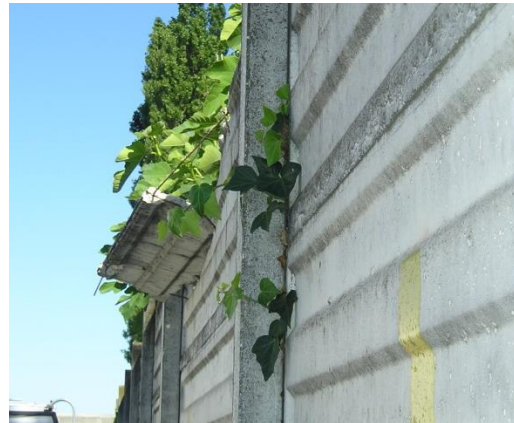
Figure 6.79 Examples of collapse: a) Collapse of a roofing due to a fire; b) Collapse of a enclosure wall due to a fall of a tree

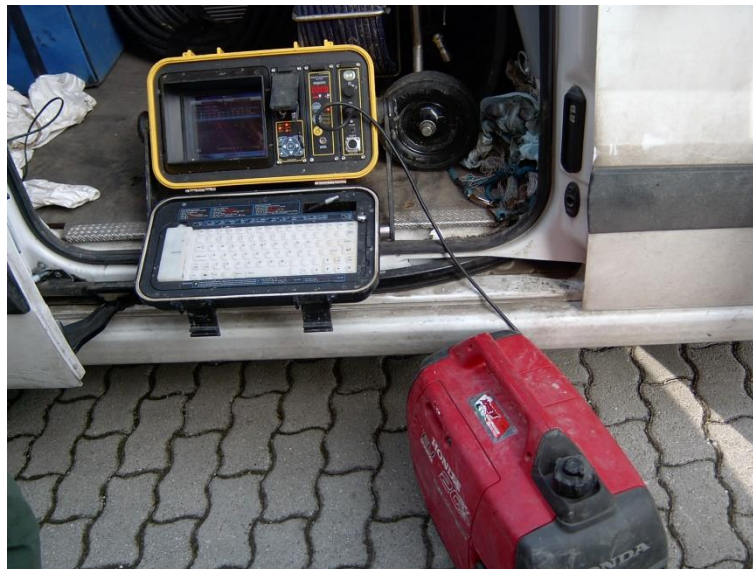
Figure 6.81 Instruments for the video inspection of a drainage system

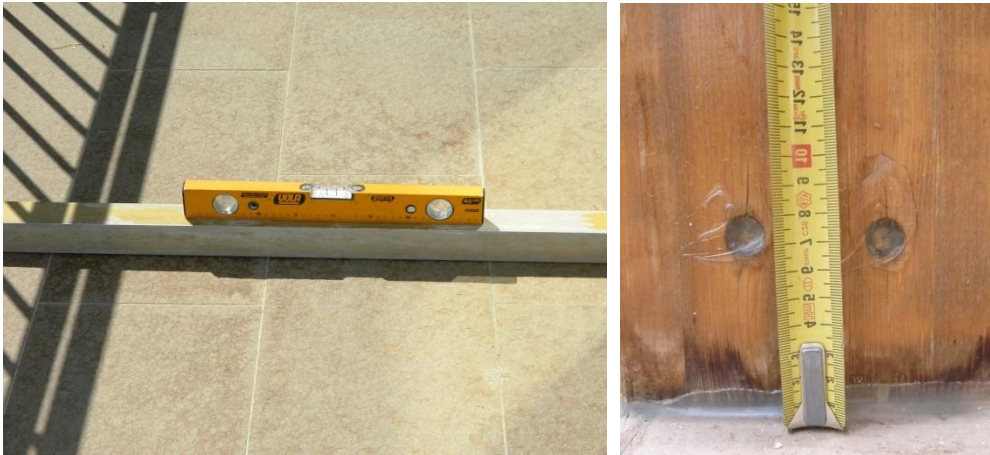
Figure 6.82 Metric survey: a) Inclination of the balcony; b) Measure of the distance between the stud axis and the flooring

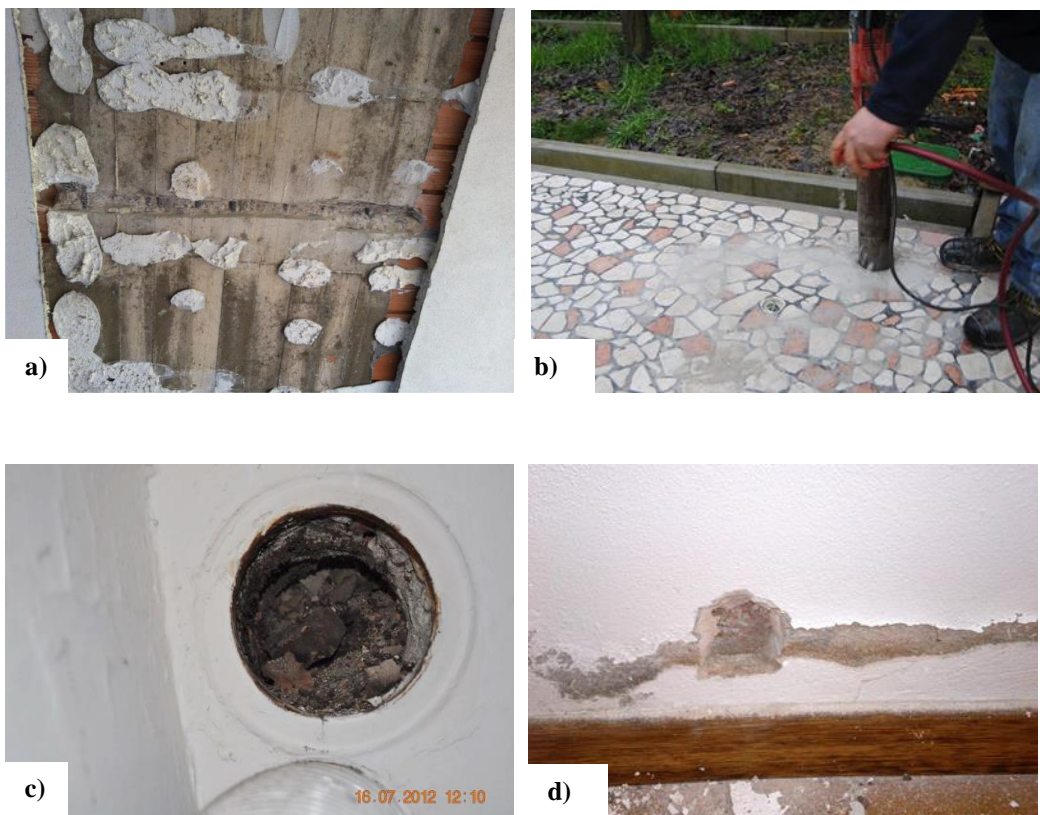
- Sampling or excavation in order to establish the layers of an element

Figure 6.83 Examples of in situ test: a) Excavation of a beam b) Sampling of an external flooring; c) inspection hole for an exhaust pipe; d) Survey on a wall

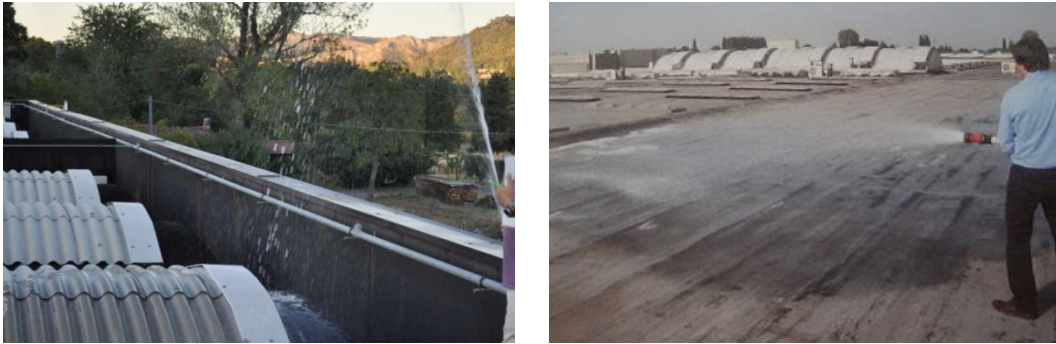
Figure 6.84 Water-tightness tests

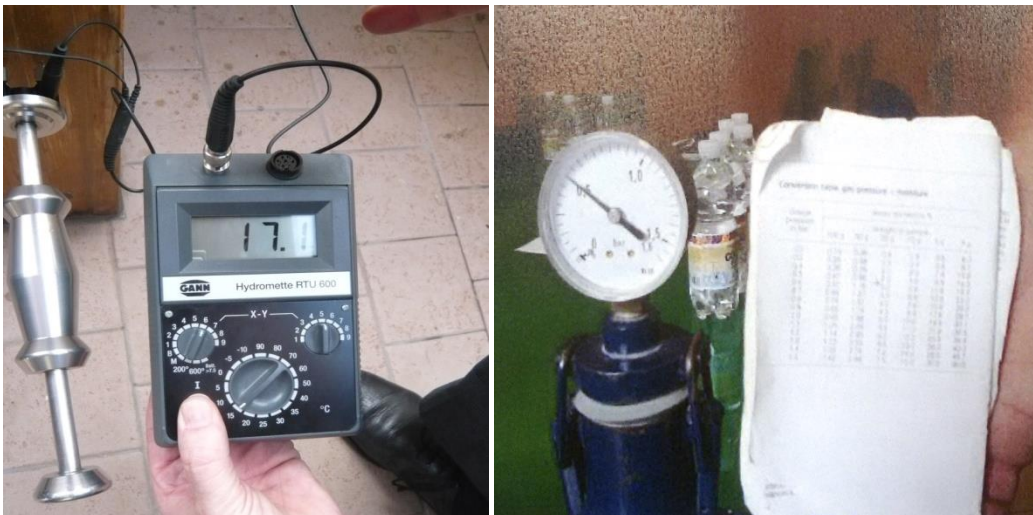
Figure 6.85 Examples of measurement of the moisture
