ALMA MATER STUDIORUM - UNIVERSITÀ DI BOLOGNA

TESI DI LAUREA

BRIDGE FAILURES:

CAUSES, CONSEQUENCES AND CHANGES IN CODES

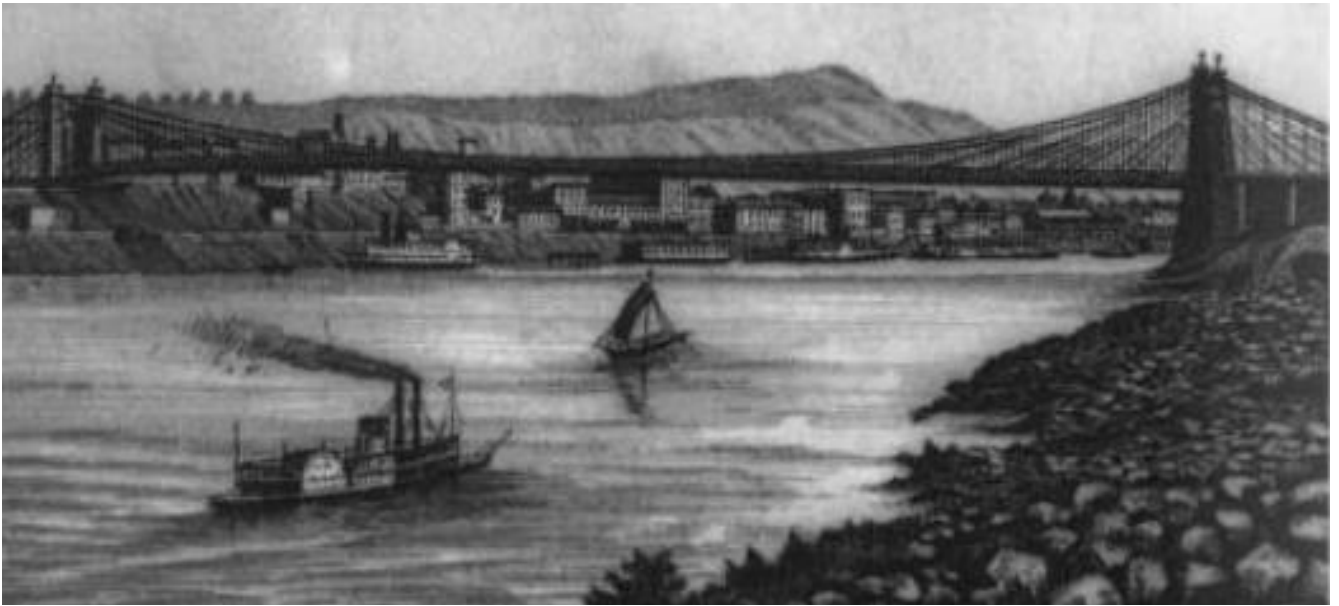
Figure 1

Year	<u>1854</u>
Type	<u>Road</u>
Country	<u>United States</u>
Cause	Natural hazard (Storm)
Details	Storm
Fatalities	0
Injuries	0
Collapse	complete
Phase	in service

It was the largest suspension bridge in the world from its completion in 1849, until the Queenston-Lewiston Bridge was opened in 1851. It was the first to span the Ohio River and it was designed by Charles Ellet Jr., who also worked on the Niagara Falls Suspension Bridge, failed ten years later. The main span is 1,010 feet (310 m) from tower to tower. The east tower is 153.5 feet (46.8 m) above the low-water level of the river, or 82 feet (25 m) from the base of the masonry. The west tower is 132.75 feet (40.46 m) above low water, with 69 feet (21 m) of masonry. On May 17, 1854 a strong windstorm destroyed the deck of the bridge through torsional movement and vertical undulations that rose almost as high as the towers

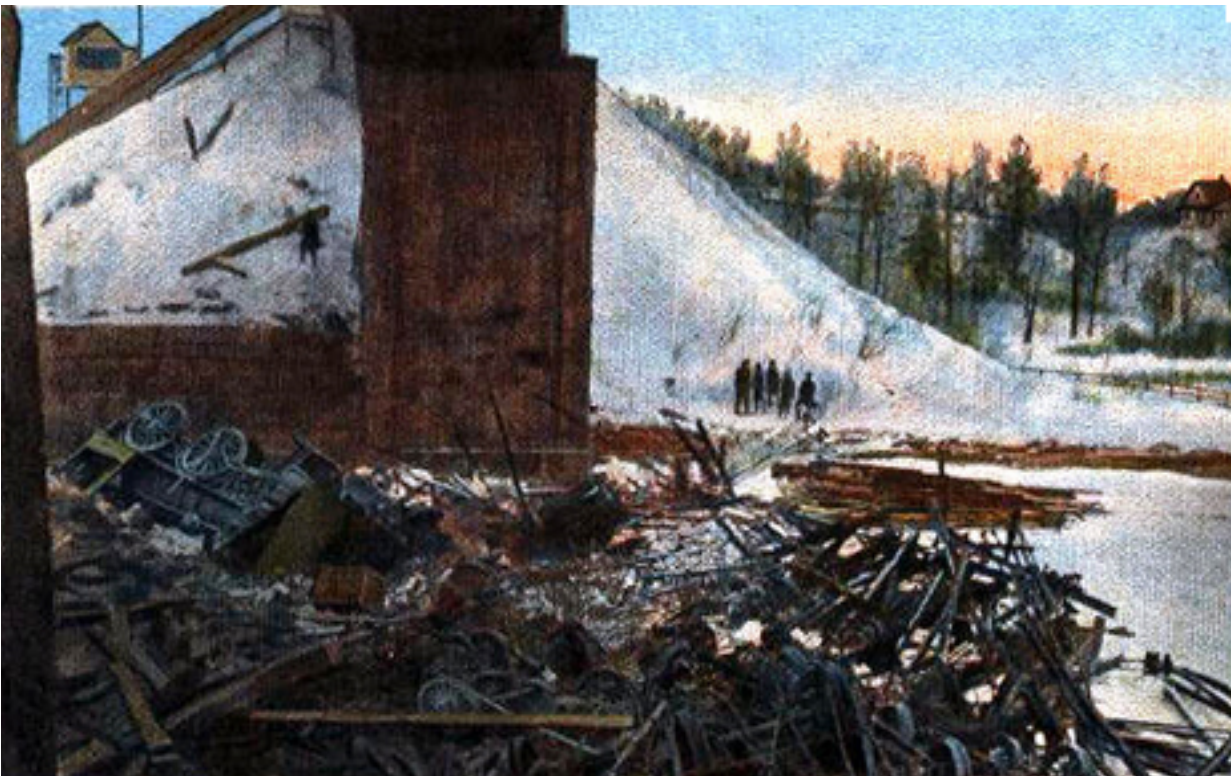
Figure 5

The compression members of the bridge have no lateral connections with each other, thus acting as separate long slender columns that cause weaknesses for buckling.

Therefore the structure was deficient in many parts and the failure of one of these weak parts was the trigger.

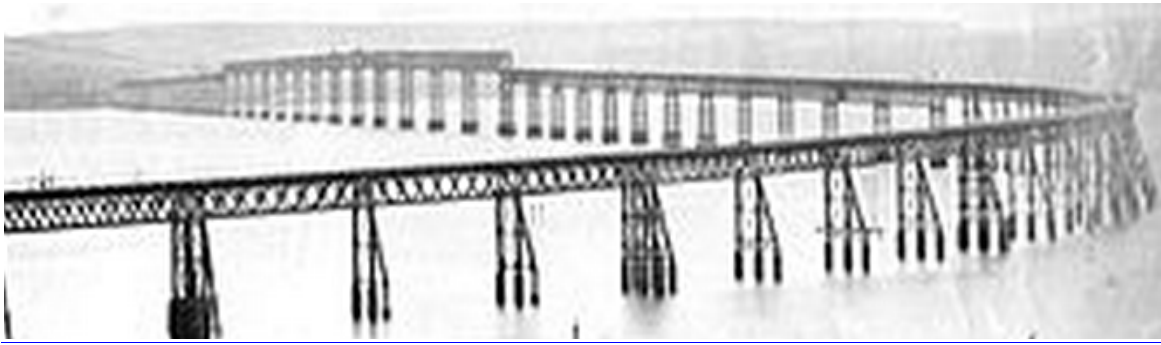
Figure 7

Many faults in design, materials, and processes that had contributed to the failure.

Bouch had been advised that calculating wind loads was unnecessary for girders shorter than 200 feet (61 m), and had not followed this up for his new design with longer girders. The section in the middle of the bridge, where the rail ran inside high girders (through trusses), rather than on top of lower ones (deck trusses), to allow a sea lane below high enough for the masts of ships, was potentially top heavy and very vulnerable to high winds. The piers consisted of four cast iron columns 15in. In diameter, and two columns 18in in diameter, in the form of cylinders, all one and a half inches in thickness, and filled with portland cement concrete. These seven pieces were put together by horizontal and diagonal braces. The wind pressure requie to overturn the structure, with a train on it was not over the 50lbs per sq. ft. The piers being light lacce the weight to resist overturning.

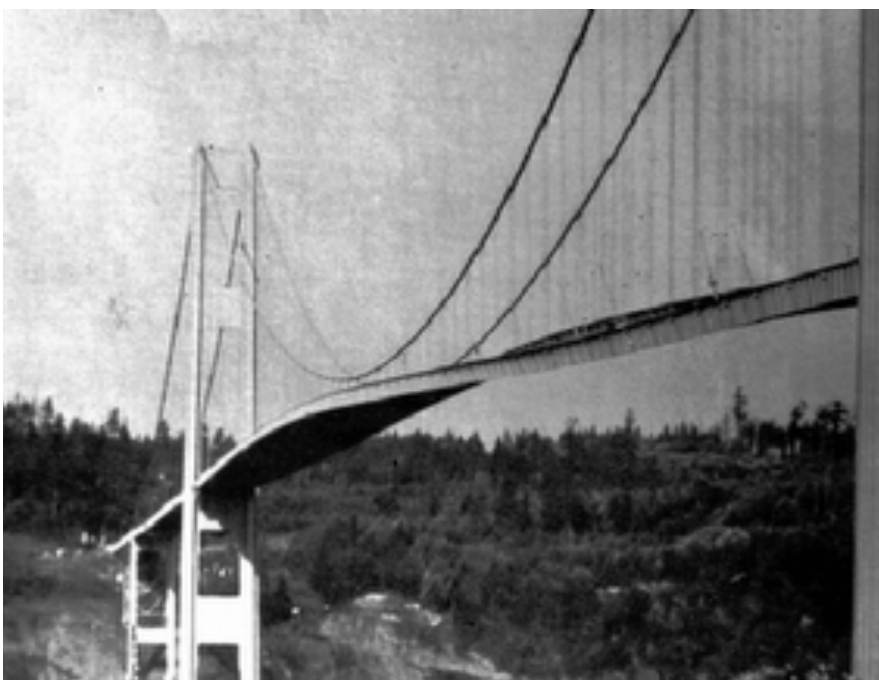
Figure 21

Year	1940
Type	Road
Country	United States
Cause	Limited knowledge
Details	Insufficient bending- and torsion stiffness, aerodynamic instability
Fatalities	0
Injuries	0
Collapse	complete
Phase	in service
Continent	North America

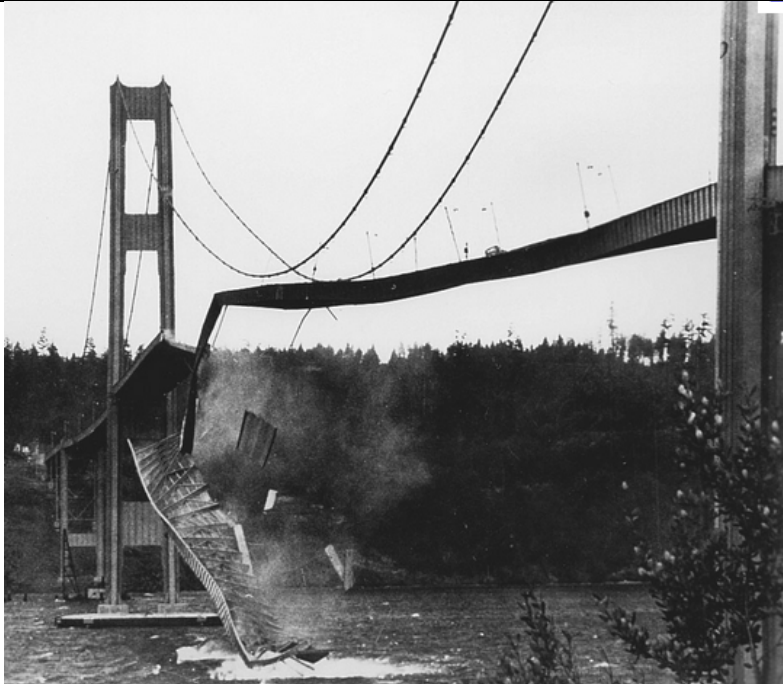
Figure 22

Length of center span	2800 ft
Width	39 ft
Depth of stiffening girders	8 ft
Start of construction	Nov, 23, 1938
Opened for traffic	July, 1, 1940
Collapse of bridge	Nov, 7, 1940

The first Tacoma Narrows Bridge opened to traffic on July 1, 1940. Its main span collapsed into the Tacoma Narrows four months later on November 7, 1940, at 11:00 AM (Pacific time) due to a physical phenomenon known as aeroelastic flutter caused by a 67 kilometres per hour (42 mph) wind. The bridge collapse had lasting effects on science and engineering. In many undergraduate physics texts the event is presented as an example of elementary forced resonance with the wind providing an external periodic frequency that matched the natural structural frequency (even though the real cause of the bridge's failure was aeroelastic flutter[1]). Its failure also boosted research in the field of bridge aerodynamics/aeroelastics which have themselves influenced the designs of all the world's great long-span bridges built since 1940.

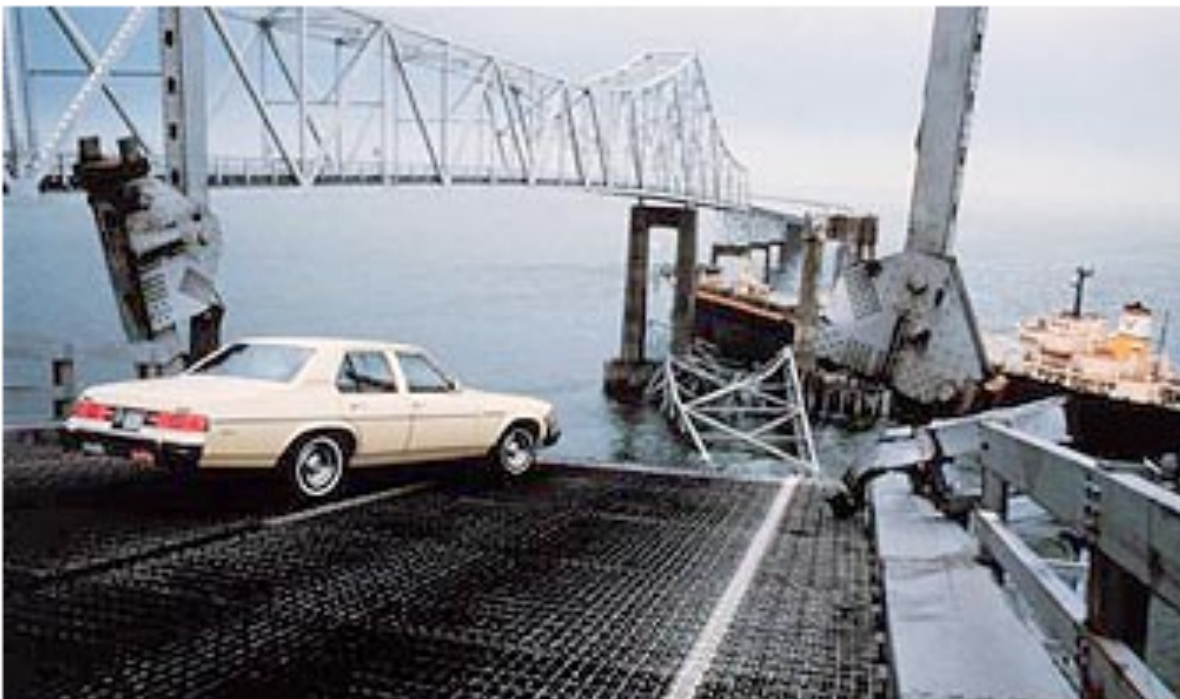
Figure 32

Year	1980
Type	Road
Country	United States
Cause	Impact
Details	Ship impact, not enough care of captain in bad weather
Fatalities	35
Injuries	0
Collapse	partial
Phase	in service

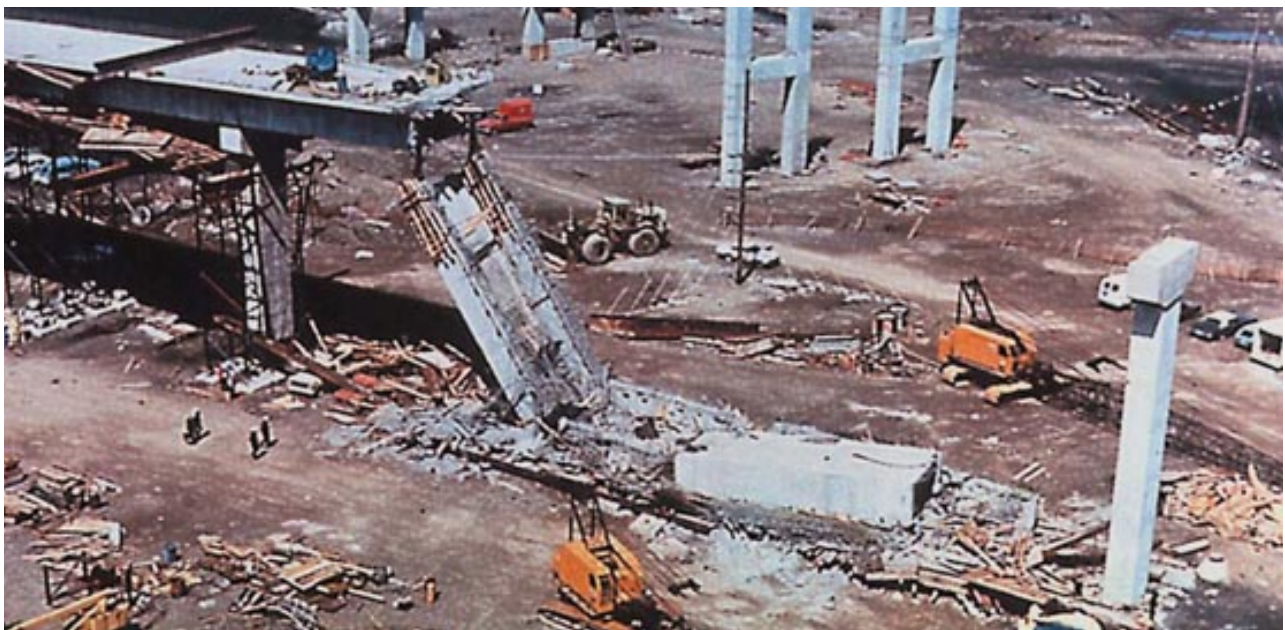
Figure 36

Year	1982
Type	Road
Country	United States
Cause	Design error
Details	Scaffolding collapses under weight of fresh concrete
Fatalities	13
Injuries	18
Collapse	partial
Phase	construction

Before the construction of the expressway, portions of Truck Route 912 were on Kennedy Avenue. 5.7 miles (9.2 km) of new expressway from the Toll Road to Chicago Avenue was constructed. On April 15, 1982, fourteen workers were killed and eighteen injured when falsework beneath a ramp failed during a concrete pour.

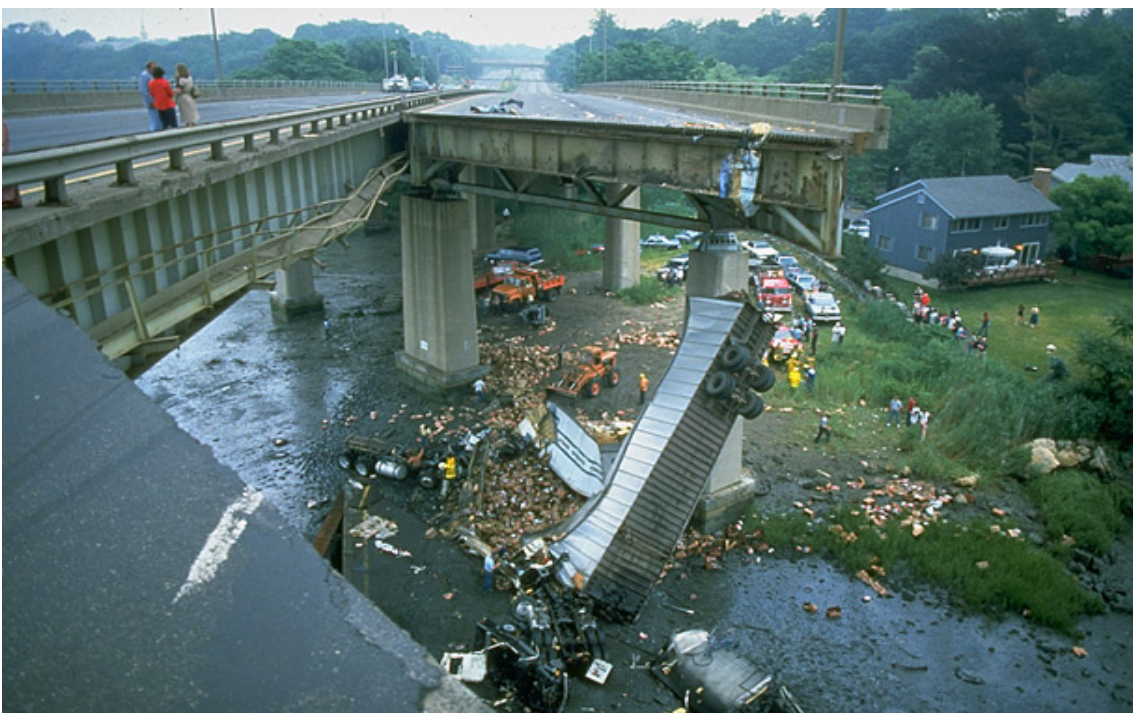
Figure 37

Year	1983
Type	Road
Country	United States
Cause	Deterioration
Details	Corrosion of joint hangers (Gerber-joint), constraint stresses due to big skewness
Fatalities	3
Injuries	3
Collapse	partial
Phase	in service

The Mianus River Bridge carries Interstate 95 over the Mianus River in the Cos Cob section of Greenwich, Connecticut. The bridge had a 100-foot section of its deck of its northbound span collapse on June 28, 1983. Three people were killed when their vehicles fell with the bridge into the Mianus River 70 feet below, and three were seriously injured. Casualties from the collapse were few because the disaster occurred at 1:30 a.m., when traffic was low on the often crowded highway.

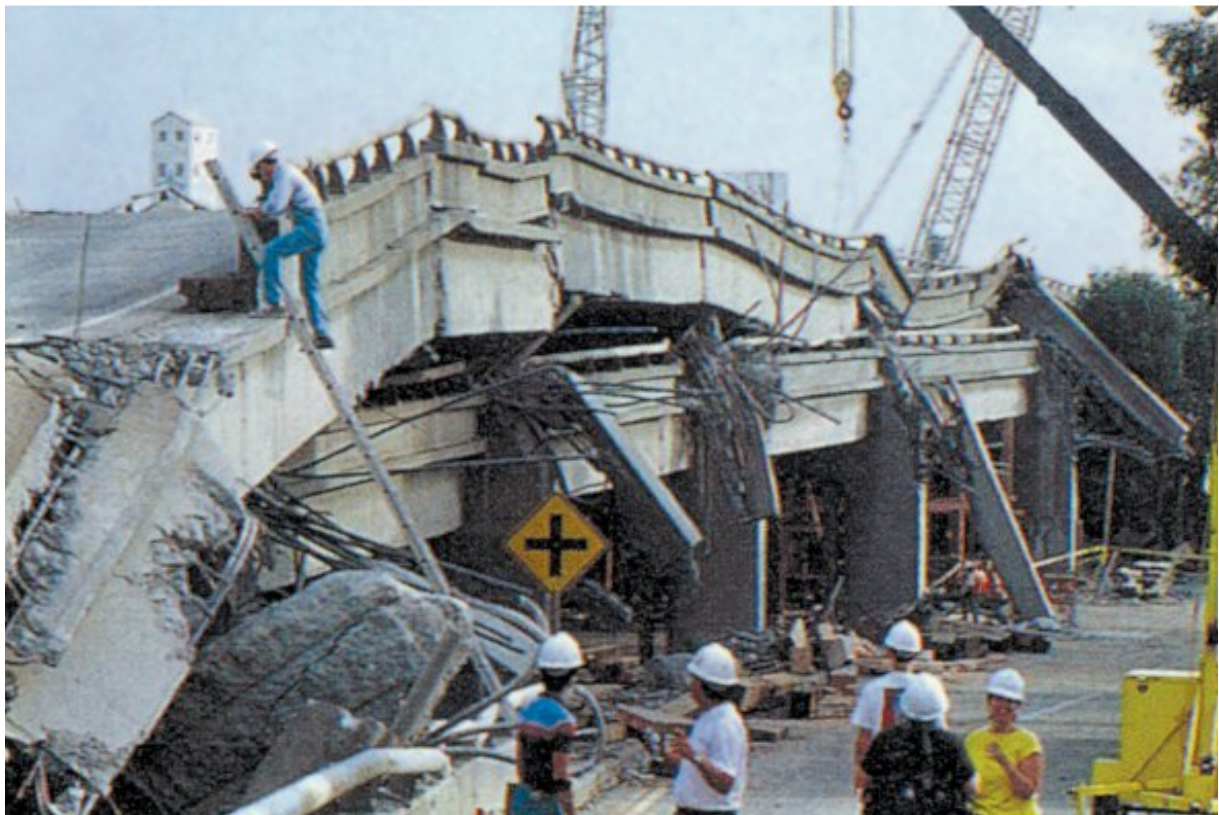
Figure 39

The Cypress Street Viaduct, often referred to as the Cypress Structure, was a 1.6 mile long, raised two-tier, multi-lane (four lanes per deck) freeway constructed of reinforced concrete that was originally part of the Nimitz Freeway (State Highway 17, and later, Interstate 880) in Oakland, California.

After the earth stopped moving, local residents and workers began crawling into and climbing upon the shattered structure with the goal of rescuing those left alive. Many were saved; some only by amputation of trapped limbs.[2] The collapse of the upper tier onto the lower tier resulted in 42 fatalities—two-thirds of the total quake death toll of 63[3].

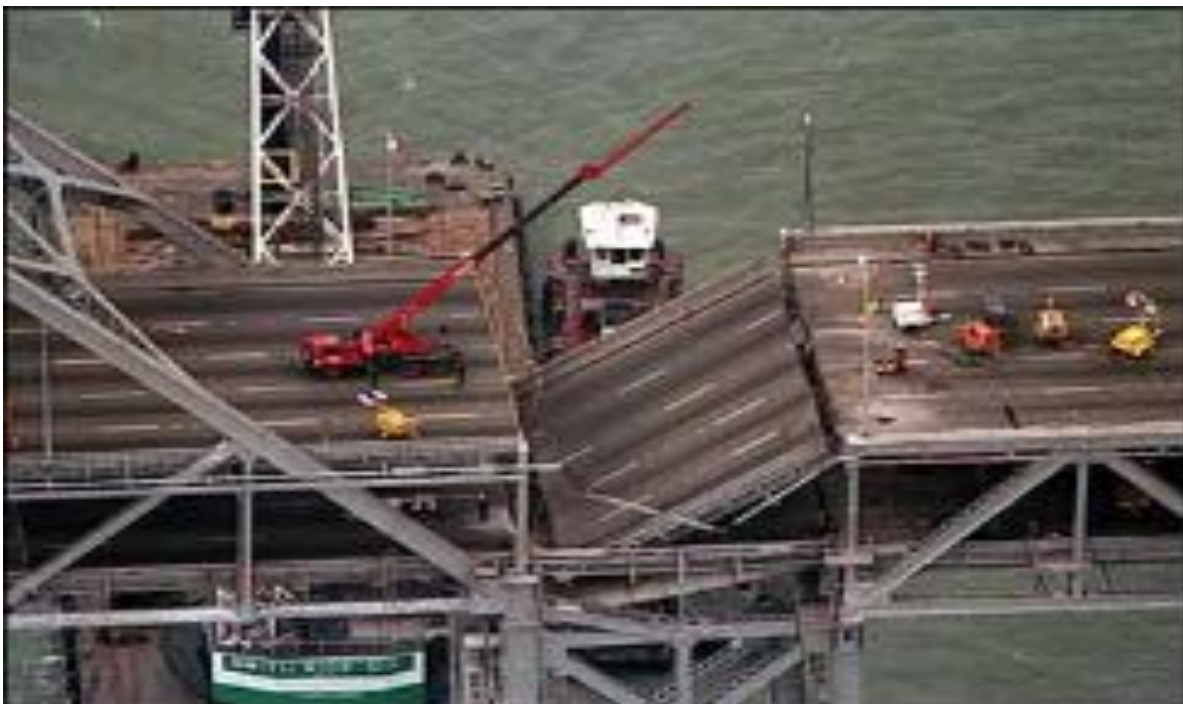
Figure 42

Year	1989
Type	Road
Country	United States
Cause	Natural hazard (Earthquake)
Details	Loma Prieta earthquake
Fatalities	1
Injuries	0
Collapse	partial
Phase	in service

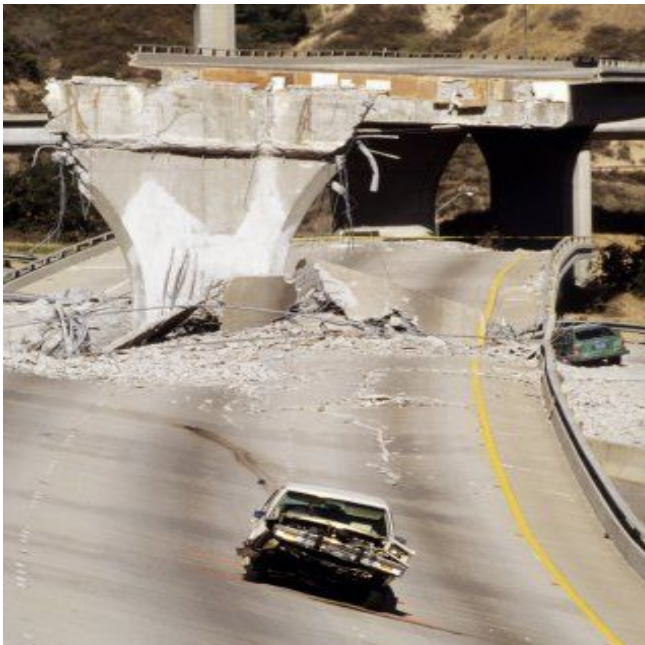
Figure 43

January 17, 1994, Northridge earthquake, which caused 57 deaths and widespread damages.

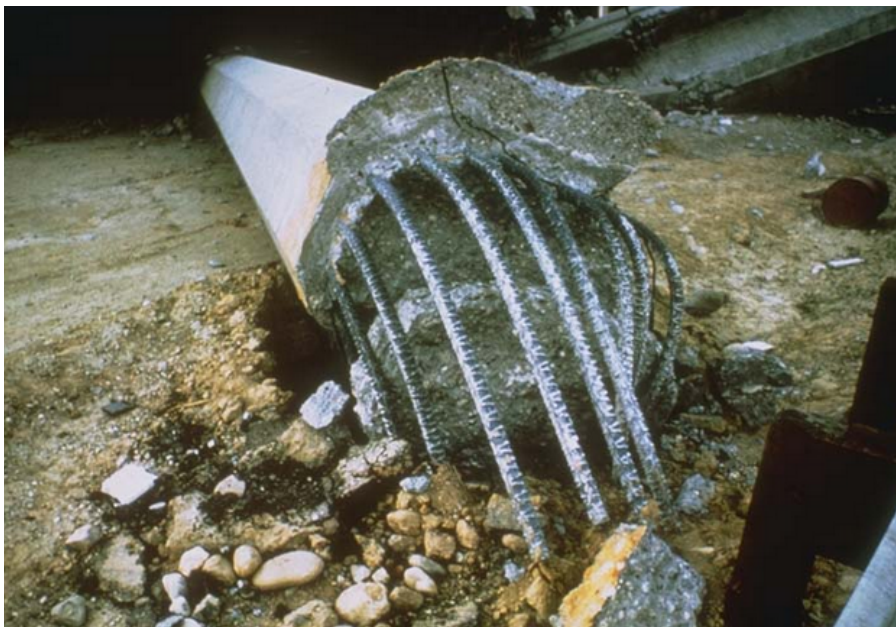
Figure 45

Bridge near Covington, Tennessee (Hatchie River)

Cause Natural hazard/Change in structural environment (Flooding)

Details Scouring and undermining of the foundations

A federal investigation found that the river channel had moved 83 feet since the bridge was built in 1936, and that the bridge likely failed as a result of the deterioration of timber piles that were originally buried and not designed to be in water.

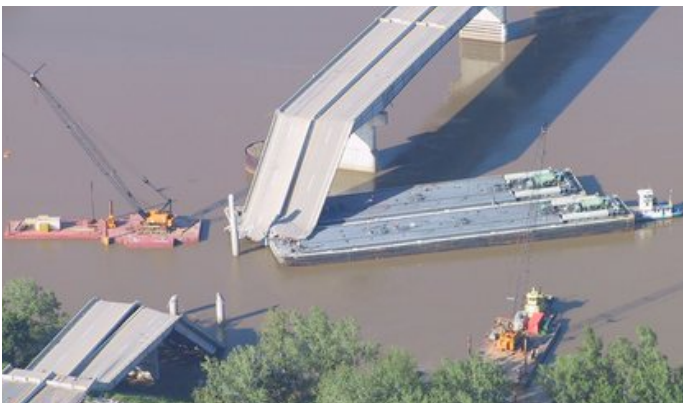
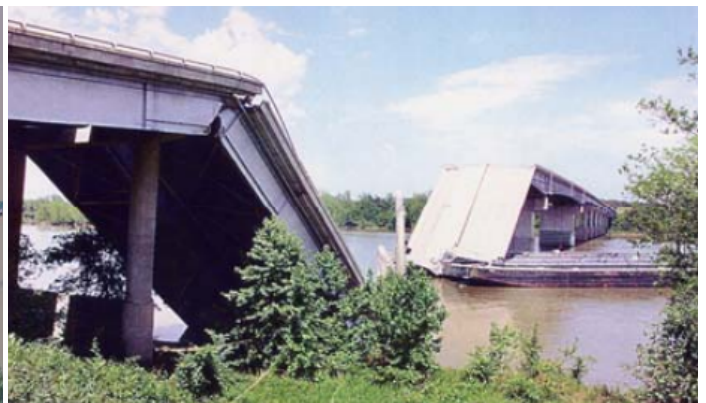
Figure 48

A barge collided with the Interstate 40 Bridge near Webbers Falls, Oklahoma, collapsing multiple spans and killing 14 people.

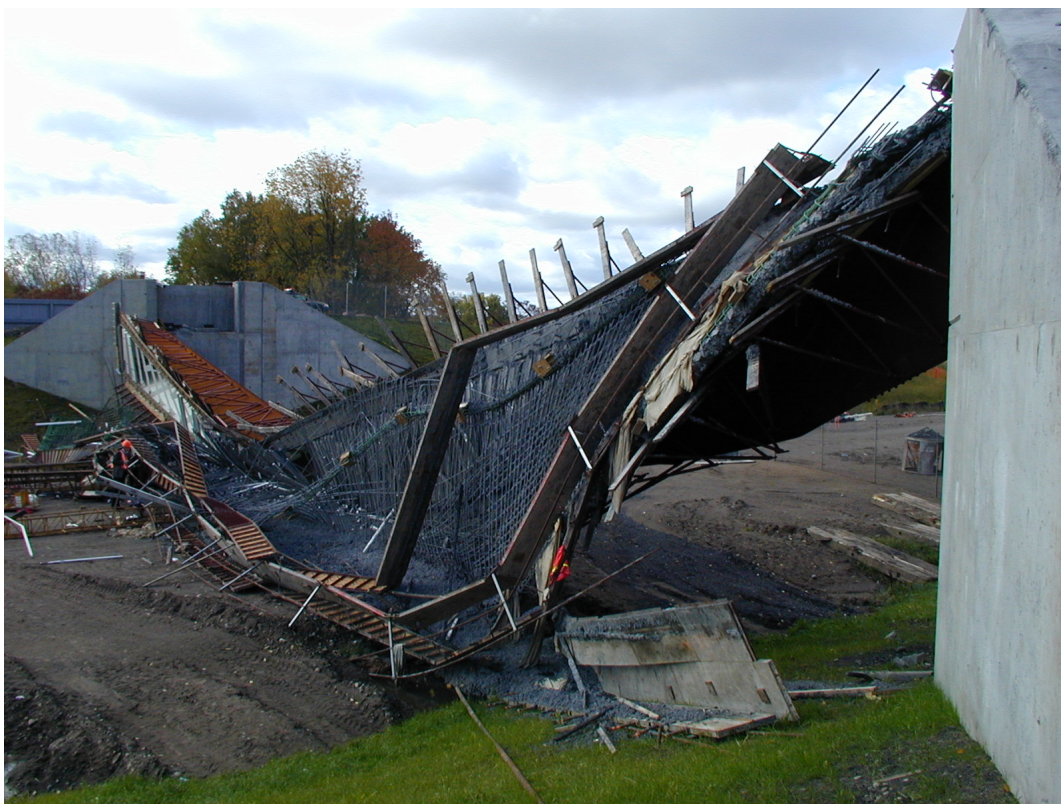
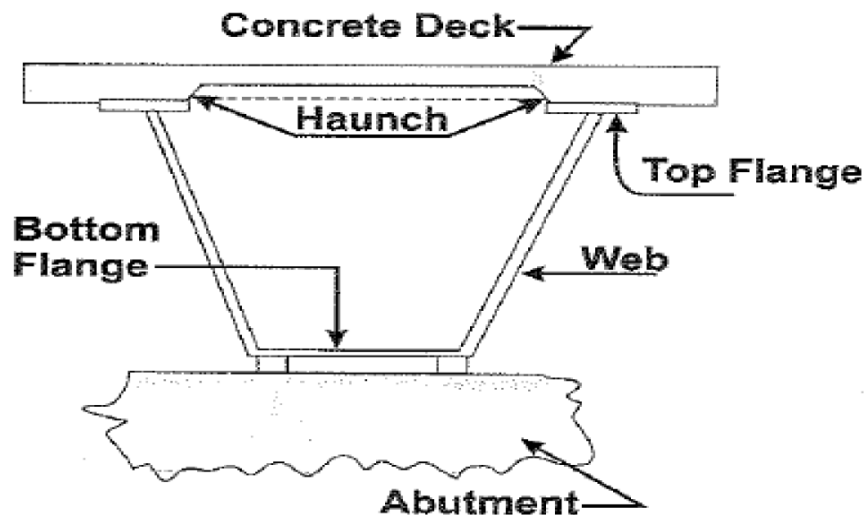
Figure 50

Collapse of the Marcy Pedestrian Bridge during the construction phase due to Lateral-Torsional-Buckling (LTB) during the deck concreting phase, which killed a worker.

Since the bridge is classified as a single box girder, the designed girder was excluded from the governing code subsection 10.51, which provides specifications for two or more single cell composite box girders. Only in this subsection the buckling phenomena were mentioned, although the global torsional buckling was not considered. Moreover the codes address the topic of bracing only with regards to bridges which have been already erected and bracers are specified to support flanges that will never be made composite. Consequently, since the considered bridge collapsed during the execution and is a composite structure these codes can't be considered valid for it.

Though diaphragms can't be considered as bracing systems if not anchored, this distinction is not clearly expressed in the NYCDOT code, where diaphragms are called bracing.

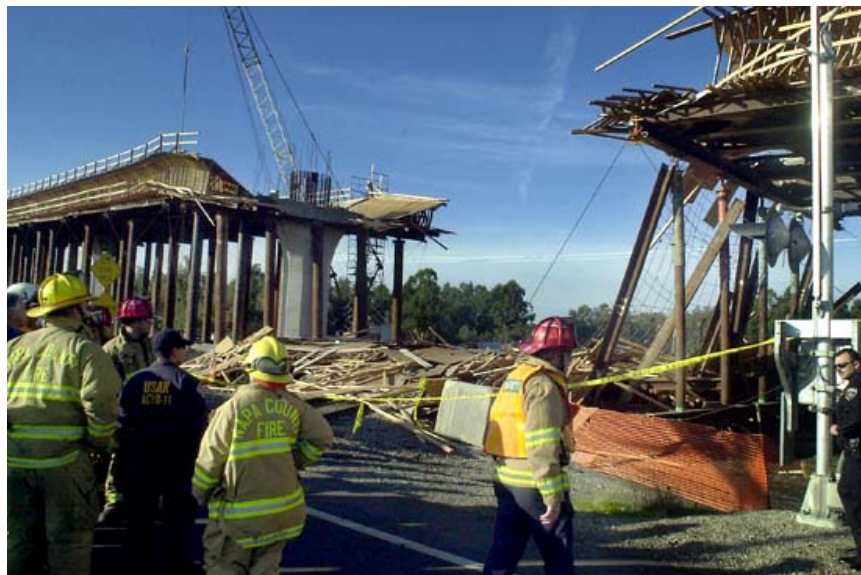
Figure 56

OSHA's investigation uncovered evidence that the three 100-ton hydraulic jacks used to raise the bridge construction's falsework were placed up to two inches off center, predisposing them to shifting under the weight they supported.

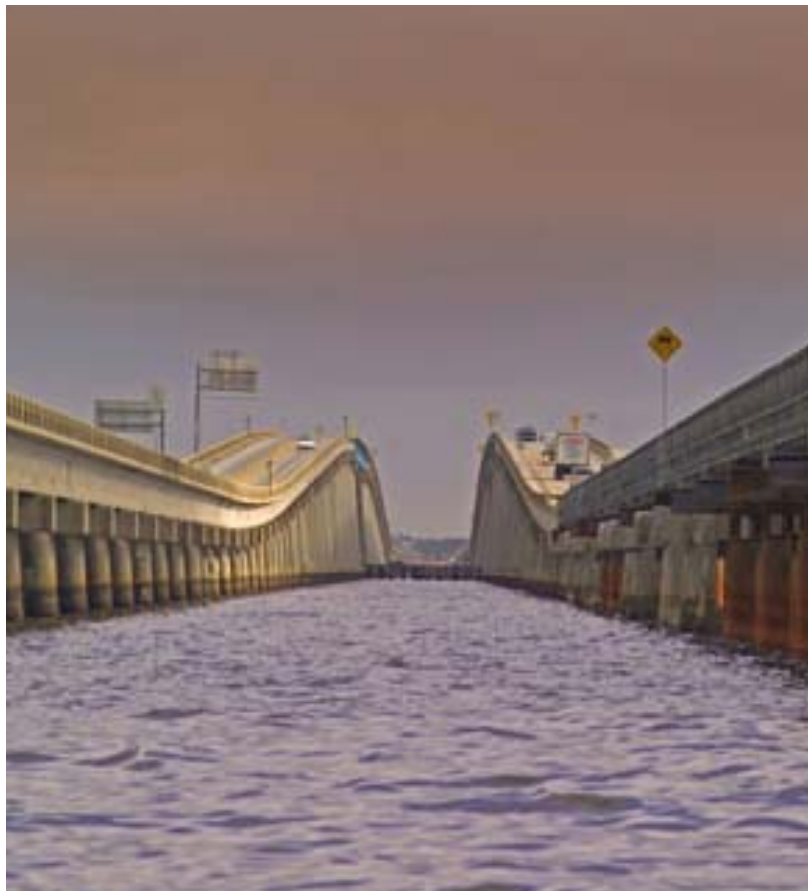
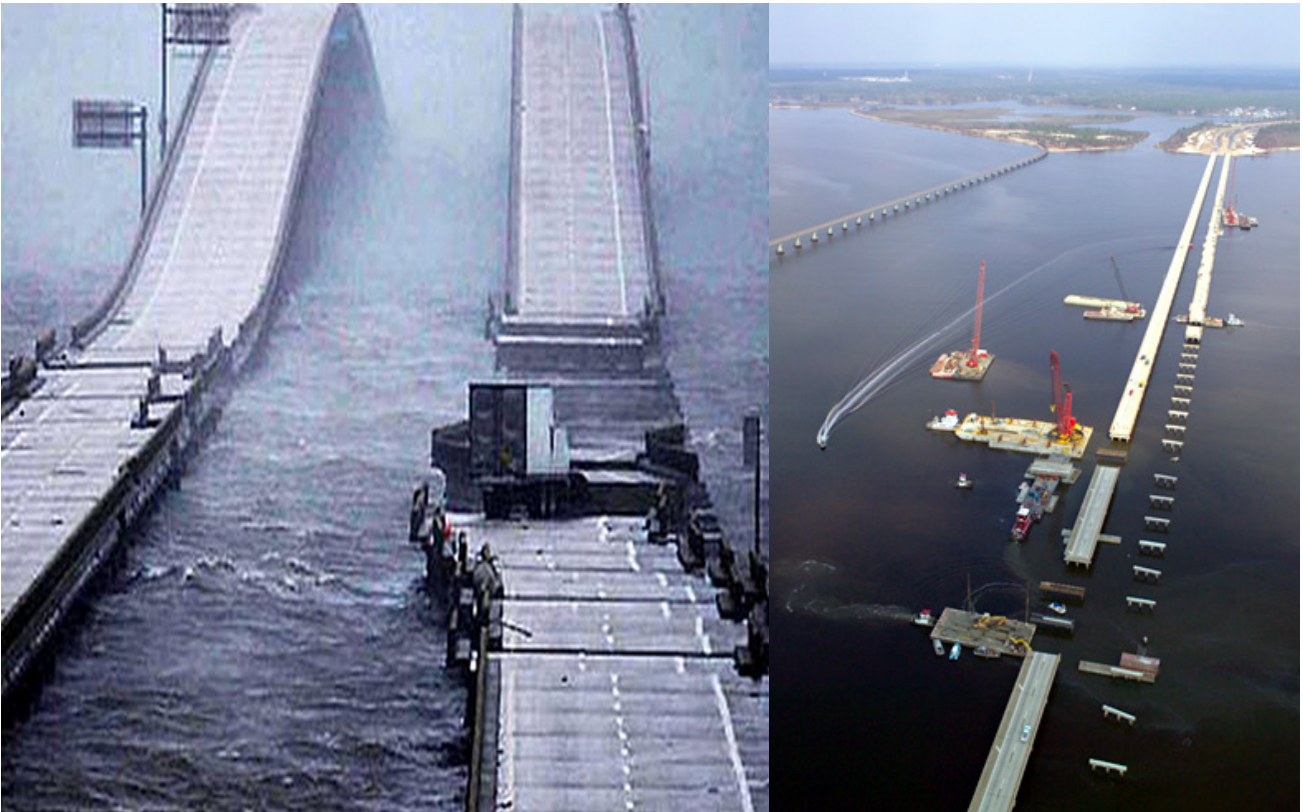
Figure 64-65

Interstate 10 Bridge, Escambia Bay, Florida

Year	2004
Type	Road
Country	United States
Cause	Natural hazard (Hurricane)
Details	Hurricane Yvan
Fatalities	0
Injuries	0
Collapse	partial
Phase	in service

Hurricane Ivan struck Pensacola, Florida on September 16, 2004, with wind velocity of 120-mile-per-hour, causing severely damages like in the 2.5 mile I-10 bridge over Escambia Bay. The hurricane's damage resulted in over 3,400 feet of the bridge that drops into the bay.

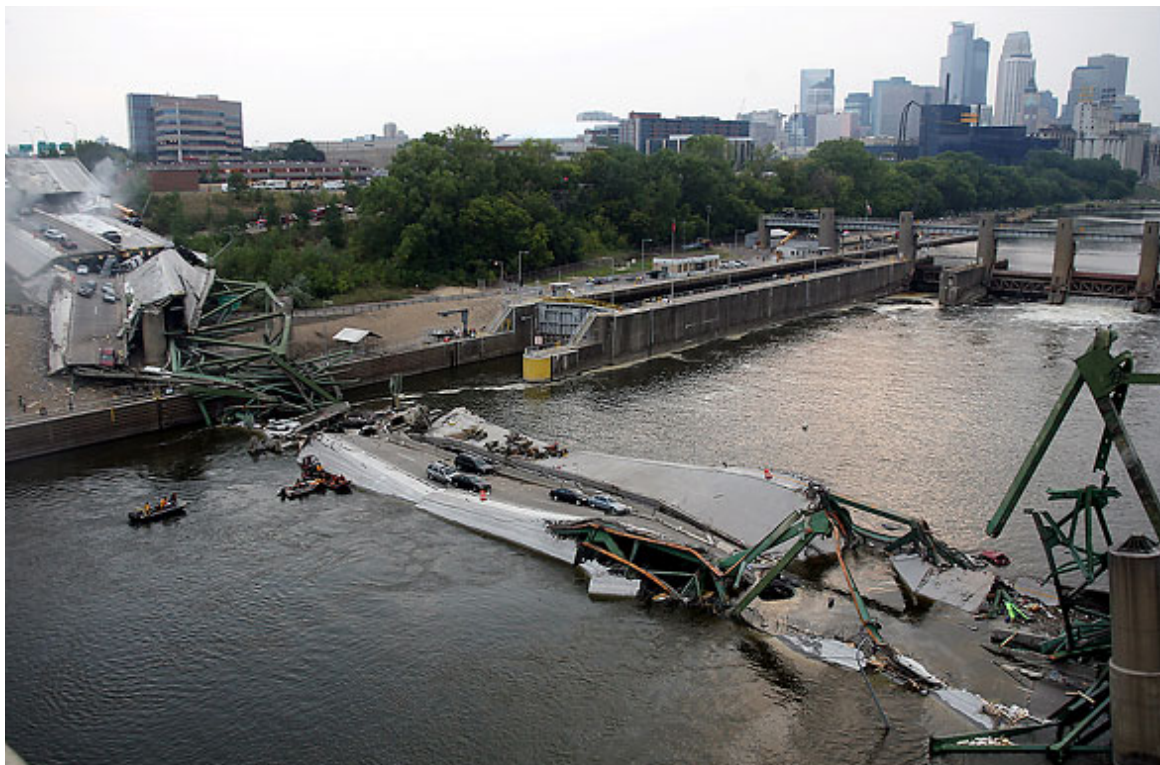
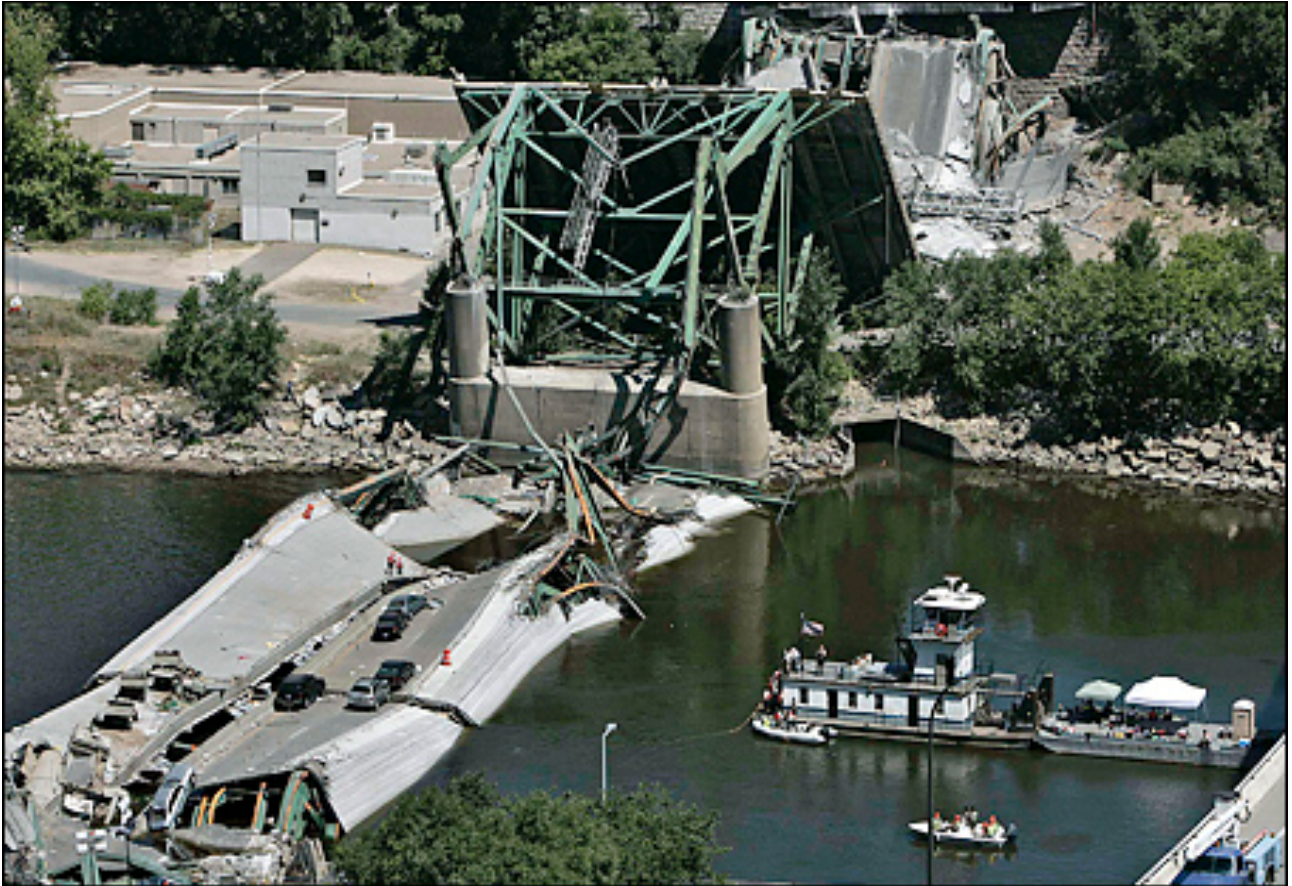
Figure 70

Structural fatigue, and the lack of a backup system in the event of a failure, may have been factors in the collapse of the Interstate 35-West bridge in Minnesota.

It is not still known exactly what caused the bridge to give way in Minneapolis, but state reports from 2001 and 2005 indicated there were *fatigue cracks* in the bridge's trusses, and that the bridge had no secondary system to bear the weight of traffic in the event of an unexpected failure. (*no redundancy*)

The bridge "exhibited several fatigue problems, primarily due to unanticipated out-of-plane distortion of the girders. Concern about fatigue cracking in the deck truss is heightened by a lack of redundancy in the main truss system," a 2001 report by the Minnesota transportation department found.

"Structural fatigue and fatigue cracks" could have contributed to the collapse, Roberto Ballarini, a structural engineer and head of the civil engineering department at the University of Minnesota, said.
